# ECOSUMMARY

A Report by the Surface Water Assessment and Monitoring Program (SWAMP)  
#96-004

## Carlton Branch, Hillsborough County A BioRecon Assessment April 1997

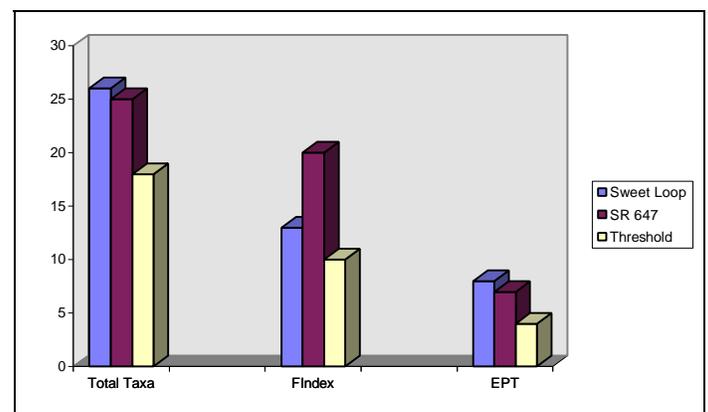
Fig. 2. BioRecon Scores

Both sites on Carlton Branch passed all three measurements of the BioRecon (Fig. 2). This indicated

a healthy stream macroinvertebrate community at the time of sampling. The two sites had similar numbers of Total Taxa and EPT species. The SR 674 site had more Florida Index species, probably due to greater recruitment potential downstream. The upper site may not be continually flowing, restricting the colonization of longer living aquatic organisms.
