For
Save Our Canals

Bay Crest - Tampa, FL
Reports 1 & 2

Report Service Dates:
Aug. 24th & Dec. 21st 2006

Report Release Date:
December 22, 2006

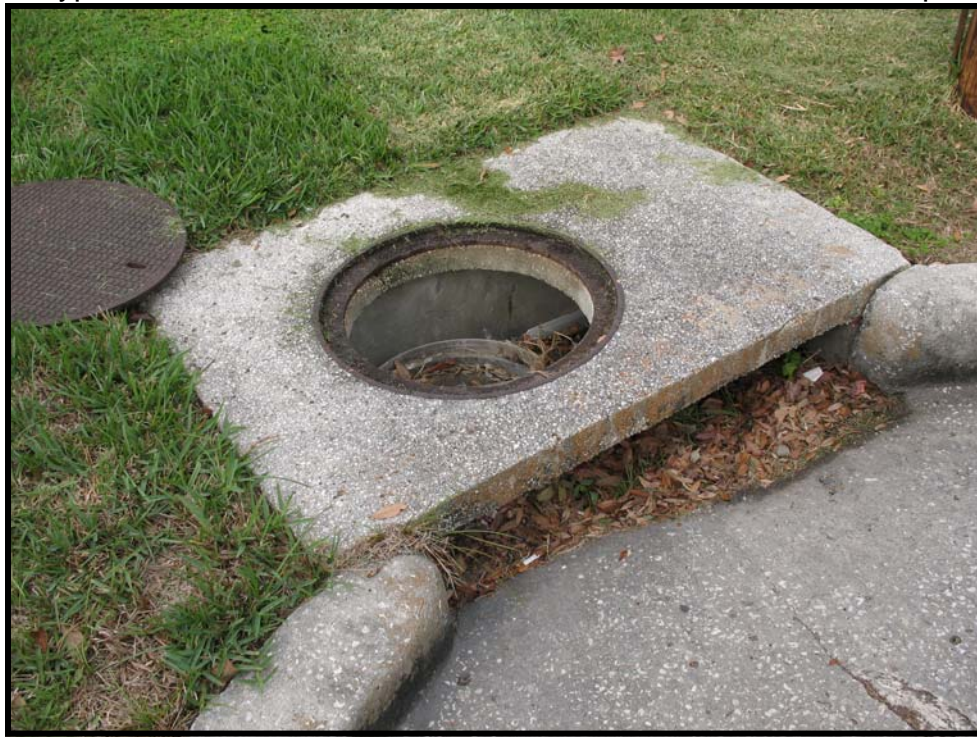
Typical catchbasin with throated inlet and manhole cover on top.

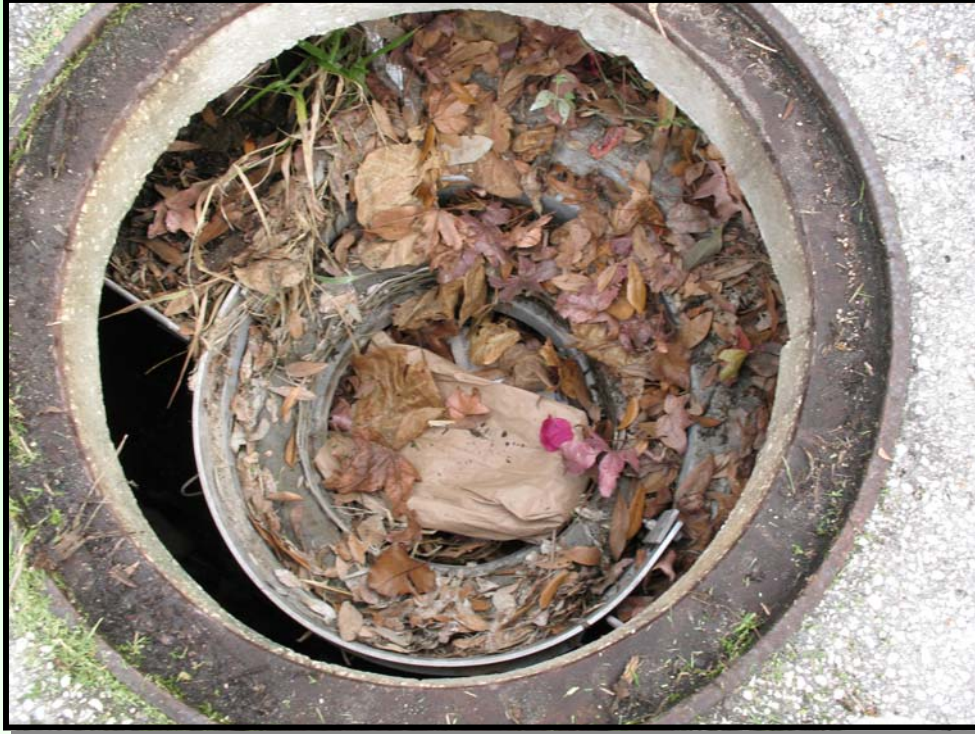
View inside catchbasin before the Curb Inlet Basket was removed.

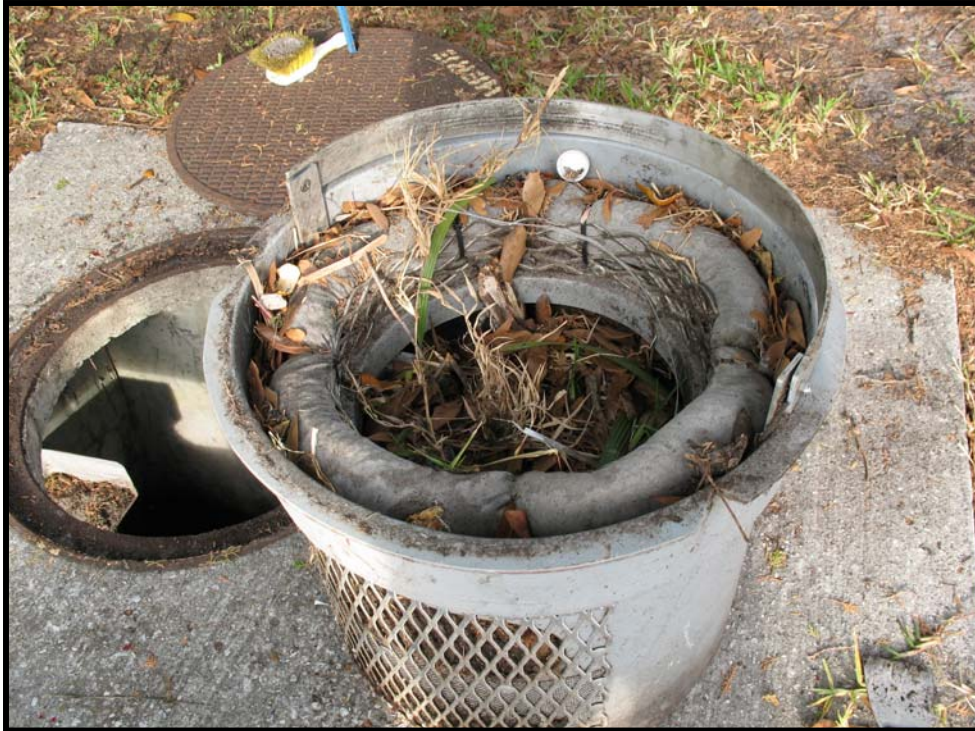
The Curb Inlet Basket has been removed from catchbasin.

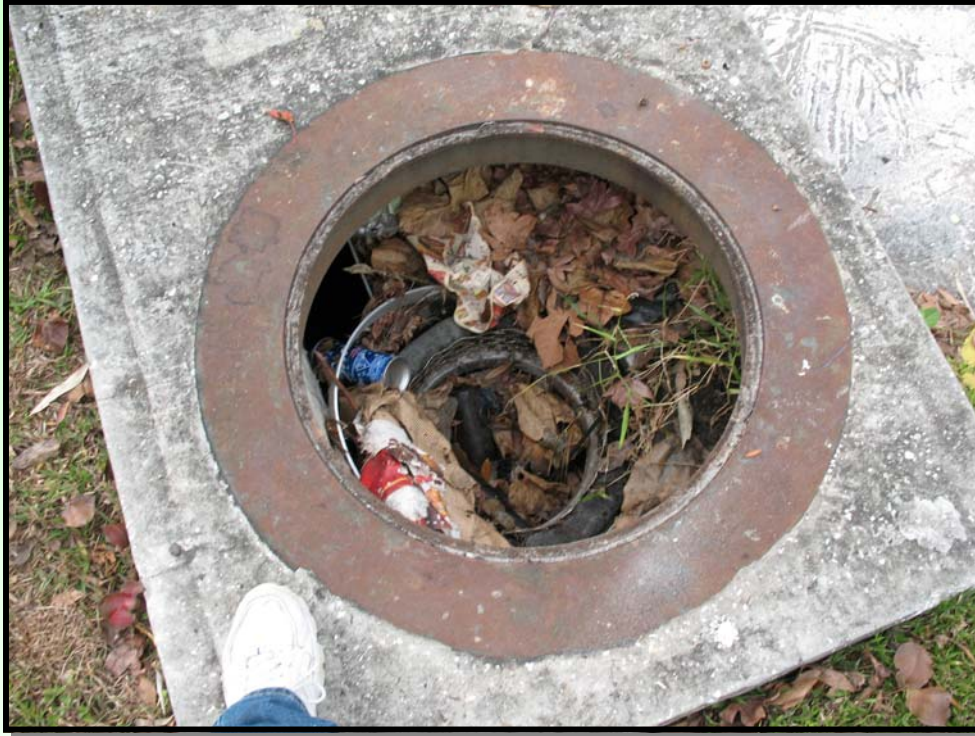
View inside catchbasin before the Curb Inlet Basket was removed.

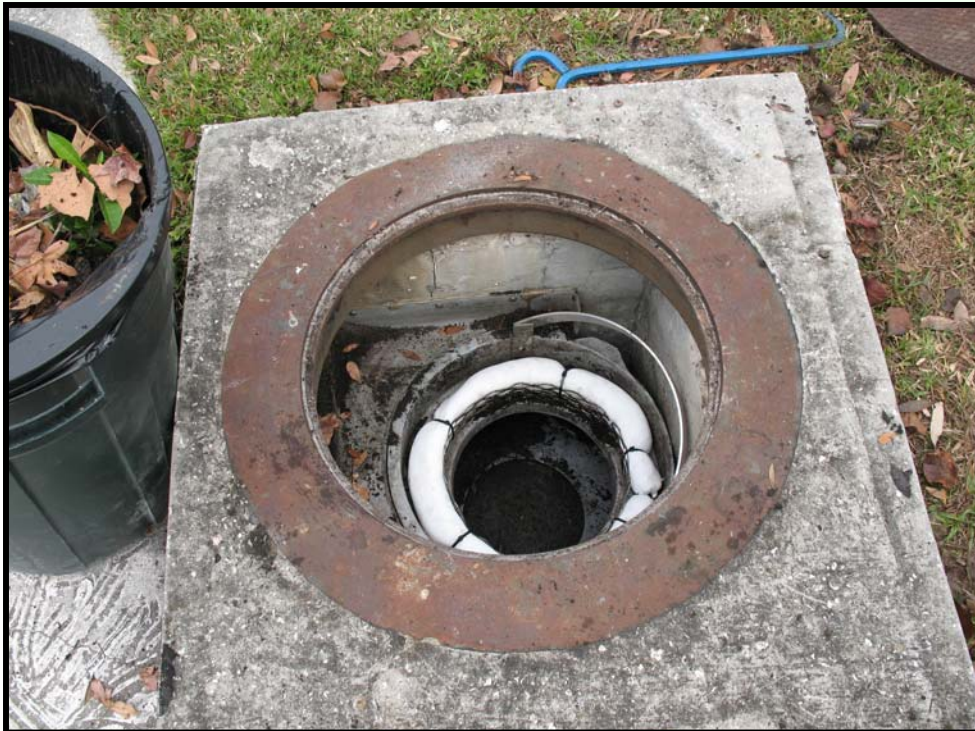
The Curb Inlet Basket has been serviced and the manhole cover is ready to be replaced.
