LAKE ASSESSMENT REPORT FOR TWIN LAKE IN HILLSBOROUGH COUNTY, FLORIDA

Date Assessed: August 13, 2008

Assessed by: Grant Harley and David Eilers

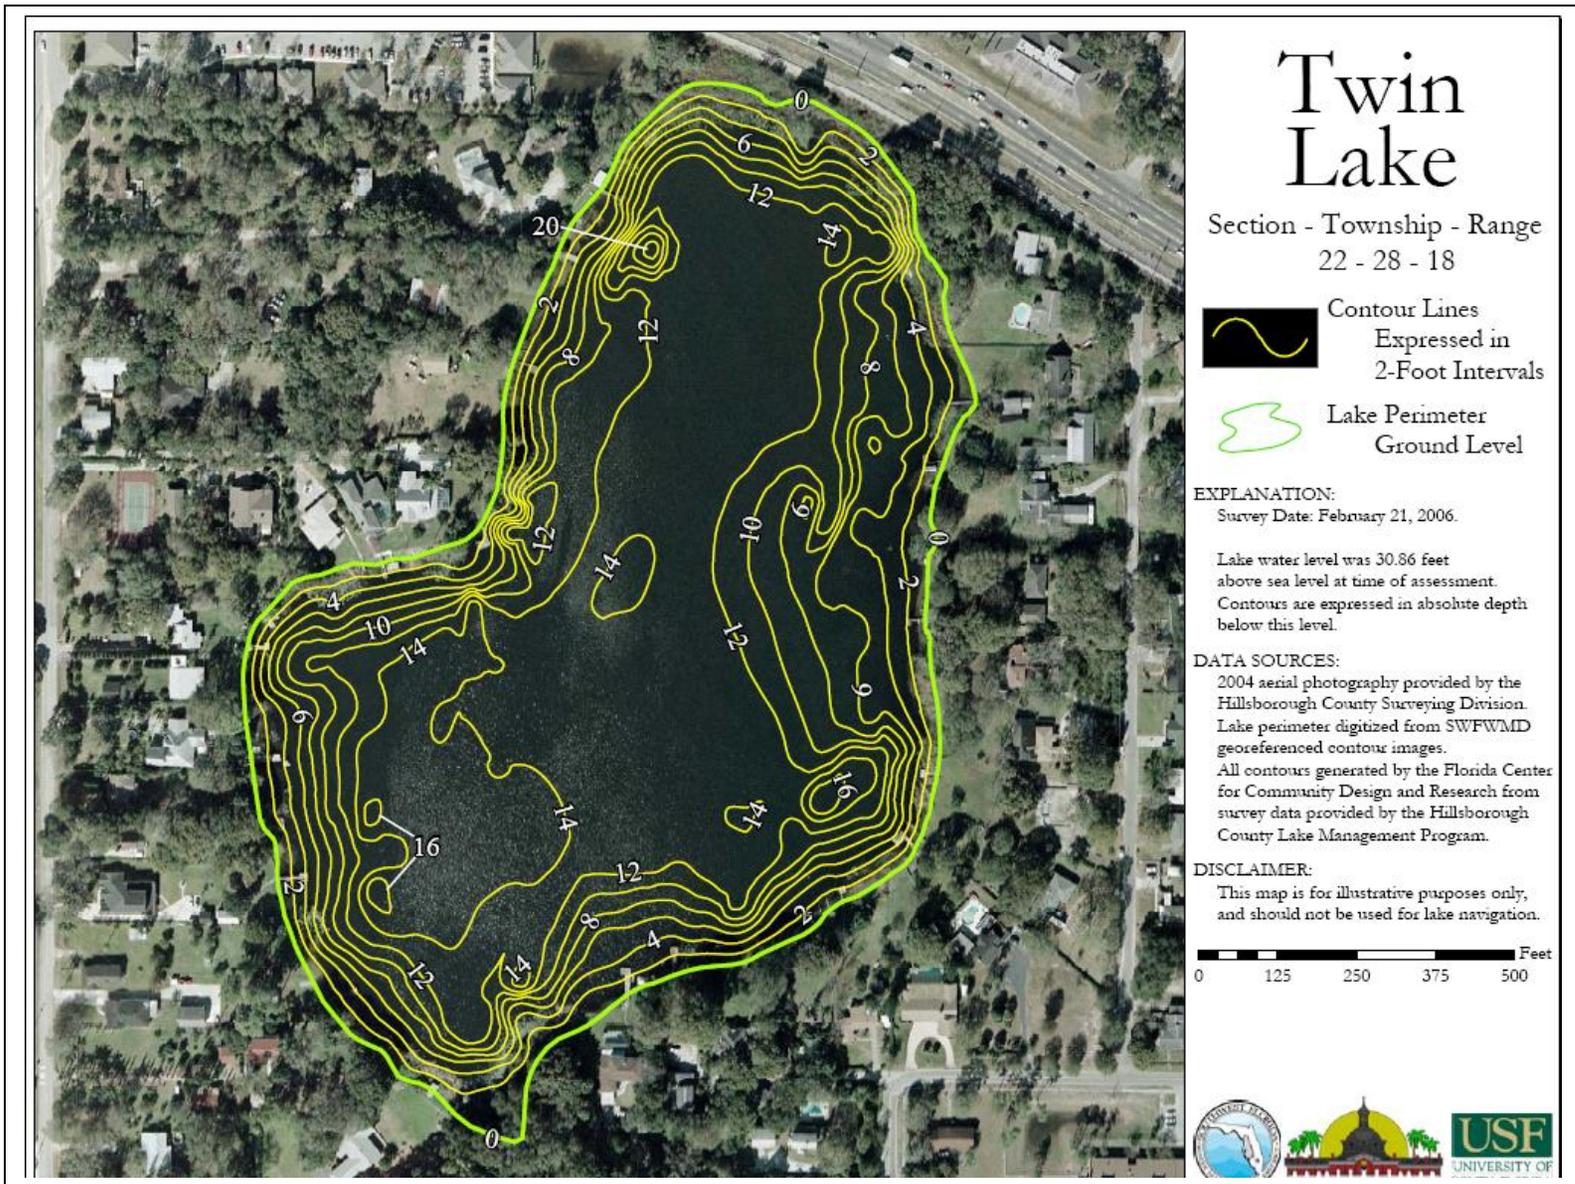
Figure 1. Contour map for Twin Lake created in 2006. The mapping technique used in 2008 employs a standard DGPS for horizontal position and a fathometer for depth.

Bathymetric Mapⁱⁱ. Table 1 provides the lake’s morphologic parameters in various units. The bottom of the lake was mapped using a Lowrance LCX 28C HD Wide Area Augmentation System (WAAS)ⁱⁱⁱ enabled Global Positioning System (GPS) with fathometer (bottom sounder) to determine the boat’s position, and bottom depth in a single measurement. The result is an estimate of the lake’s area, mean and maximum depths, and volume and the creation of a bottom contour map (Figure 2). Besides pointing out the deeper fishing holes in the lake, the morphologic data derived from this part of the assessment can be valuable to overall management of the lake vegetation as well as providing flood storage data for flood models.

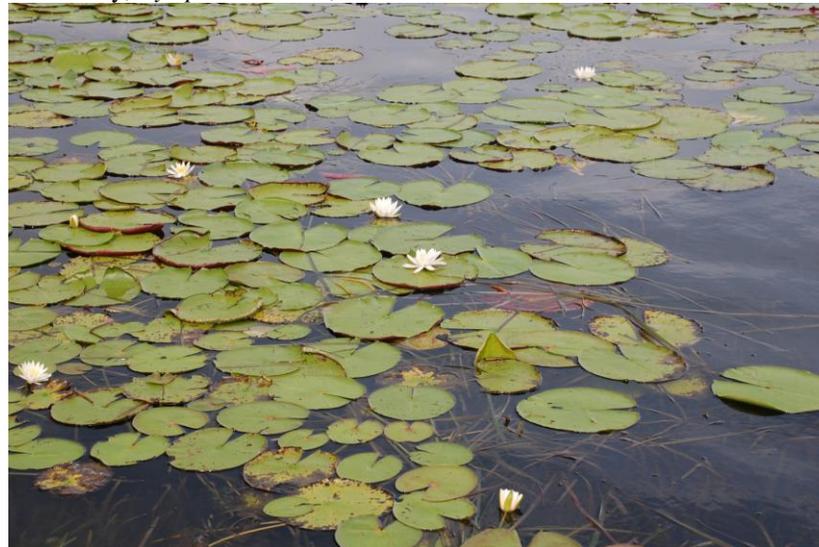
Figure 4. Photograph of American White Water Lily, *Nymphaea odorata*, on Twin Lake.

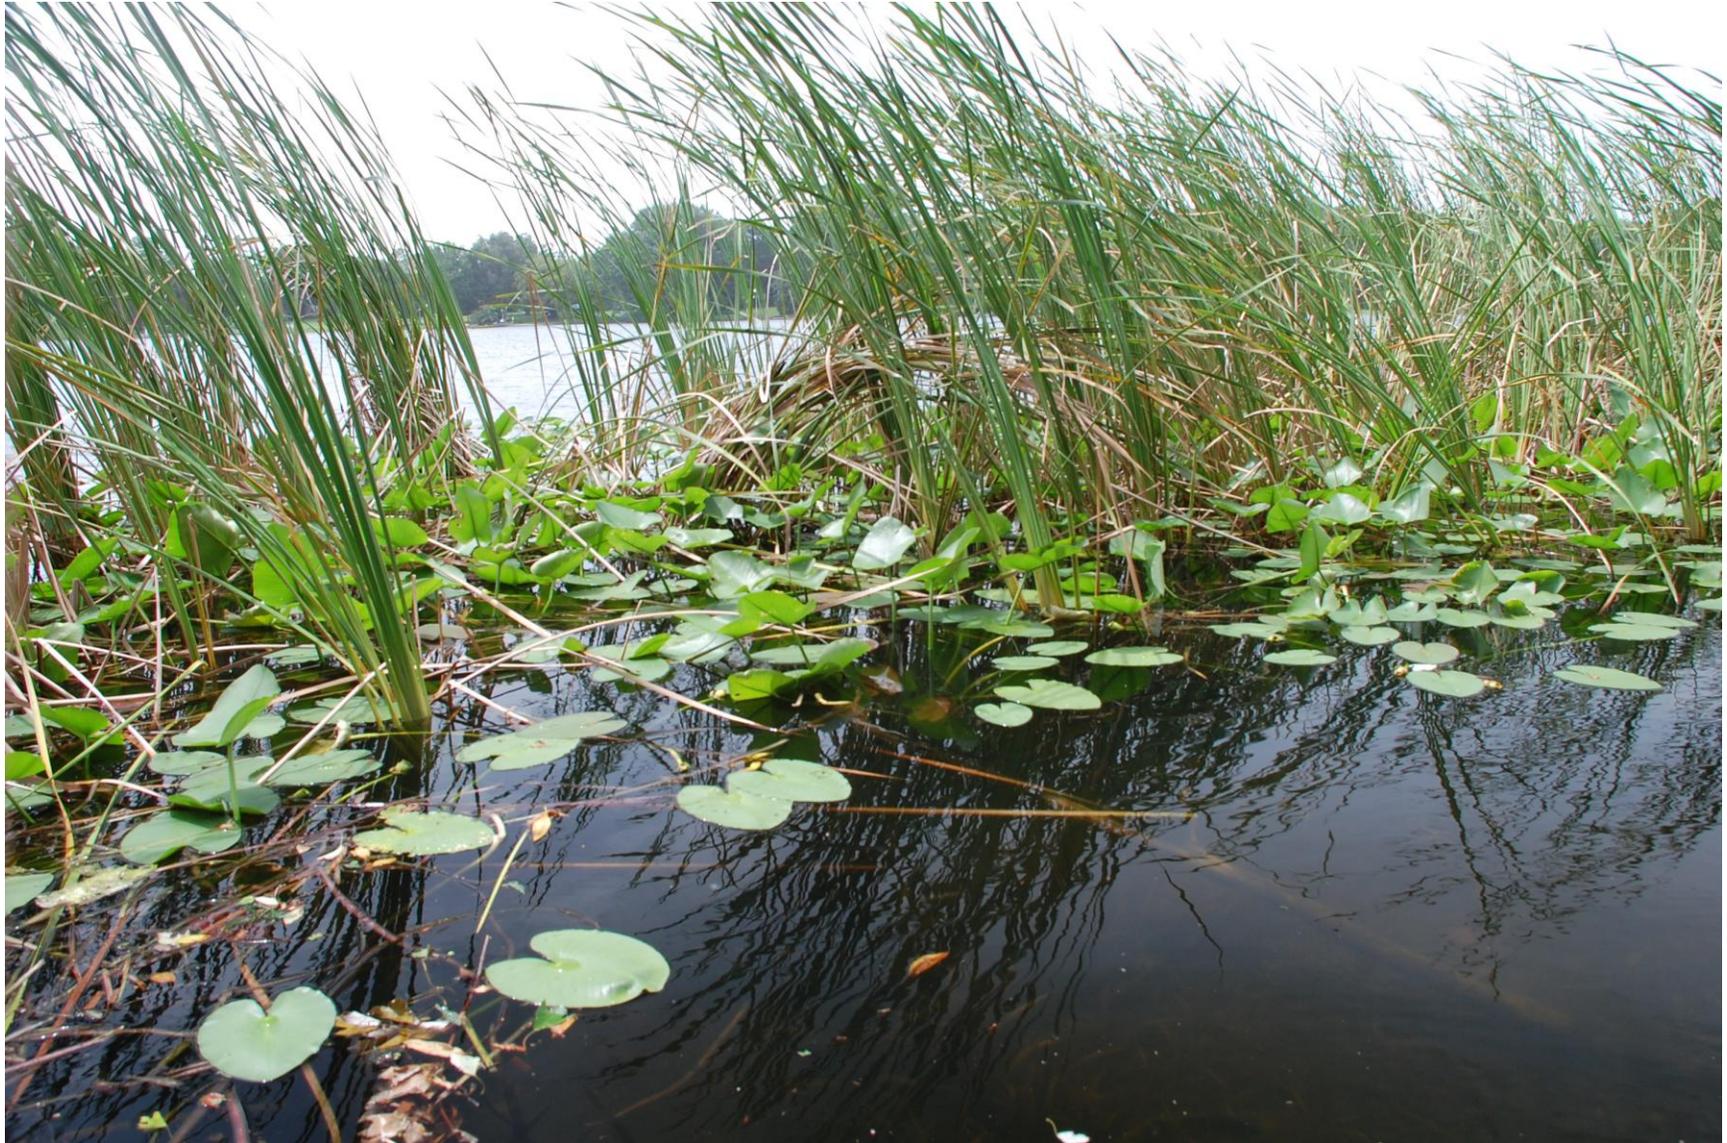
Figure 5. Photograph of Photograph of Cattails, *Typha spp*, on Twin Lake.

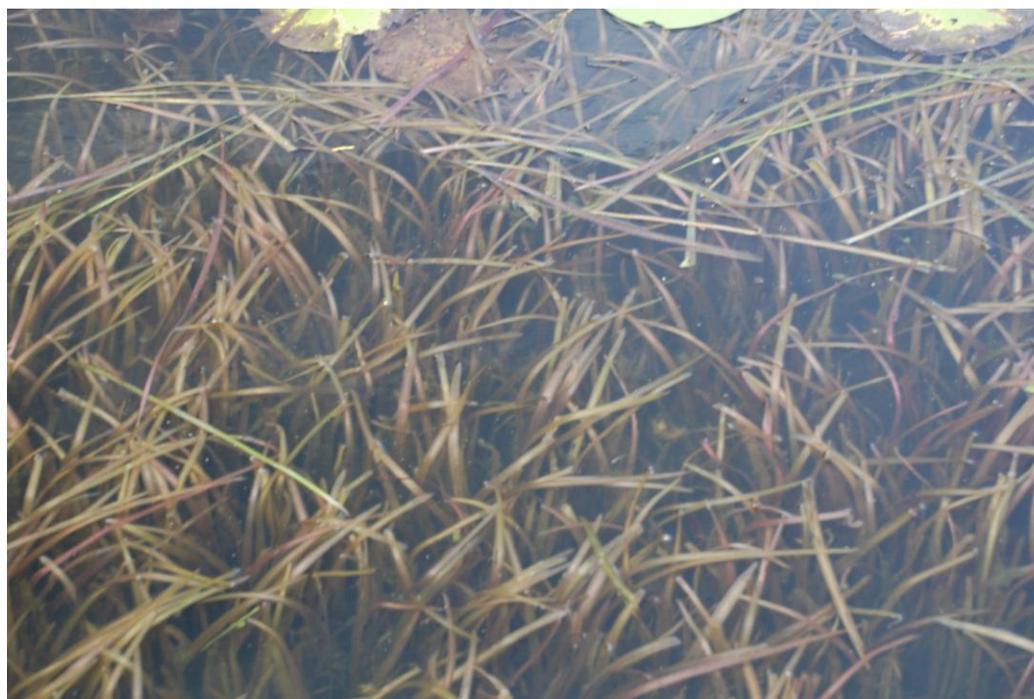
Figure 6. Photograph of Photograph of Tapegrass, *Vallisneria Americana*, on Twin Lake, Submerged vegetation such as this native species improves water quality and provides habitat for native fish and invertebrates.
