LAKE ASSESSMENT REPORT FOR LAKE ARMISTEAD IN HILLSBOROUGH COUNTY FLORIDA

Date Assessed: June 7, 2006

Assessed by: Sarah Koenig and David Eilers

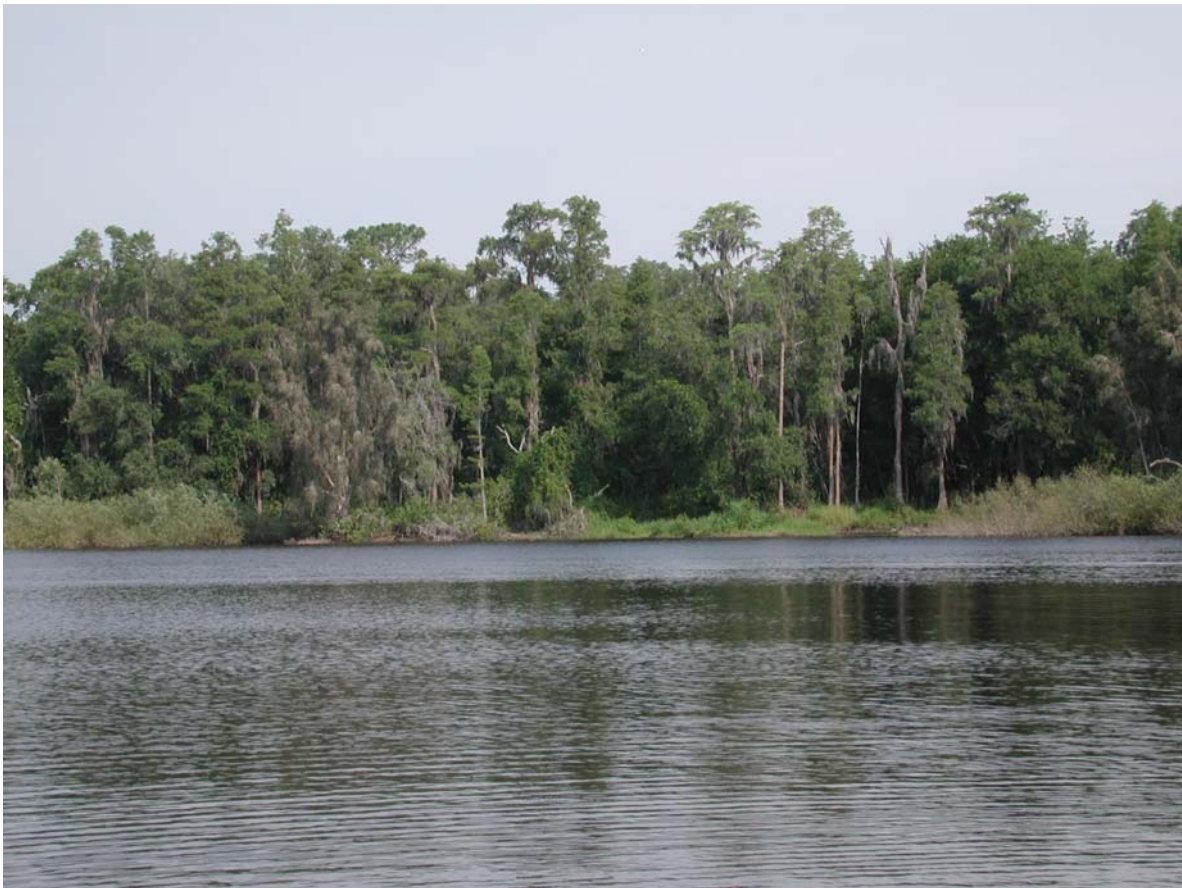
Figure 1. General Photo of Lake Armistead (6/7/2006).

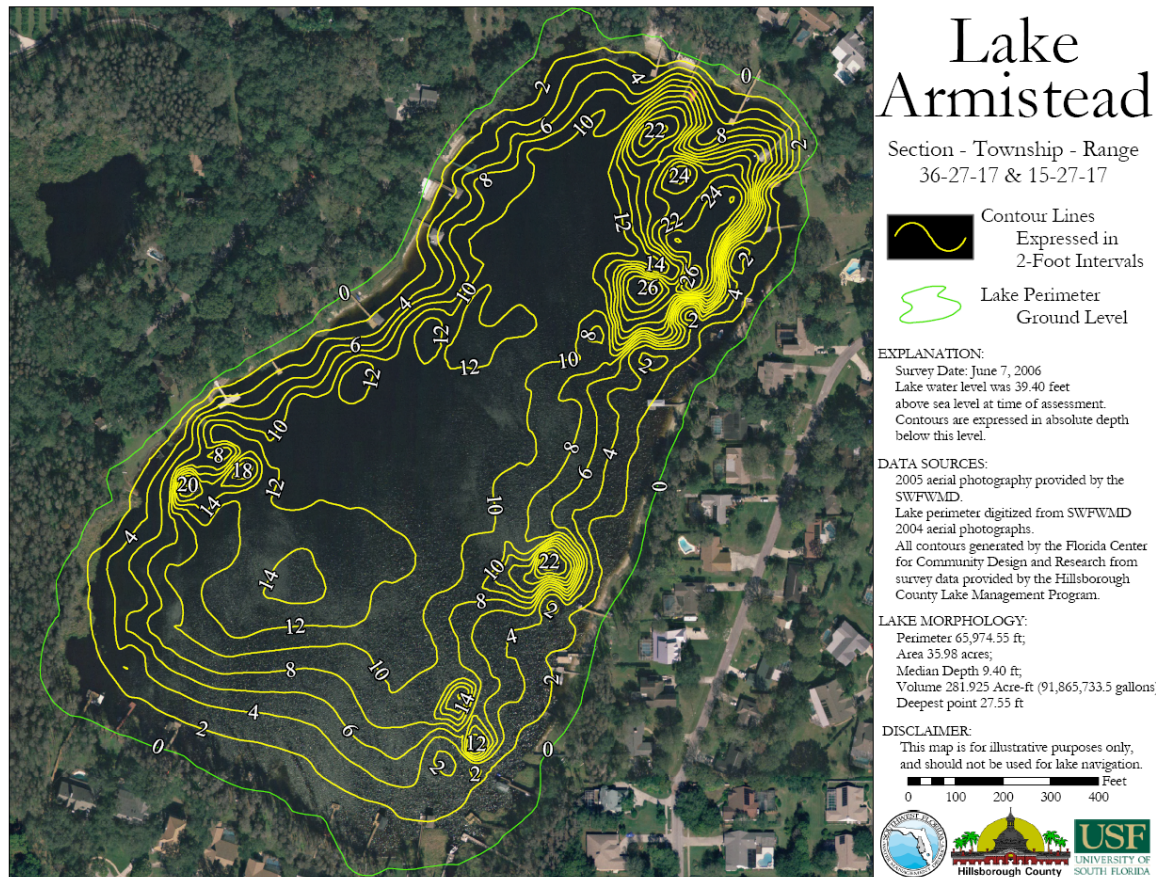
Figure 2. Contour map for Lake Armistead. The lake was mapped during the 2006 lake assessment project. A differential global positioning system and fathometer combination instrument was used to obtain simultaneous horizontal and vertical measurements.

Bathymetric Mapⁱⁱ. The bottom of the lake was mapped using a Lowrance LCX 26C HD Wide Area Augmentation System (WAAS)ⁱⁱⁱ enabled Global Positioning System (WAAS-GPS) with fathometer (bottom sounder) to determine the boat's position, and bottom depth in a single measurement. The result is an estimate of the lake's area, mean and maximum depths, and volume and the creation of a bottom contour map (Figure 2). Besides pointing out the deeper fishing holes in the lake, the morphologic data derived from this part of the assessment can be valuable to overall management of the lake vegetation as well as providing flood storage data for flood models. Table 1 provides the lake's morphologic parameters in various units.

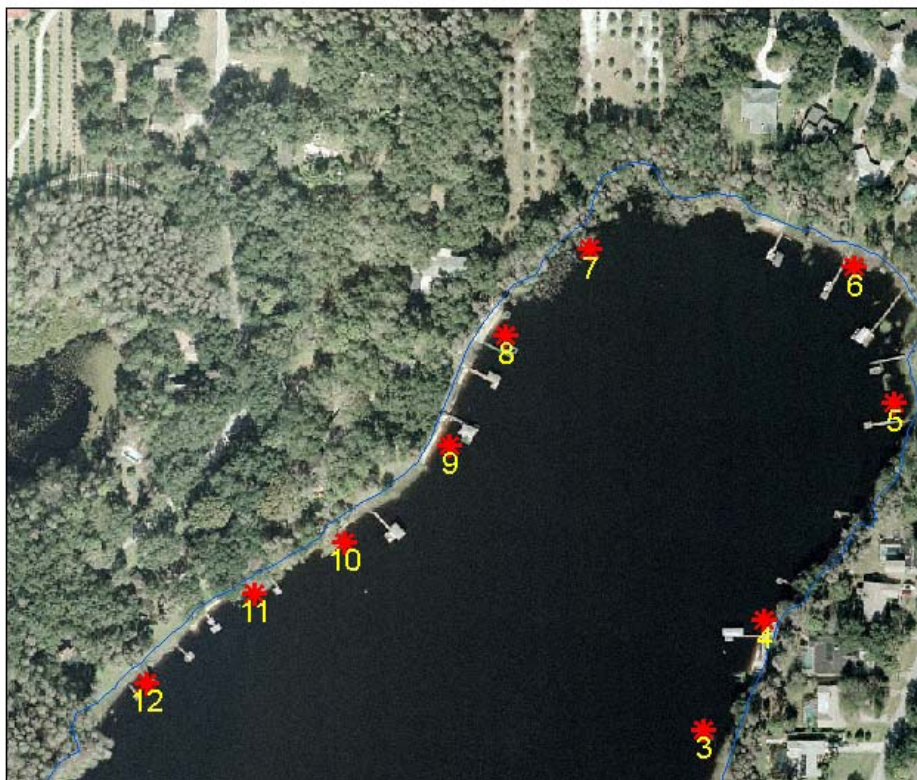
Figure 3. 2005 six inch resolution aerial and vegetation assessment sites on Lake Armistead.

The lake's apparent vegetative cover and shoreline detail are evaluated using the aerial shown in Figure 3 and by use of GPS. Submerged vegetation is determined from evenly spaced contours sampled using a Lowrance 26c HD, combined DGPS/fathometer described earlier. Fifteen vegetation assessment sites were used for Lake Armistead (Figure 3) as dictated by the *Lake Assessment Protocol* (copy available on request) for a lake of this size. The site positions are set using a DGPS and then loaded into a GIS mapping program (ArcGIS) for display. Each site is field sampled in the three primary vegetative zones (emergent, submerged and floating). The latest aerals (2005, 6 inch resolution, SWFWMD aerals) are used to provide shore details (docks, structures, vegetation zones) and to calculate the extent of surface vegetation coverage. The primary indices of submerged vegetation cover and biomass for the lake, percent area coverage (PAC) and percent volume infestation (PVI), are determined by transiting the lake by boat and employing a fathometer to collect "hard and soft return" data. These data are later analyzed for presence and absence of vegetation and to determine the height of vegetation if present. The PAC index is determined from the presence and absence analysis of 100 sites in the lake and the PVI index is determined by measuring the difference between hard returns (lake bottom) and soft returns (top of vegetation) for sites (within the 100 analyzed sites) where plants are determined present.

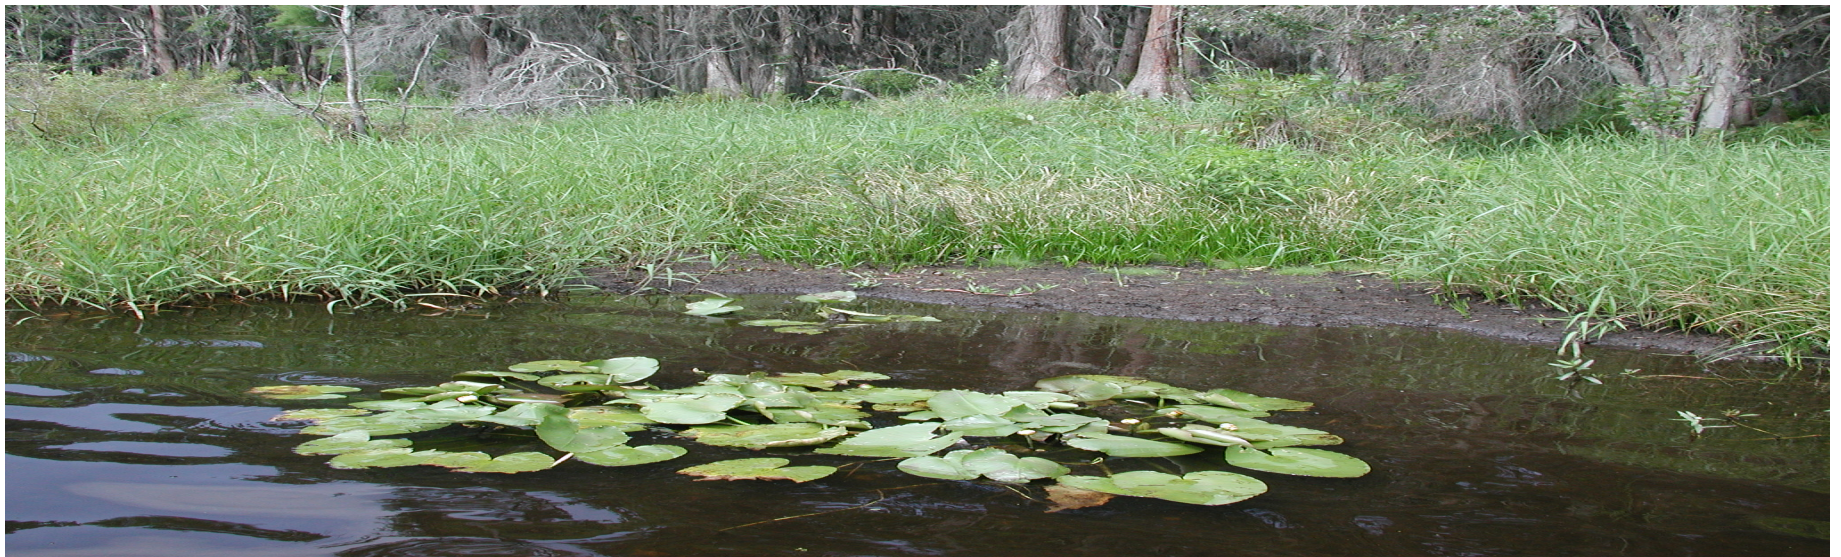
Figure 4- Spatterdock, Yellow Pondlily, shown in Lake Armistead.

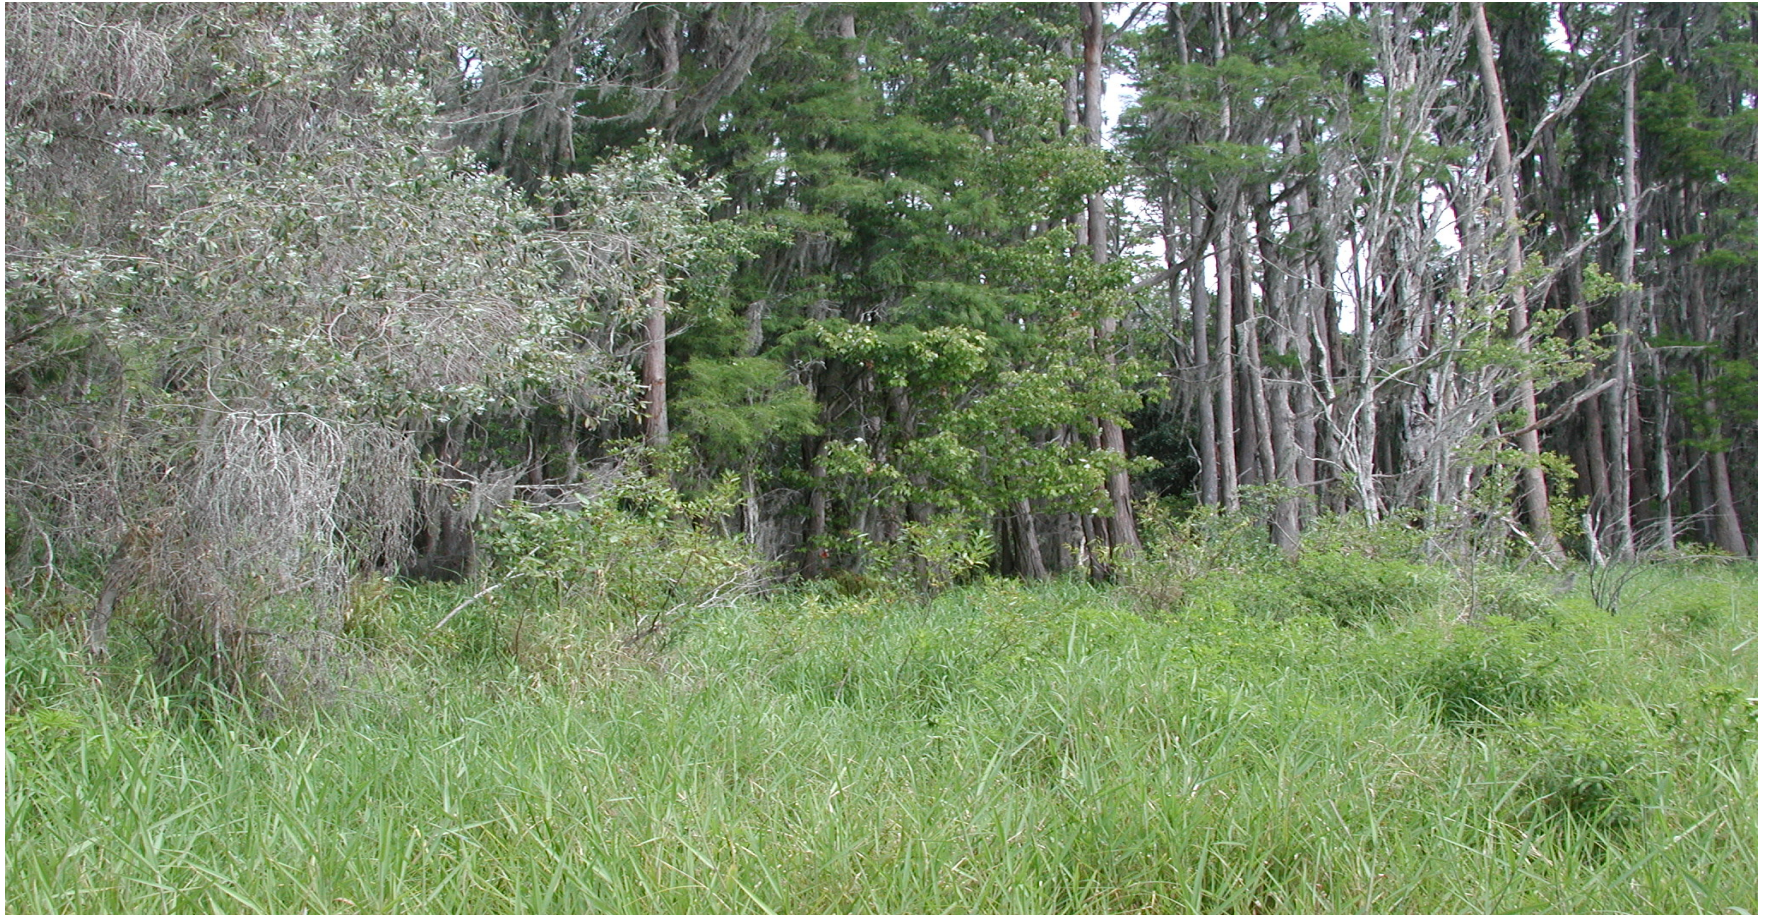
Figure 5- Lake Armistead shoreline vegetation showing Melaleuca (upper left), Red Maple (center background), Maidencane (foreground grass), and Primrose Willow (foreground shrubs).
