LAKE ASSESSMENT REPORT FOR LAKE ELIZABETH IN HILLSBOROUGH COUNTY FLORIDA

Date Assessed: July 27, 2006

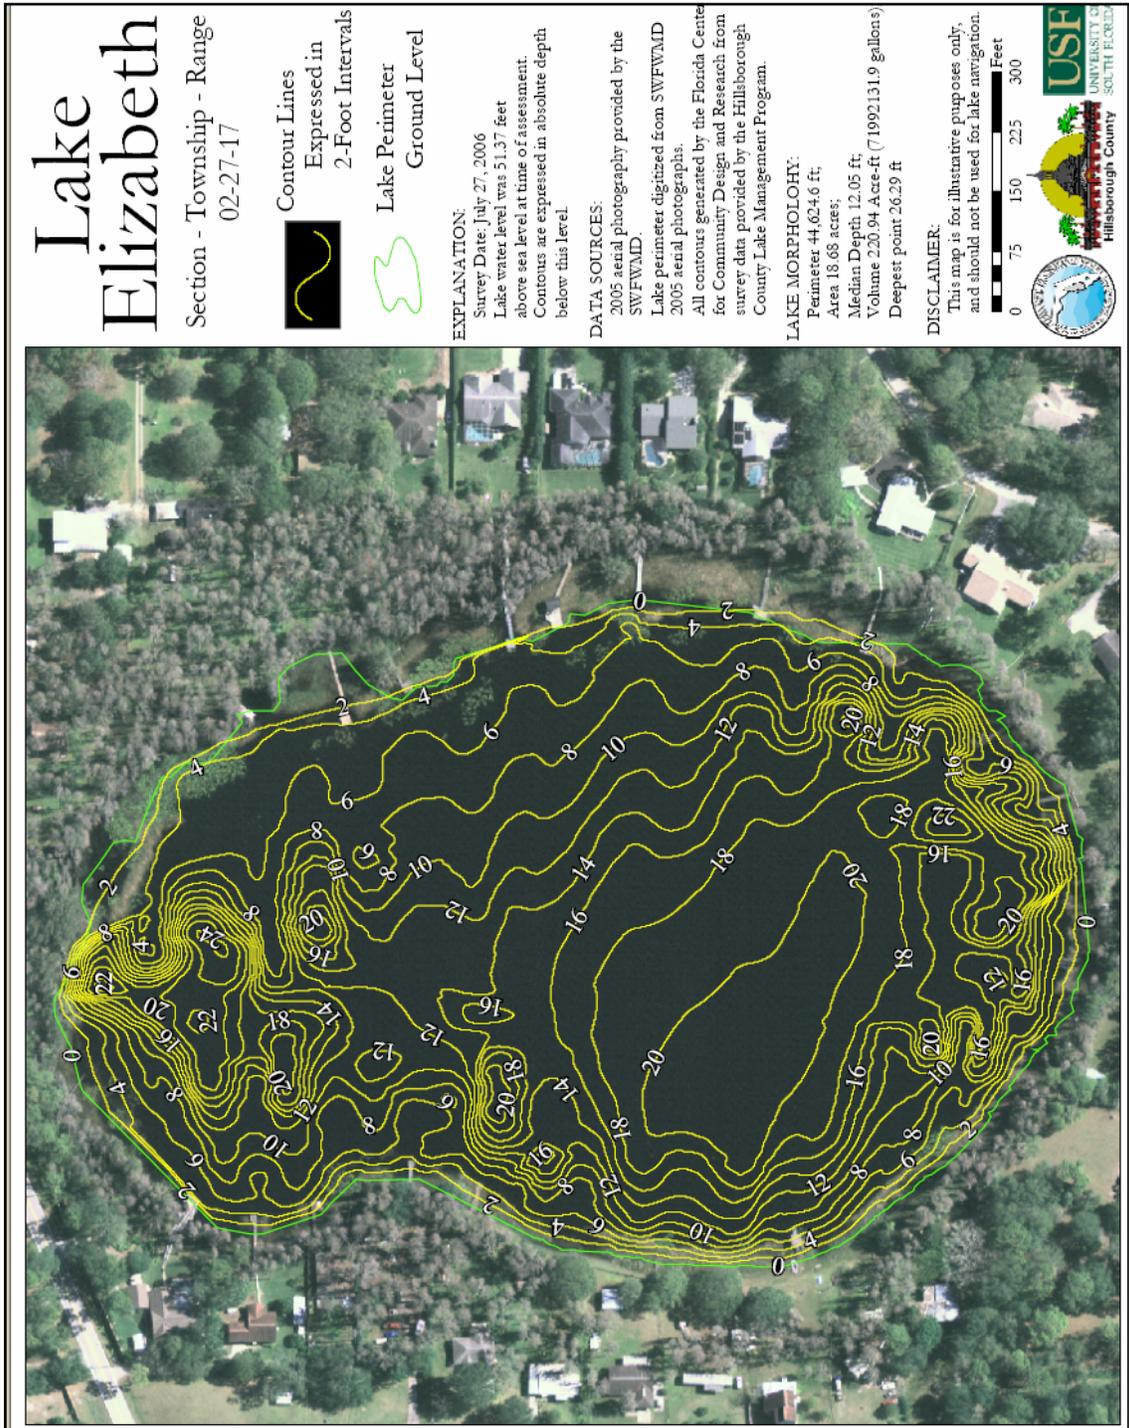
Figure 2. Contour map for Lake Elizabeth. The lake was mapped during the 2006 lake assessment project. A differential global positioning system and fathometer combination instrument was used to obtain simultaneous horizontal and vertical measurements.

Bathymetric Mapⁱⁱ. The bottom of the lake was mapped using a Lowrance LCX 26C HD Wide Area Augmentation System (WAAS)ⁱⁱⁱ enabled Global Positioning System (WAAS-GPS) with fathometer (bottom sounder) to determine the boat’s position, and bottom depth in a single measurement. The result is an estimate of the lake’s area, mean and maximum depths, and volume and the creation of a bottom contour map (Figure 2). Besides pointing out the deeper fishing holes in the lake, the morphologic data derived from this part of the assessment can be valuable to overall management of the lake vegetation as well as providing flood storage data for flood models. Table 1 provides the lake’s morphologic parameters in various units.

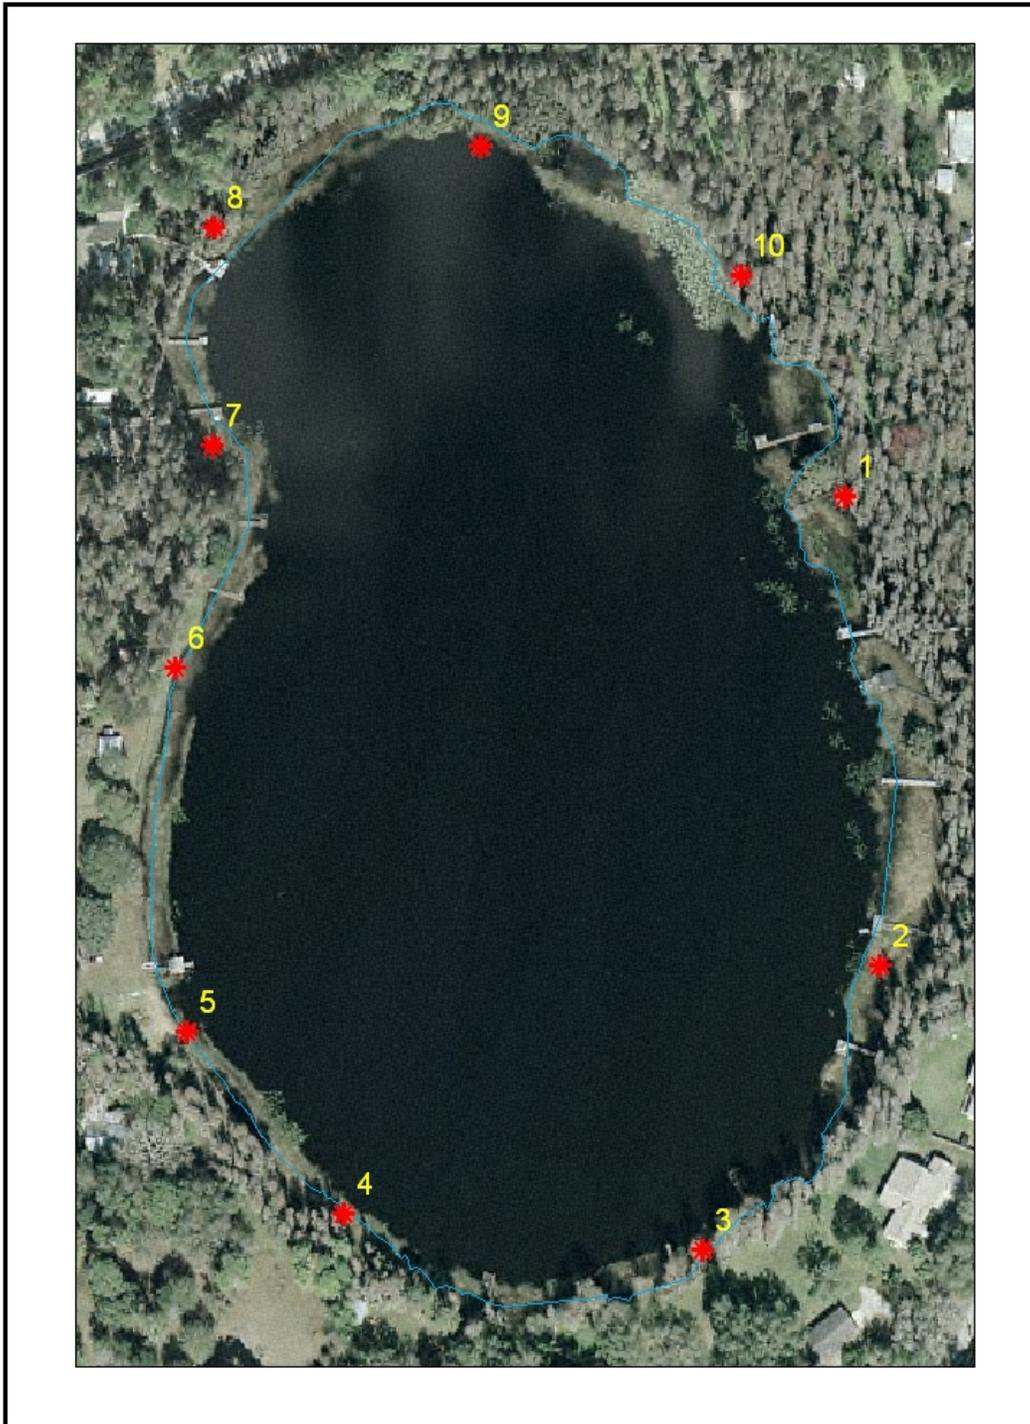
Figure 3. 2005 six inch resolution aerial and vegetation assessment sites on Lake Elizabeth.

The lake's apparent vegetative cover and shoreline detail are evaluated using the aerial shown in Figure 3 and by use of GPS. Submerged vegetation is determined from evenly spaced contours sampled using a Lowrance 26c HD, combined DGPS/fathometer described earlier. Ten vegetation assessment sites were used for Lake Elizabeth (Figure 3) as dictated by the *Lake Assessment Protocol* (copy available on request) for a lake of this size. The site positions are set using a DGPS and then loaded into a GIS mapping program (ArcGIS) for display. Each site is field sampled in the three primary vegetative zones (emergent, submerged and floating). The latest aerials (2005, 6 inch resolution, SWFWMD aerials) are used to provide shore details (docks, structures, vegetation zones) and to calculate the extent of surface vegetation coverage. The primary indices of submerged vegetation cover and biomass for the lake, percent area coverage (PAC) and percent volume infestation (PVI), are determined by transiting the lake by boat and employing a fathometer to collect "hard and soft return" data. These data are later analyzed for presence and absence of vegetation and to determine the height of vegetation if present. The PAC index is determined from the presence and absence analysis of 100 sites in the lake and the PVI index is determined by measuring the difference between hard returns (lake bottom) and soft returns (top of vegetation) for sites (within the 100 analyzed sites) where plants are determined present.

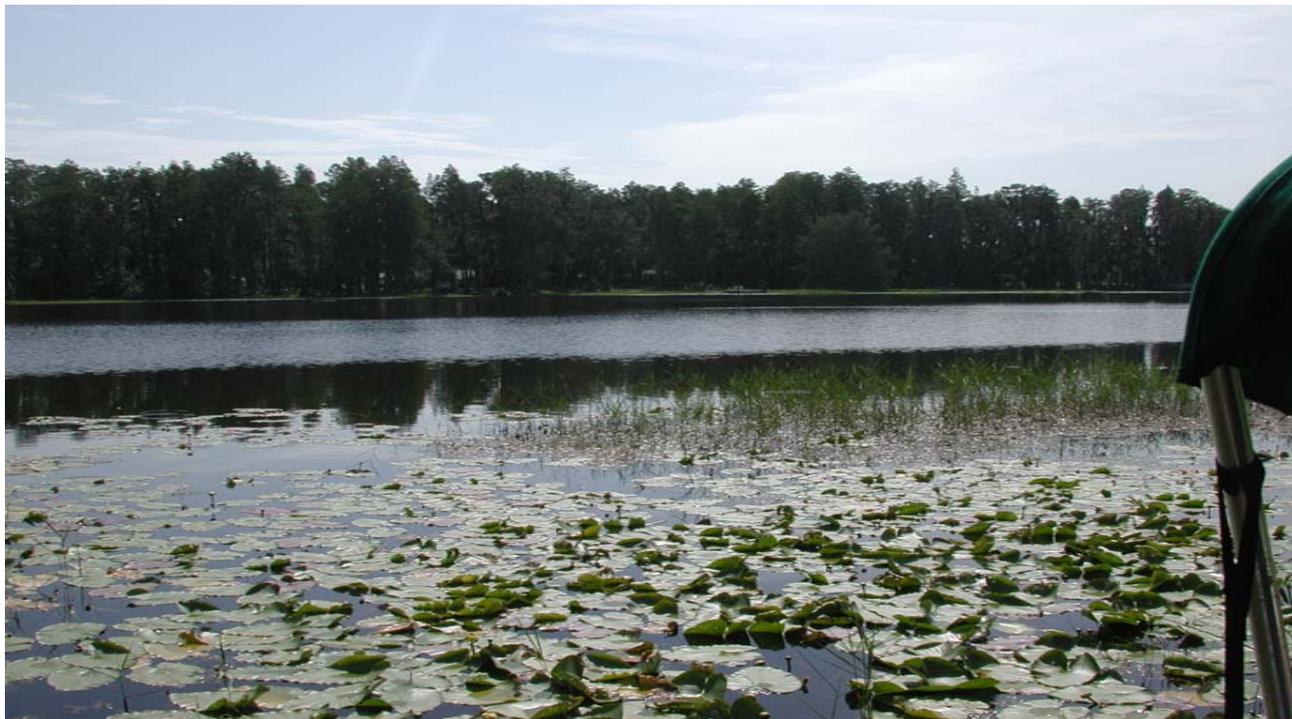
Figure 4- Spatterdock (*Nuphar lutea var. advena*) growing in Lake Elizabeth.

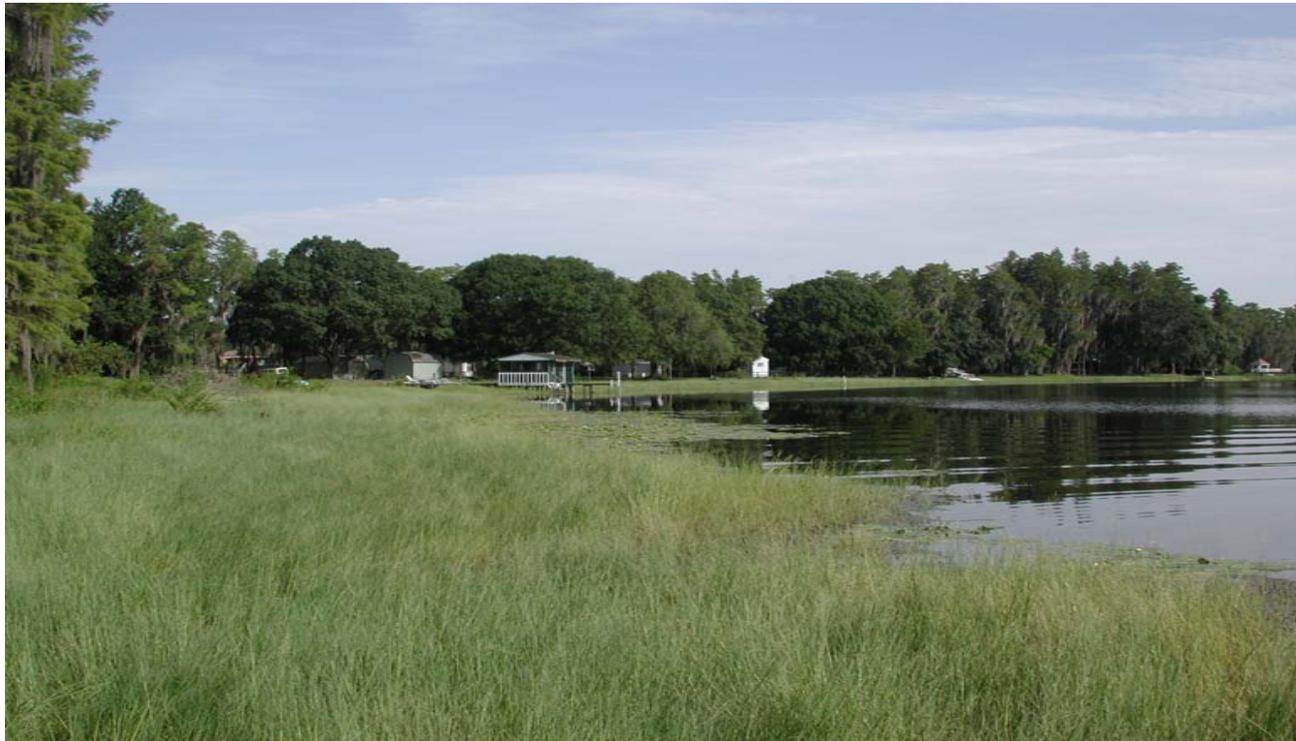
Figure 5- Torpedo Grass (*Panicum repens*) Growing as a rim of vegetation on Lake Elizabeth.

Lake Elizabeth is a small (17acre) lake that would be considered in the in the high mesotrophic (good) category of lakes based on water chemistry. It has a normal to low concentration of aquatic vegetation. That is about 30% of the open water areas contain submerged vegetation and this vegetation helps to maintain the nutrient balance in the lake as well as provide good fish habitat. The lake has many open water areas that support various types of recreation and has a good diversity of plant species. The primary pest plants in the lake include: Torpedo grass (*Panicum repens*) and Alligator weed (*Alternanthera philoxeroides*).

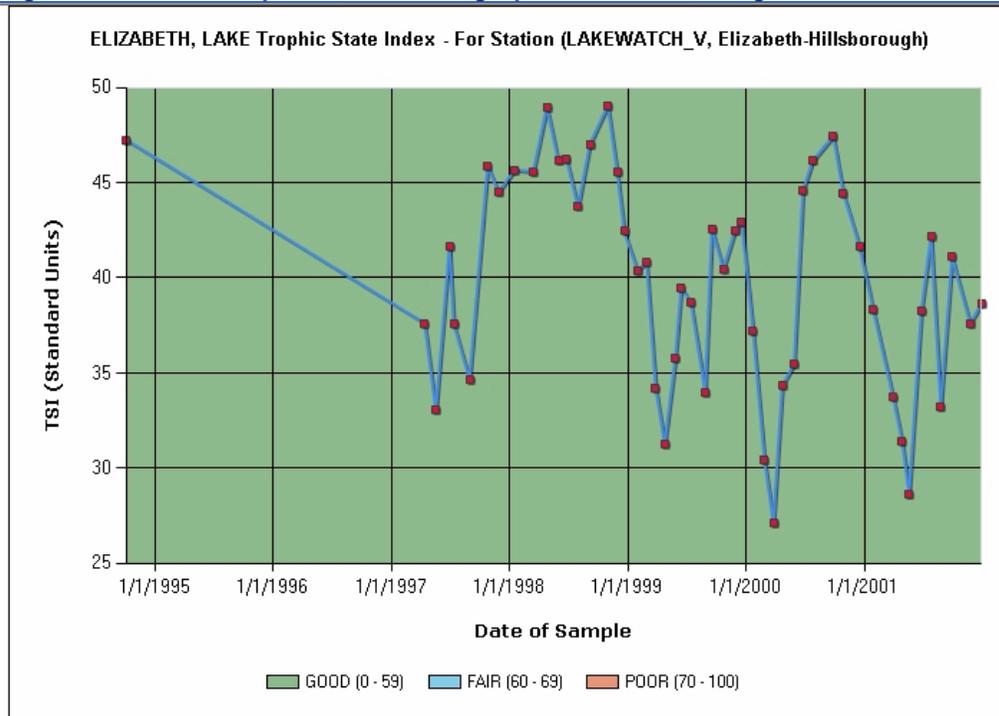
Figure 6. Recent Trophic State Index graph from Hillsborough Watershed Atlas.

Note: The graph above includes benchmarks for using verbal descriptors of "good", "fair" and "poor". The verbal descriptors for these benchmarks are based on an early determination by stakeholders of the generally acceptable and understood terms for describing the state of lakes. The same benchmarks are used for nutrient graphs (Nitrogen and Phosphorus), chlorophyll graphs and trophic state index (TSI) graphs. The TSI is a calculated index of lake condition based on nutrient and chlorophyll (a) concentrations (please see "Learn more about Trophic State Index"). The benchmarks are established based on the TSI range that relates to a specific descriptor. The source for the TSI concentration relationships is the [Florida Water Quality Assessment, 1996, 305\(b\)](#) (Table 2-8). For many lakes there is more than a single source of water quality data. You have the option with the "Select Data Source" drop down to select any available data source and create the graph using that source or you may select "All" to graph all available data. The graph header will also change to reflect the source used.

for the lake. The trophic state index (TSI) calculated from the sample data (47.25) is comparable to the values shown in Figure 6. The LAKEWATCH volunteer became inactive in 2002 so the lake's water quality recent trends are unknown; however, the fact that the assessment data is in the same general region as the trend data give some confidence that the lake's overall trend has not change significantly.

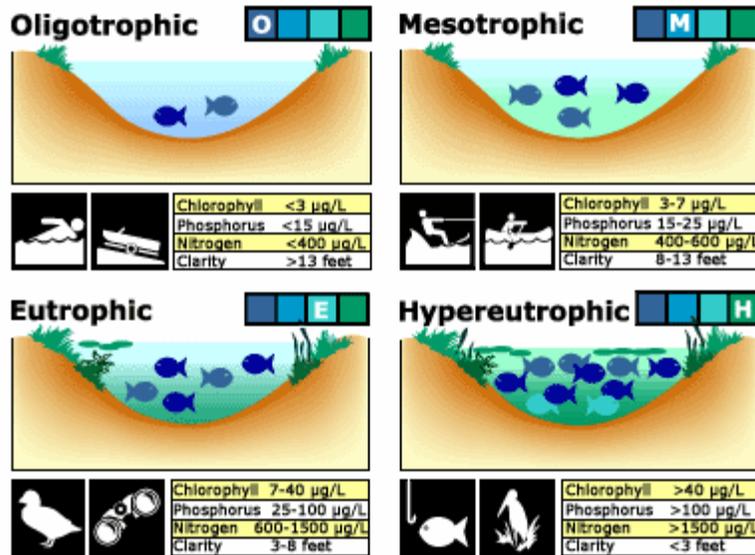
Oligotrophic (oh-lig-oh-TROH-fik) where waterbodies have the lowest level of productivity; **Mesotrophic** (mees-oh-TROH-fik) where waterbodies have a moderate level of biological productivity; **Eutrophic** (you-TROH-fik) where waterbodies have a high level of biological productivity; **Hypereutrophic** (HI-per-you-TROH-fik) where waterbodies have the highest level of biological productivity. The trophic state of a waterbody can also affect its use or perceived utility. Figure 1 illustrates this concept.

Figure 1: Trophic states, concentrations of constituents, and typical waterbody uses.

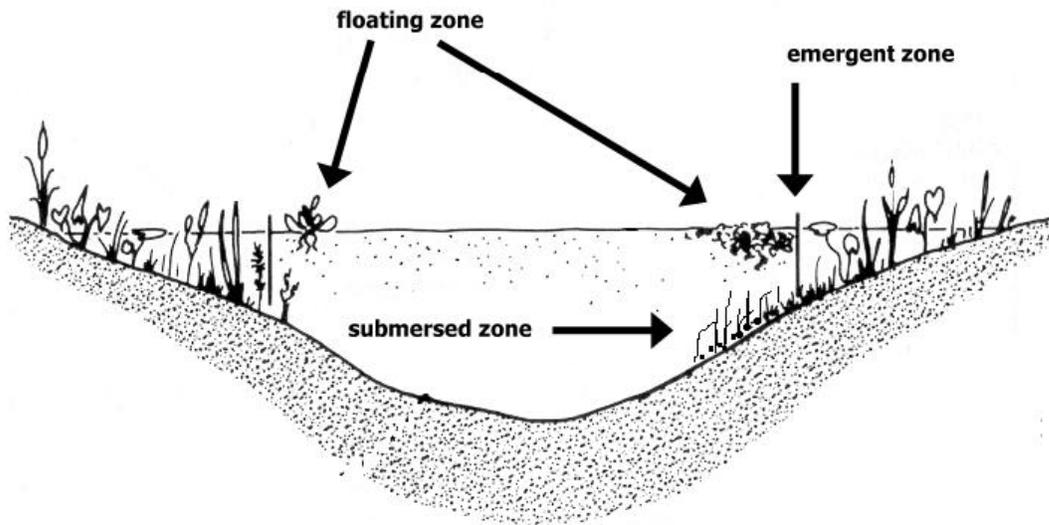
iv The three primary aquatic vegetation zones are shown below:
