LAKE ASSESSMENT REPORT FOR LAKE CARROLL IN HILLSBOROUGH COUNTY FLORIDA

Date Assessed: 6/21/06

Assessed by: Sarah Koenig and David Eilers

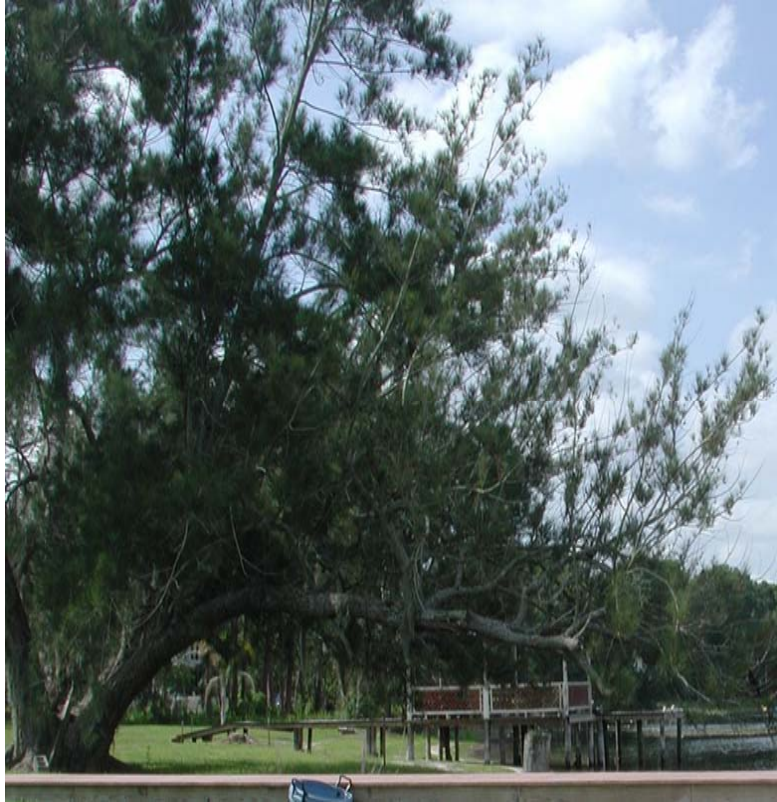
Figure 5. Australian Pine (*Casuarina equisetifolia*) is a non-native invasive species shown here on Lake Carroll.

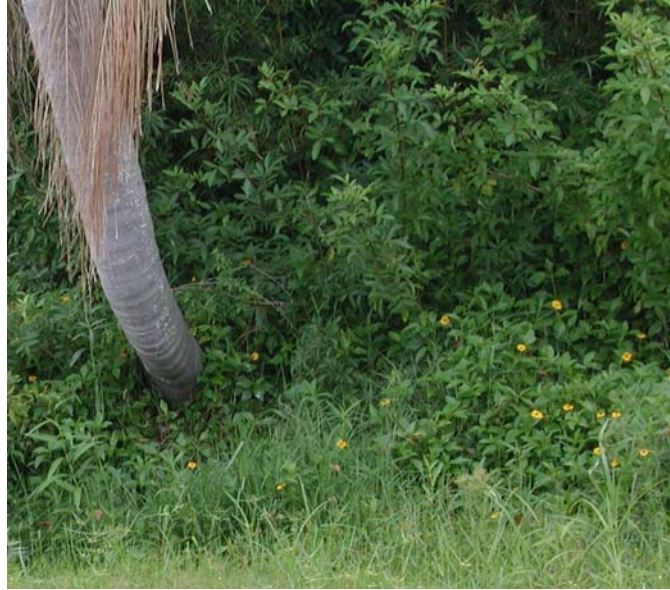
Figure 6. Creeping Oxeye (*Sphagneticola trilobata*), foreground with yellow flowers and Brazilian Pepper (*Schinus terebinthifolius*), background, are both non-native invasive species on Lake Carroll

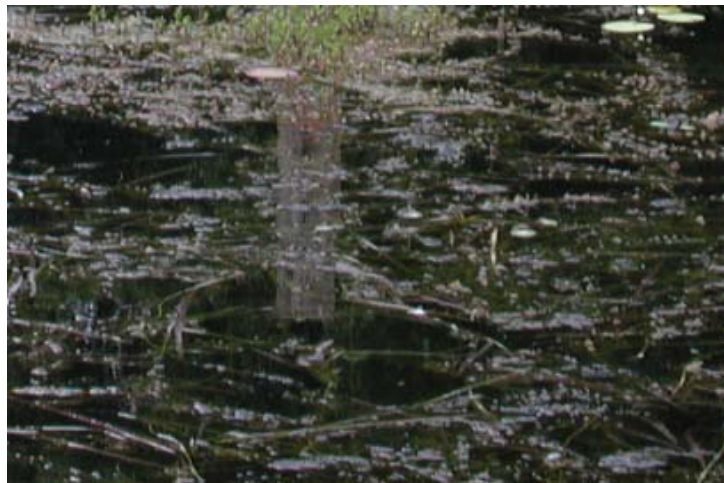
Figure 7. Hydrilla mixed with other submerged plants.

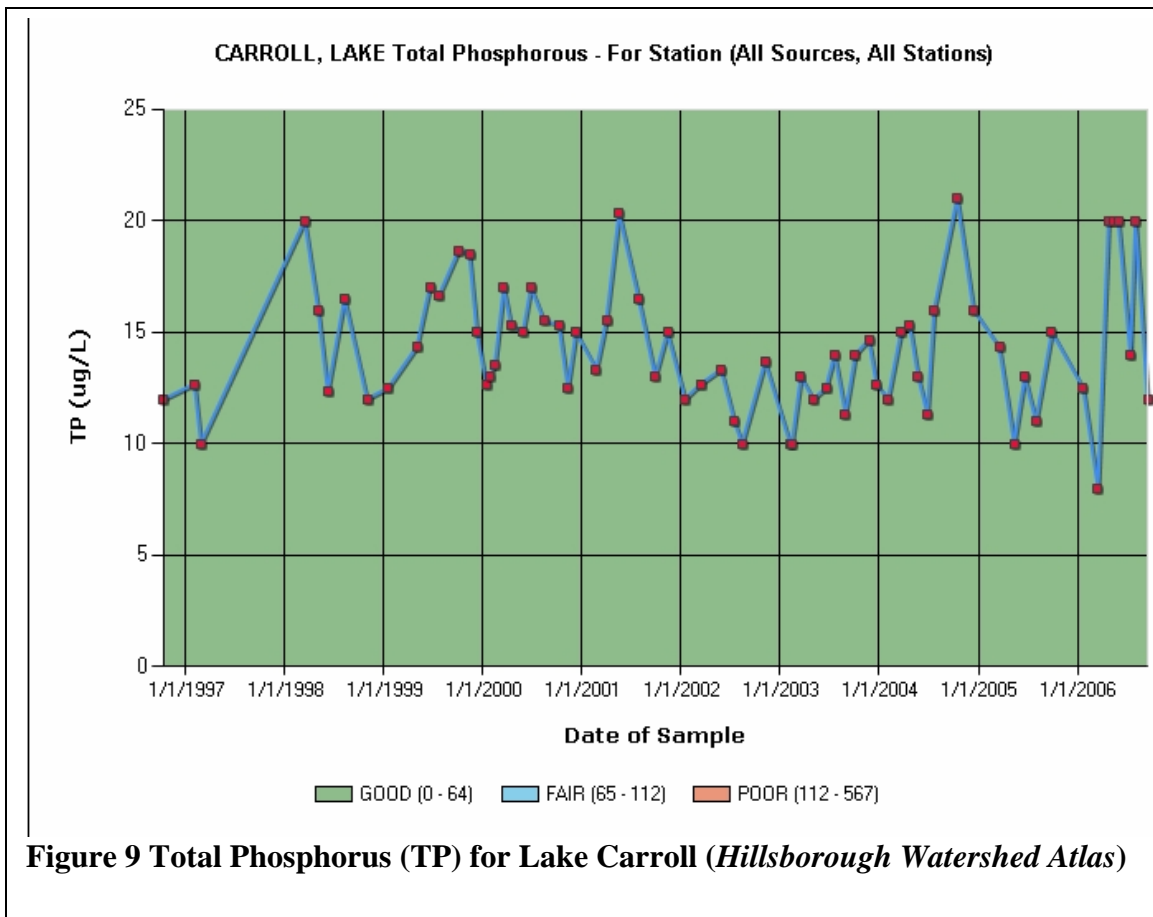
A critical element in any lake assessment is the long-term water chemistry data set. The primary source of water quality trend data for Florida Lakes is the Florida LAKEWATCH volunteer and the Florida LAKEWATCH water chemistry data. Hillsborough County is fortunate to have a large cadre of volunteers who have collected lake water samples for significant time period. These data are displayed and analyzed on the Water Atlas as shown in the following figures. Additional data, when available, is also included on the Water Atlas; however, the LAKEWATCH data remains the primary source. By the trend data shown in these figures, the lake may be considered in generally good health in terms of the trophic state index. Lake Carroll is a clear water lake and as such it must maintain a TSI of below 40 to not be considered impaired by the State of Florida guidelines. Figure 10 shows the TSI trend for Lake Carroll from 1997 through the most recent sample set in August of 2006. This same trend data for parameters of interest are shown in Figures 11, 12 and 13.

⁴. Lake Carroll's long term water quality data contain enough violations of these criteria to be classified by Florida DEP as impaired. The more recent data indicate an improving trend. The higher TSI values correspond to sample dates that follow a 10 day and/or 20 day period of higher than average rain fall. For the period between January 1, 2005 and November 30, 2006 there is a positive relationship ($R^2 = 0.541$) between TSI and 10 day rainfall. Figure 14 shows the rainfall for the Upper Sweetwater Creek watershed.
