LAKE ASSESSMENT REPORT FOR HANNA LAKE IN HILLSBOROUGH COUNTY FLORIDA

Date Assessed: July 11, 2007
Assessed by: Sarah Koenig and David Eilers
Reviewed by: Jim Griffin, Ph.D.

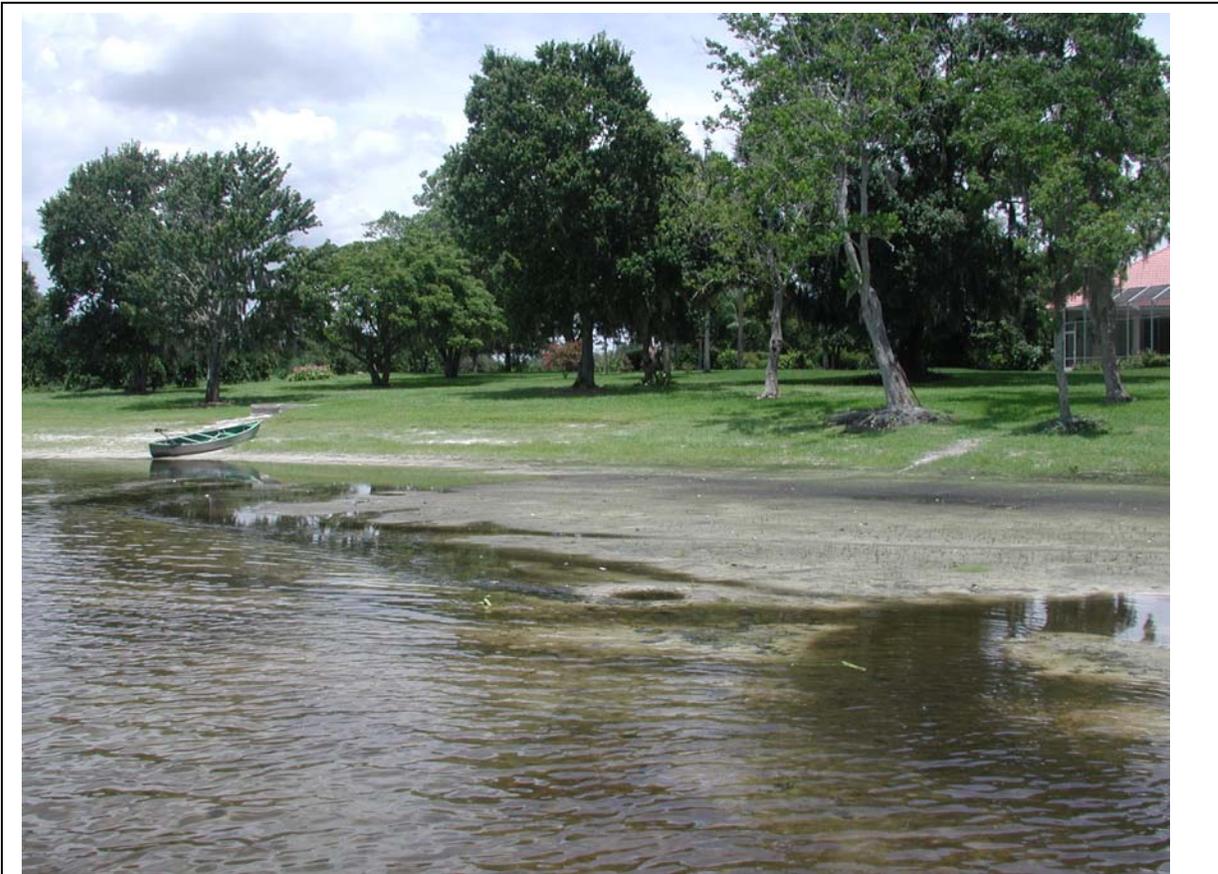
Figure 1. Photograph of Hanna Lake taken on July 11, 2007.

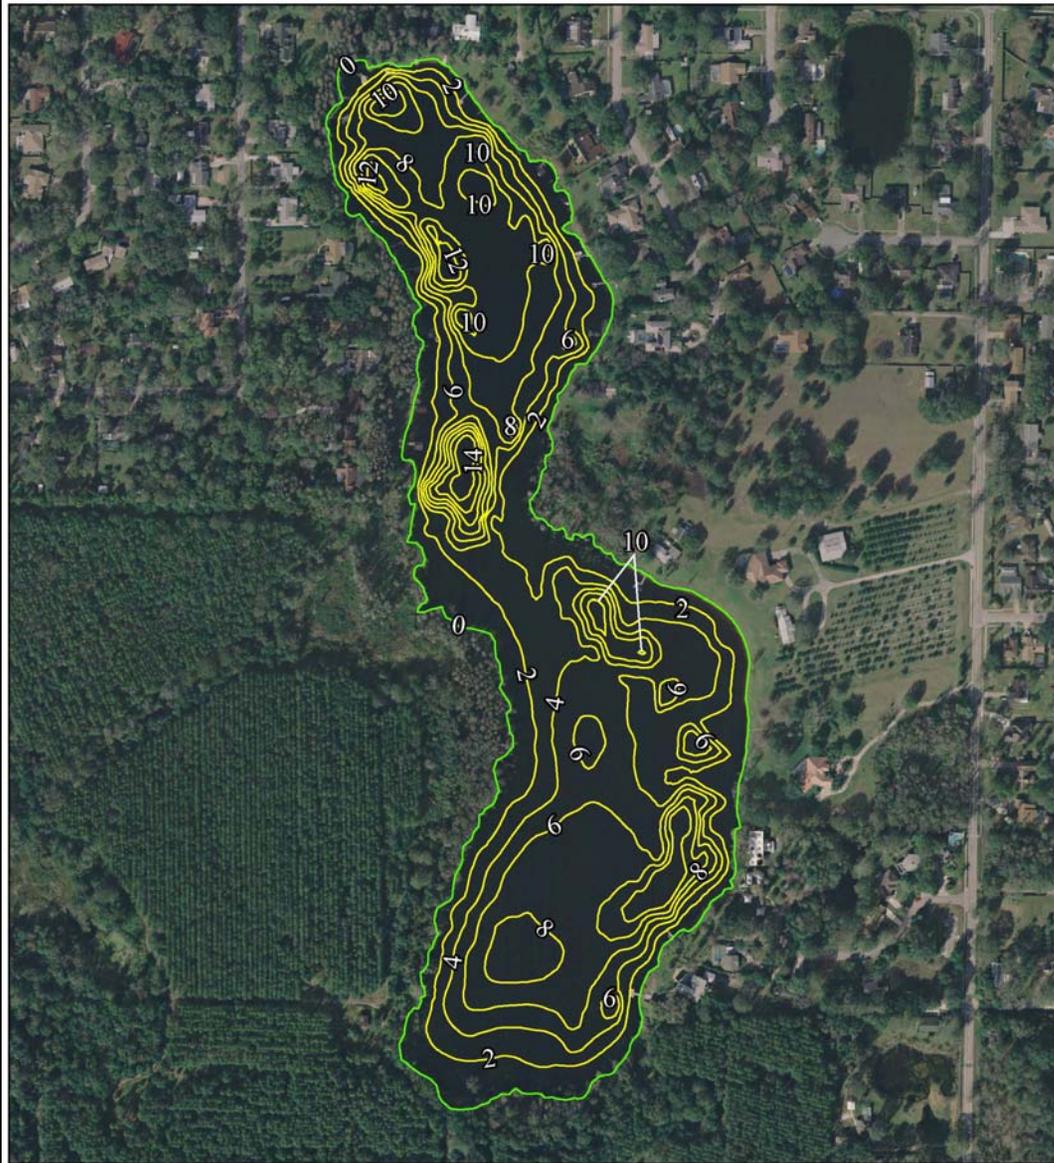
Survey Date: July 11, 2007
 Lake water level was 57.49 ft
 above sea level at time of assessment.
 Contours are expressed in absolute depth
 below this level.

Perimeter 7,793 ft;
 Area 34 Acres;
 Mean Depth 5.48 ft;
 Volume 162.2 Acre-ft, (52,854,889 gallons);
 Deepest point 15.17 ft

Figure 1. Contour map for Hanna Lake. The mapping technique used in 2007 employs a standard DGPS for horizontal position and a fathometer for depth.

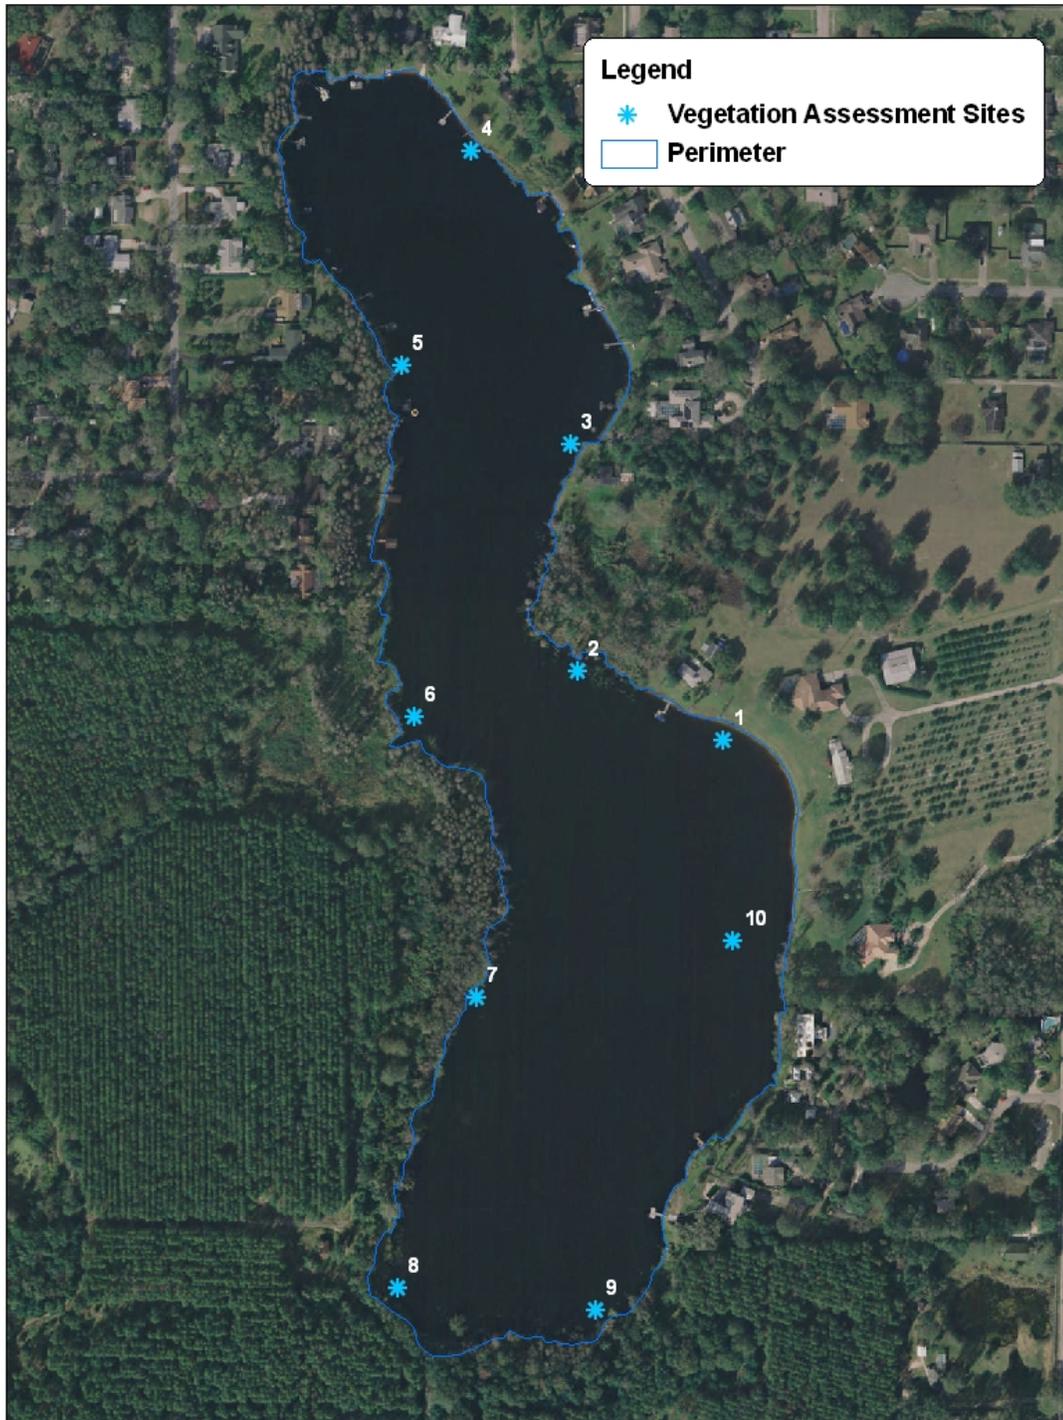
Figure 3. 2006 six-inch resolution aerial photograph showing location of vegetation assessment sites on Hanna Lake. Major emergent and floating vegetation zones as well as structures such as docks are also observable in this aerial.

The lake's apparent vegetative cover and shoreline detail are evaluated using the latest lake aerial photograph as shown in Figure 3 and by use of WAAS enabled GPS. Submerged vegetation is determined from the analysis of bottom returns from the Lowrance 26c HD combined GPS/fathometer described earlier. As depicted in Figure 3, ten vegetation assessment sites were chosen for intensive sampling based on the *Lake Assessment Protocol* (copy available on request) for a lake of this size. The site positions are set using GPS and then loaded into a GIS mapping program (ArcGIS) for display. Each site is sampled in the three primary vegetative zones (emergent, submerged and floating)^{iv}. The latest aerials high resolution aerial photos are used to provide shore details (docks, structures, vegetation zones) and to calculate the extent of surface vegetation coverage. The primary indices of submerged vegetation cover and biomass for the lake, percent area coverage (PAC) and percent volume infestation (PVI), are determined by transiting the lake by boat and employing a fathometer to collect "hard and soft return" data. These data are later analyzed for presence and absence of vegetation and to determine the height of vegetation if present. The PAC is determined from the presence and absence analysis of 100 sites in the lake and the PVI is determined by measuring the difference between hard returns (lake bottom) and soft returns (top of vegetation) for sites (within the 100 analyzed sites) where plants are determined present.

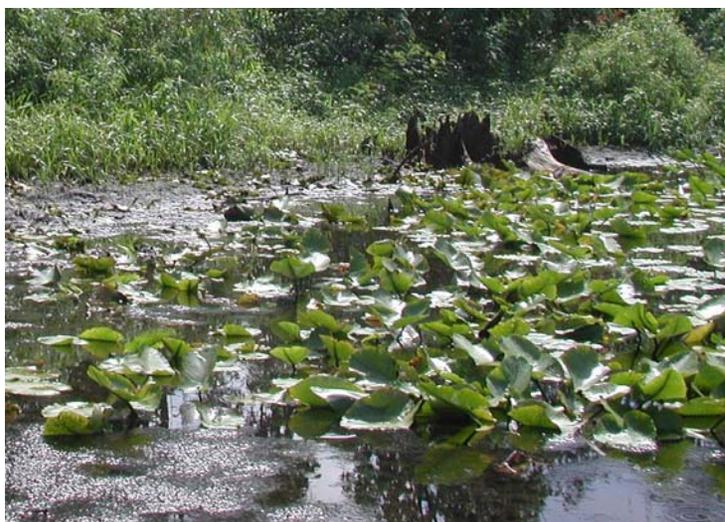
Figure 4. *Nuphar lutea var. advena*, Spatterdock, Yellow Pondlily, is a common floating leaved vegetation in Florida lakes. This species provides shelter for several species of juvenile fishes, which are recreationally important. When population numbers reach high levels this species can be considered a pest plant based on the increased difficulty of boat navigation.

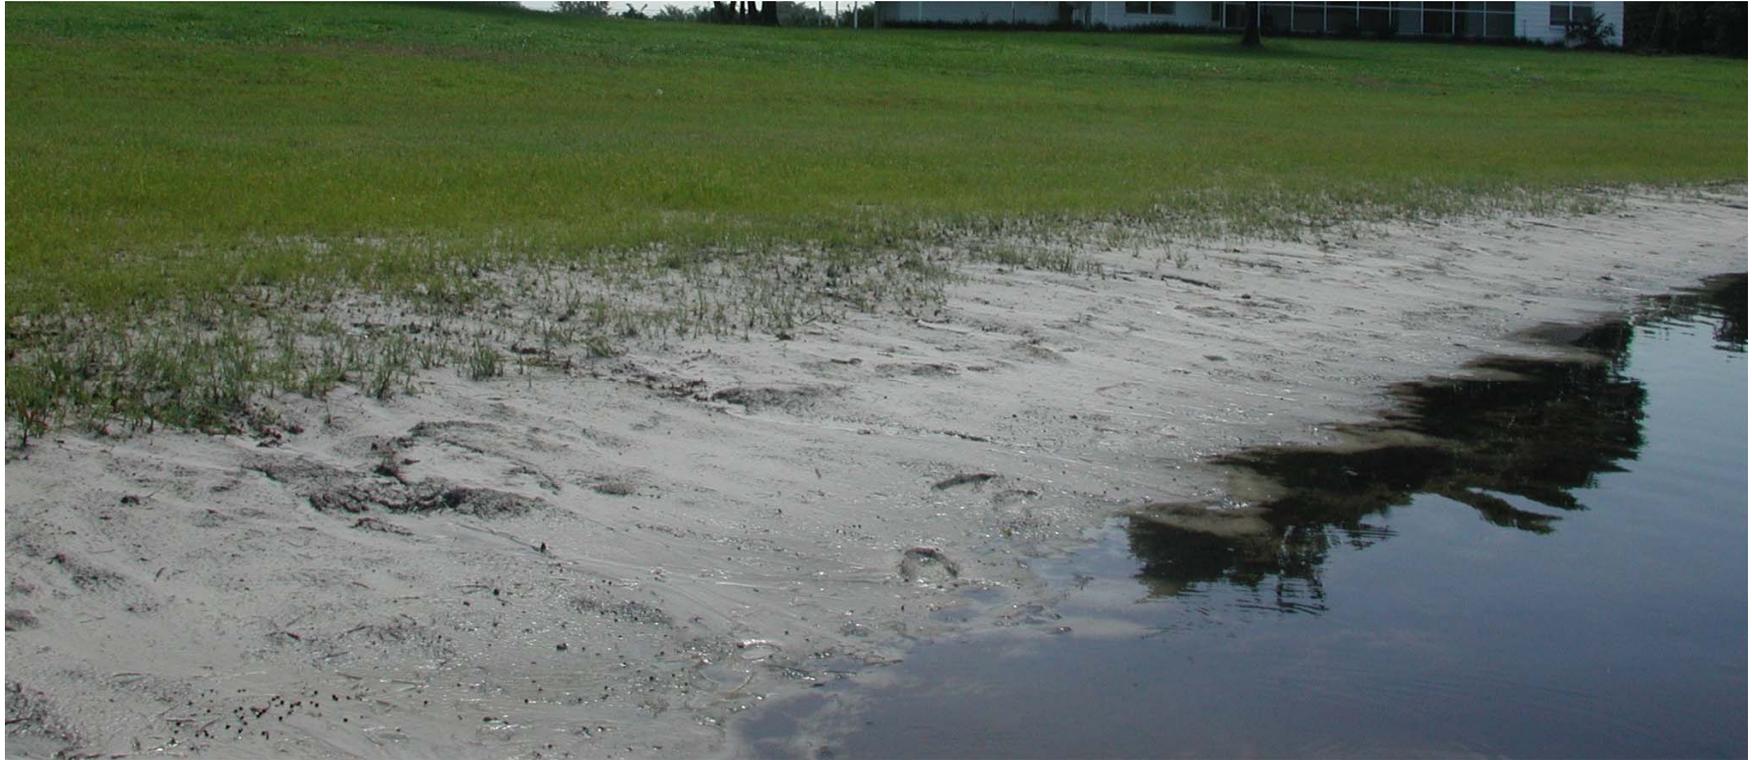
Figure 5. Lake shores that have been cleared of the native vegetative rim, such as the one pictured above, do not process the nutrients that are contained in runoff water from lawns, lowering the quality of the water in the lake and providing the raw materials for algal blooms. The natural rim of grasses, sedges, and other emergent vegetation naturally uptake the nutrients in runoff water and lower the amount of nutrients flowing into the waterbody, acting as a natural stormwater treatment filter. In addition the natural shoreline vegetation provides food and habitat for several species of native birds, reptiles and fishes.

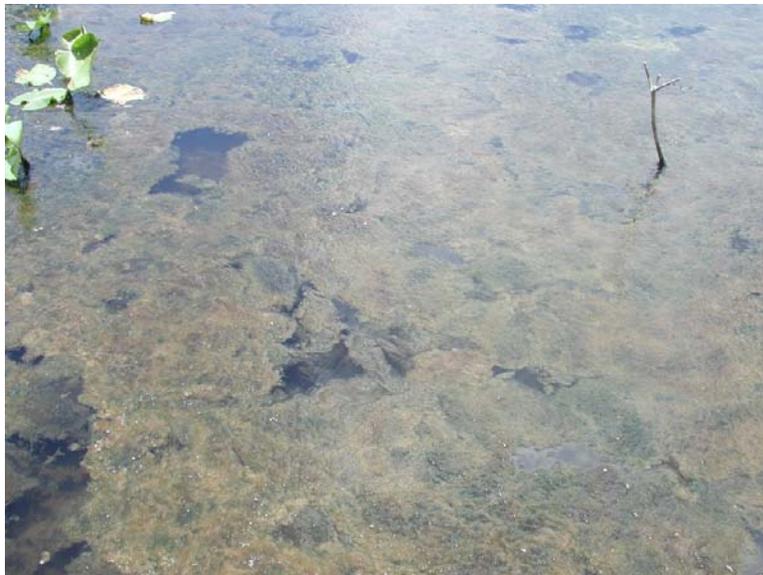
Figure 6. *Algal Spp.*, when exposed to increased nutrient loads, such as runoff fertilizers from homeowners yards and agricultural areas, can have rapid blooms lowering dissolved oxygen in the water column and smothering native submerged vegetation that is vital to water quality.

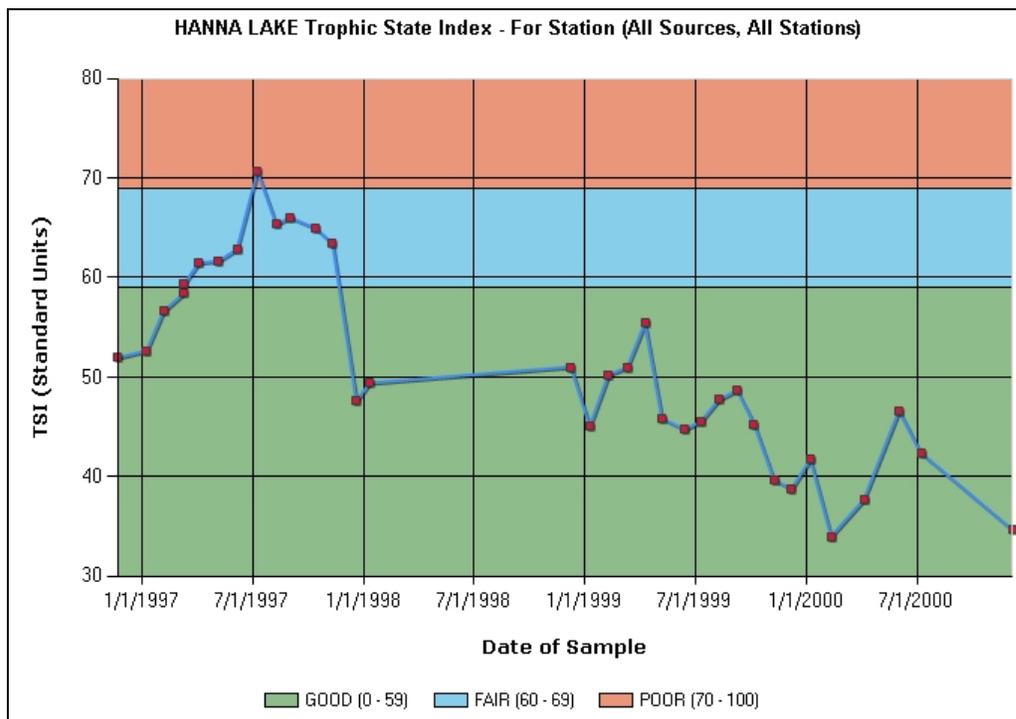
Figure 7. Recent Trophic State Index (TSI) graph from Hillsborough Watershed Atlas. For the latest date go to:

Note: The graph above includes benchmarks for using verbal descriptors of "good", "fair" and "poor". The verbal descriptors for these benchmarks are based on an early determination by stakeholders of the generally acceptable and understood terms for describing the state of lakes. The same benchmarks are used for nutrient graphs (Nitrogen and Phosphorus), chlorophyll graphs and trophic state index (TSI) graphs. The TSI is a calculated index of lake condition based on nutrient and chlorophyll (a) concentrations (please see "Learn more about Trophic State Index"). The benchmarks are established based on the TSI range that relates to a specific descriptor. The source for the TSI concentration relationships is the Florida Water Quality Assessment, 1996, 305(b) (Table 2-8).

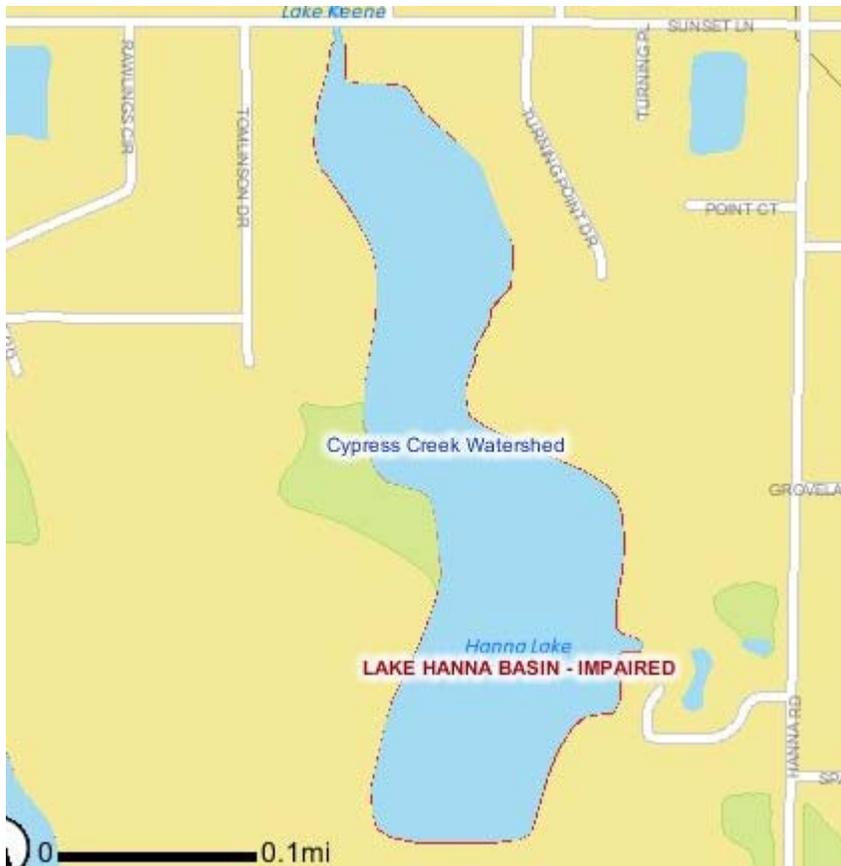
Figure 8. Hanna shows as an impaired water body (based on FDEP reports) on the Water Atlas.

v A lake is impaired if " (2) For lakes with a mean color less than or equal to 40 platinum cobalt units, the annual mean TSI for the lake exceeds 40, unless paleolimnological information indicates the lake was naturally greater than 40, or For any lake, data indicate that annual mean TSIs have increased over the assessment period, as indicated by a positive slope in the means plotted versus time, or the annual mean TSI has increased by more than 10 units over historical values. When evaluating the slope of mean TSIs

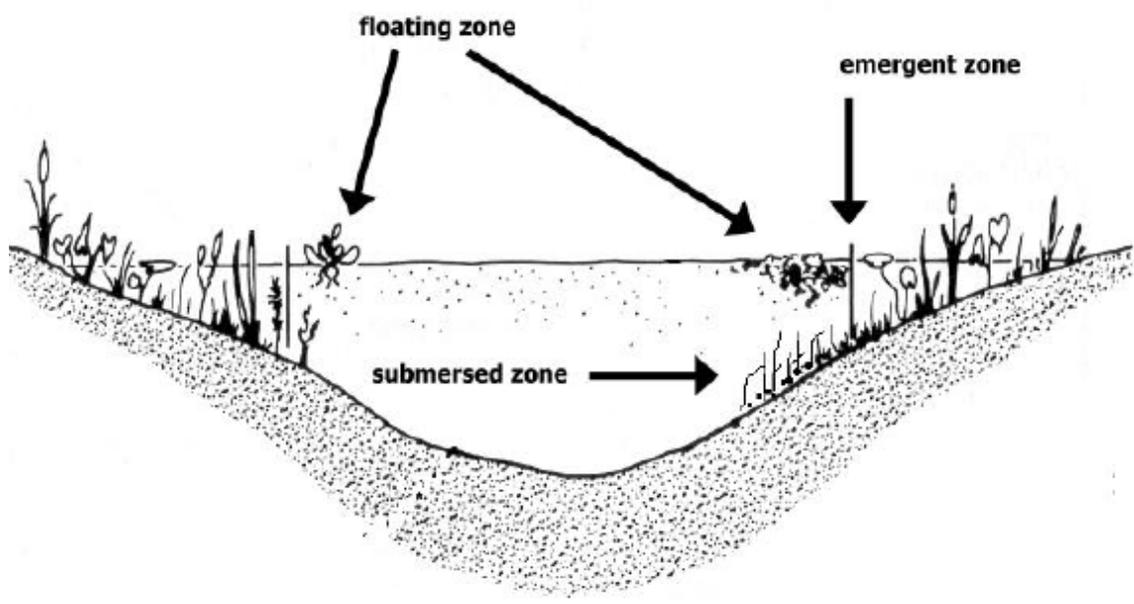
iv The tree primary aquatic vegetation zones are shown below:
