LAKE ASSESSMENT REPORT FOR HICKORY HAMMOCK LAKE IN HILLSBOROUGH COUNTY, FLORIDA

Date Assessed: August 7, 2009

Assessed by: David Eilers, Cheran Williams, and Brian Rosegger

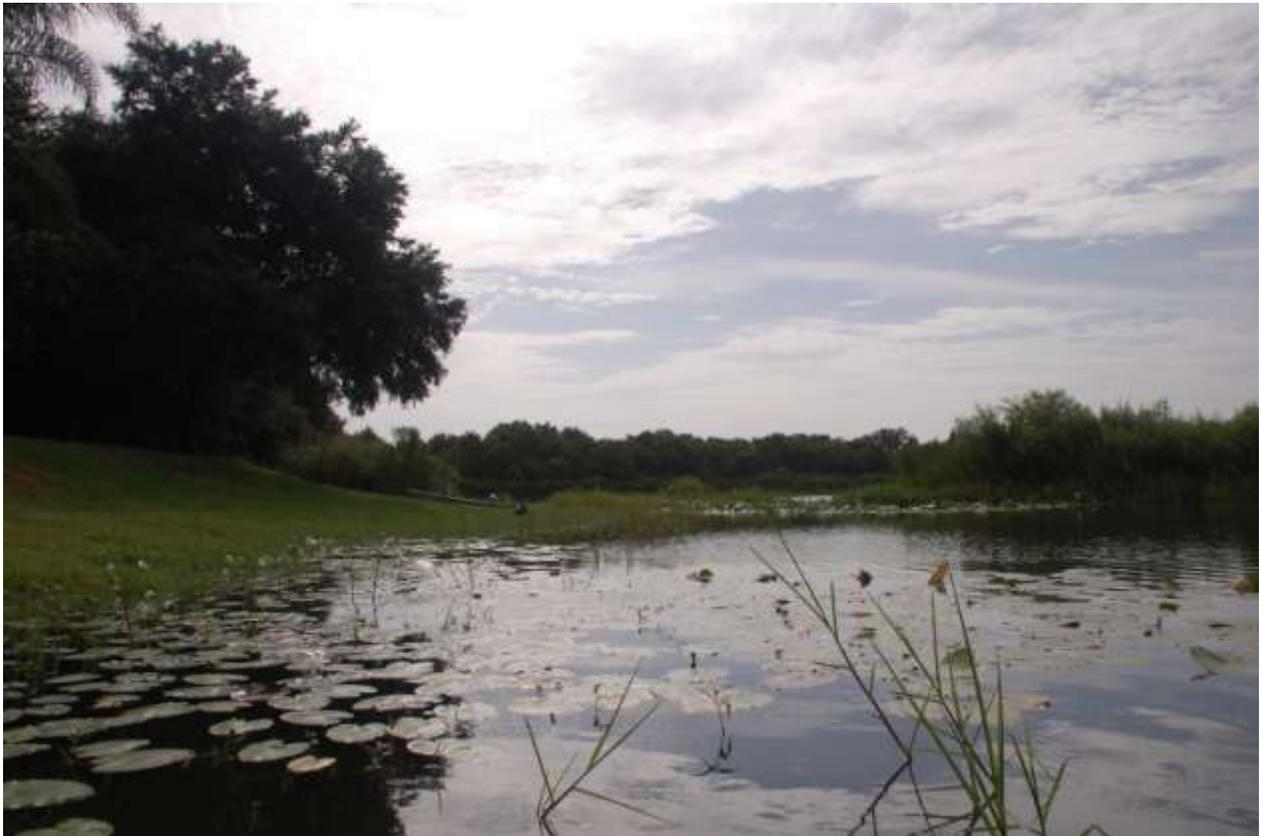
Figure 1. Photo of Hickory Hammock Lake, taken August 7, 2009.

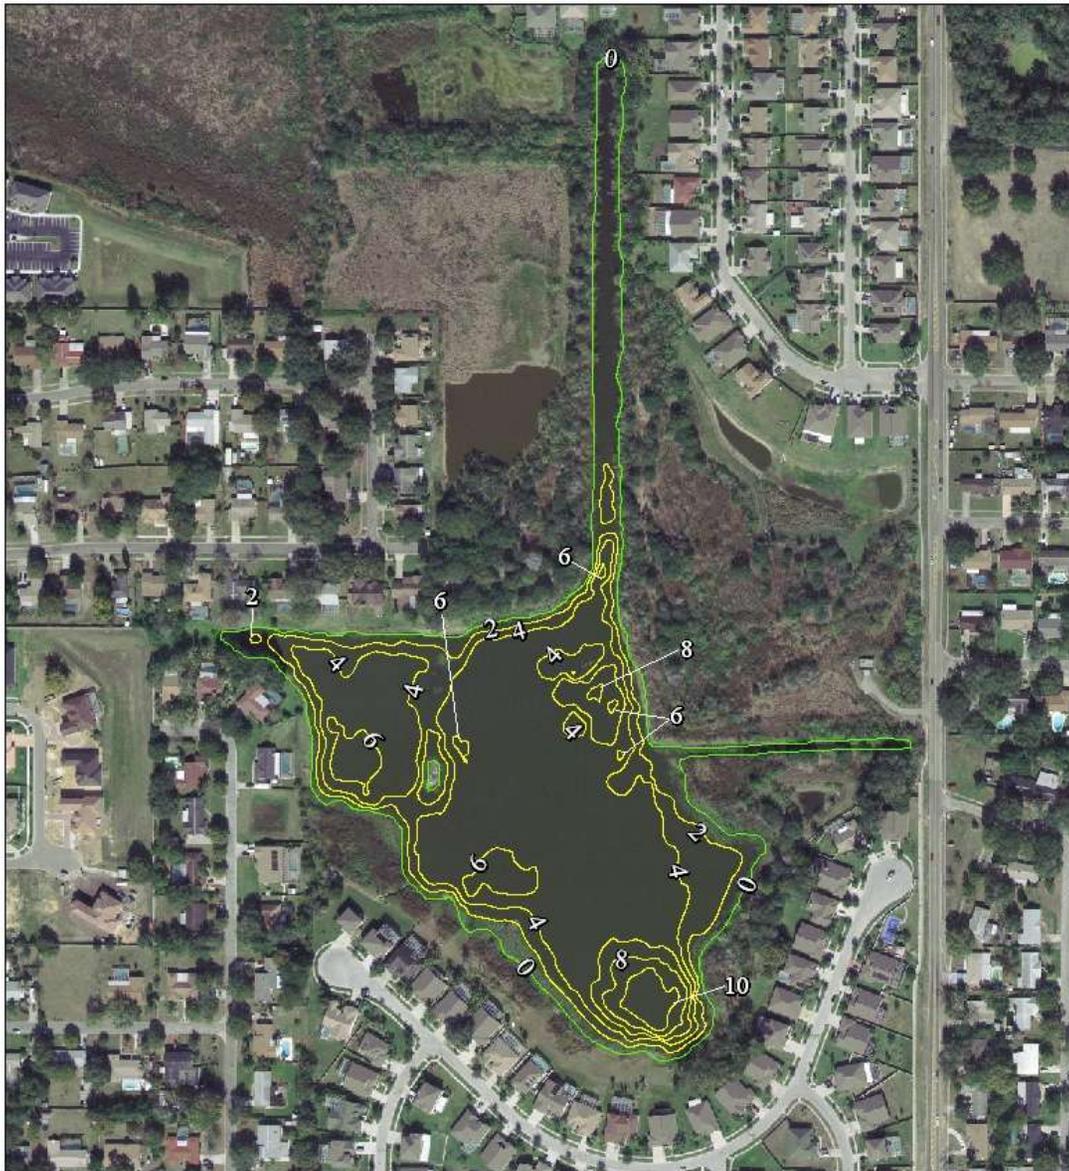
Hickory Hammock Lake

Survey Date: August 7, 2009
Lake water level was 27.25 ft above sea level at time of the assessment.
Contours are expressed in absolute depth below this level.

Perimeter 7,167.13 ft;
Area 14.51 Acres
Mean Depth 4.51 ft;
Volume 56.87 Acre-ft (18,531,612.75 gallons);
Deepest point 11.56 ft

Figure 1. Contour map for Lake Hickory Hammock. The mapping technique used in 2009 employs a standard DGPS for horizontal position and a fathometer for depth.

Bathymetric Mapⁱⁱ. Table 1 provides the lake's morphologic parameters in various units. The bottom of the lake was mapped using a Lowrance LCX 28C HD Wide Area Augmentation System (WAAS)ⁱⁱⁱ enabled Global Positioning System (GPS) with fathometer (bottom sounder) to determine the boat's position, and bottom depth in a single measurement. The result is an estimate of the lake's area, mean and maximum depths, and volume and the creation of a bottom contour map (Figure 2). Besides pointing out the deeper fishing holes in the lake, the morphologic data derived from this part of the assessment can be valuable to overall management of the lake vegetation as well as providing flood storage data for flood models.

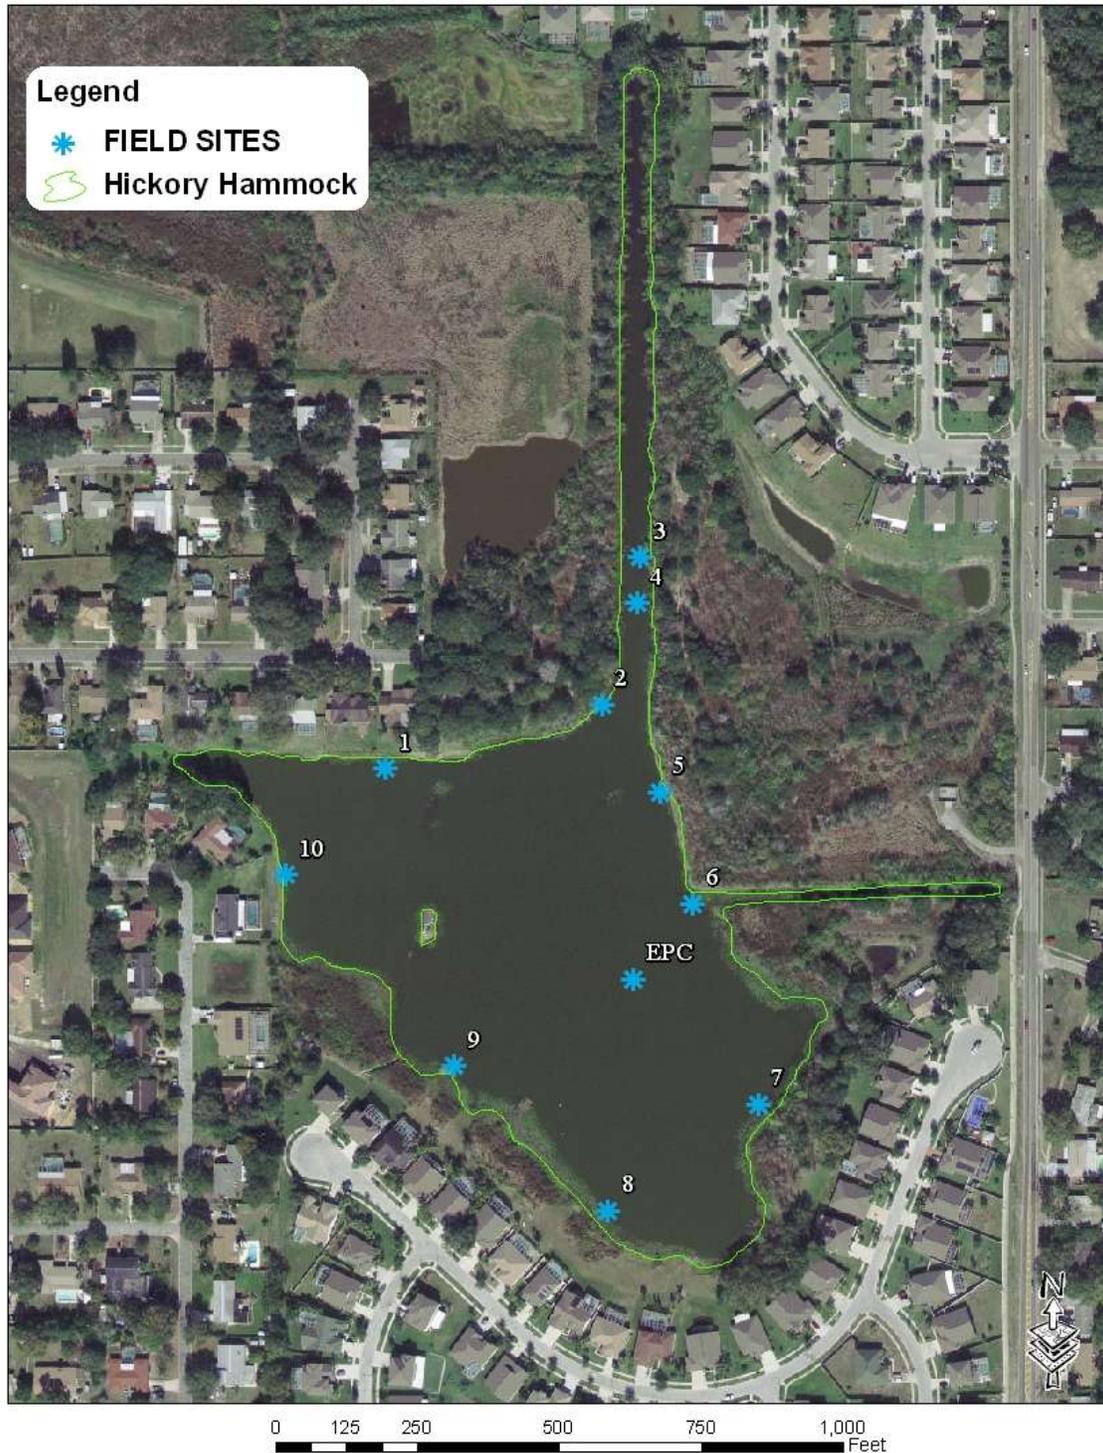
Figure 3. 2007 six-inch resolution aerial photograph showing location of vegetation assessment sites on Hickory Hammock Lake. Major emergent and floating vegetation zones as well as structures are also observable in this aerial.

The lake's apparent vegetative cover and shoreline detail are evaluated using the latest lake aerial photograph as shown in Figure 3 and by use of WAAS enabled GPS. Submerged vegetation is determined from the analysis of bottom returns from the Lowrance 28c HD combined GPS/fathometer described earlier. As depicted in Figure 3, 10 vegetation assessment sites were chosen for intensive sampling based on the *Lake Assessment Protocol* (copy available on request) for a lake of this size. The site positions are set using GPS and then loaded into a GIS mapping program (ArcGIS) for display. Each site is sampled in the three primary vegetative zones (emergent, submerged and floating).^{iv} The latest high resolution aerial photos are used to provide shore details (docks, structures, vegetation zones) and to calculate the extent of surface vegetation coverage. The primary indices of submerged vegetation cover and biomass for the lake, percent area coverage (PAC) and percent volume infestation (PVI), are determined by transiting the lake by boat and employing a fathometer to collect "hard and soft return" data. These data are later analyzed for presence and absence of vegetation and to determine the height of vegetation if present. The PAC is determined from the presence and absence analysis of 100 sites in the lake and the PVI is determined by measuring the difference between hard returns (lake bottom) and soft returns (top of vegetation) for sites (within the 100 analyzed sites) where plants are determined present (Figure 6).

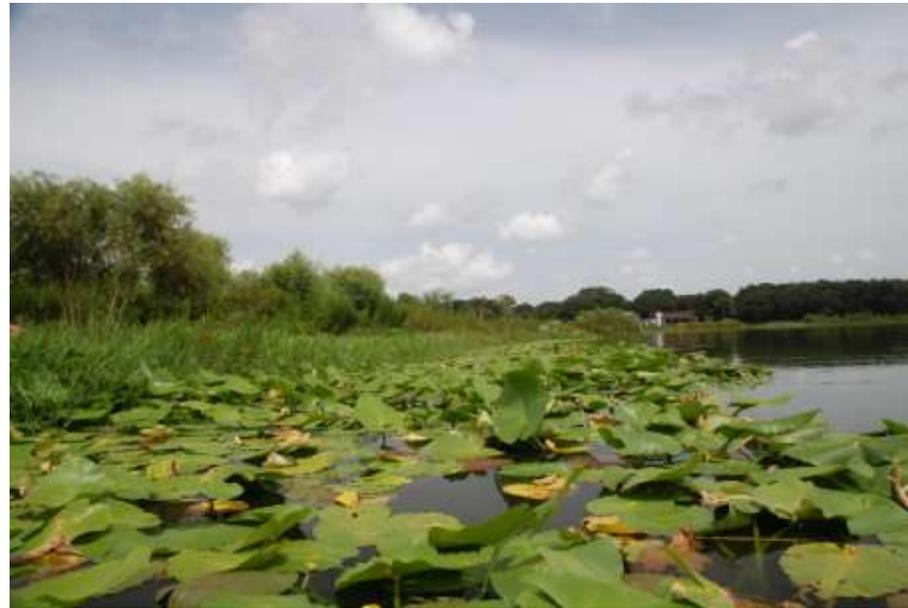
Figure 4. Photograph of *Nuphar lutea var. advena*, Spatterdock, on Hickory Hammock Lake. This native species was the most dominant floating leaved vegetation found during the assessment.

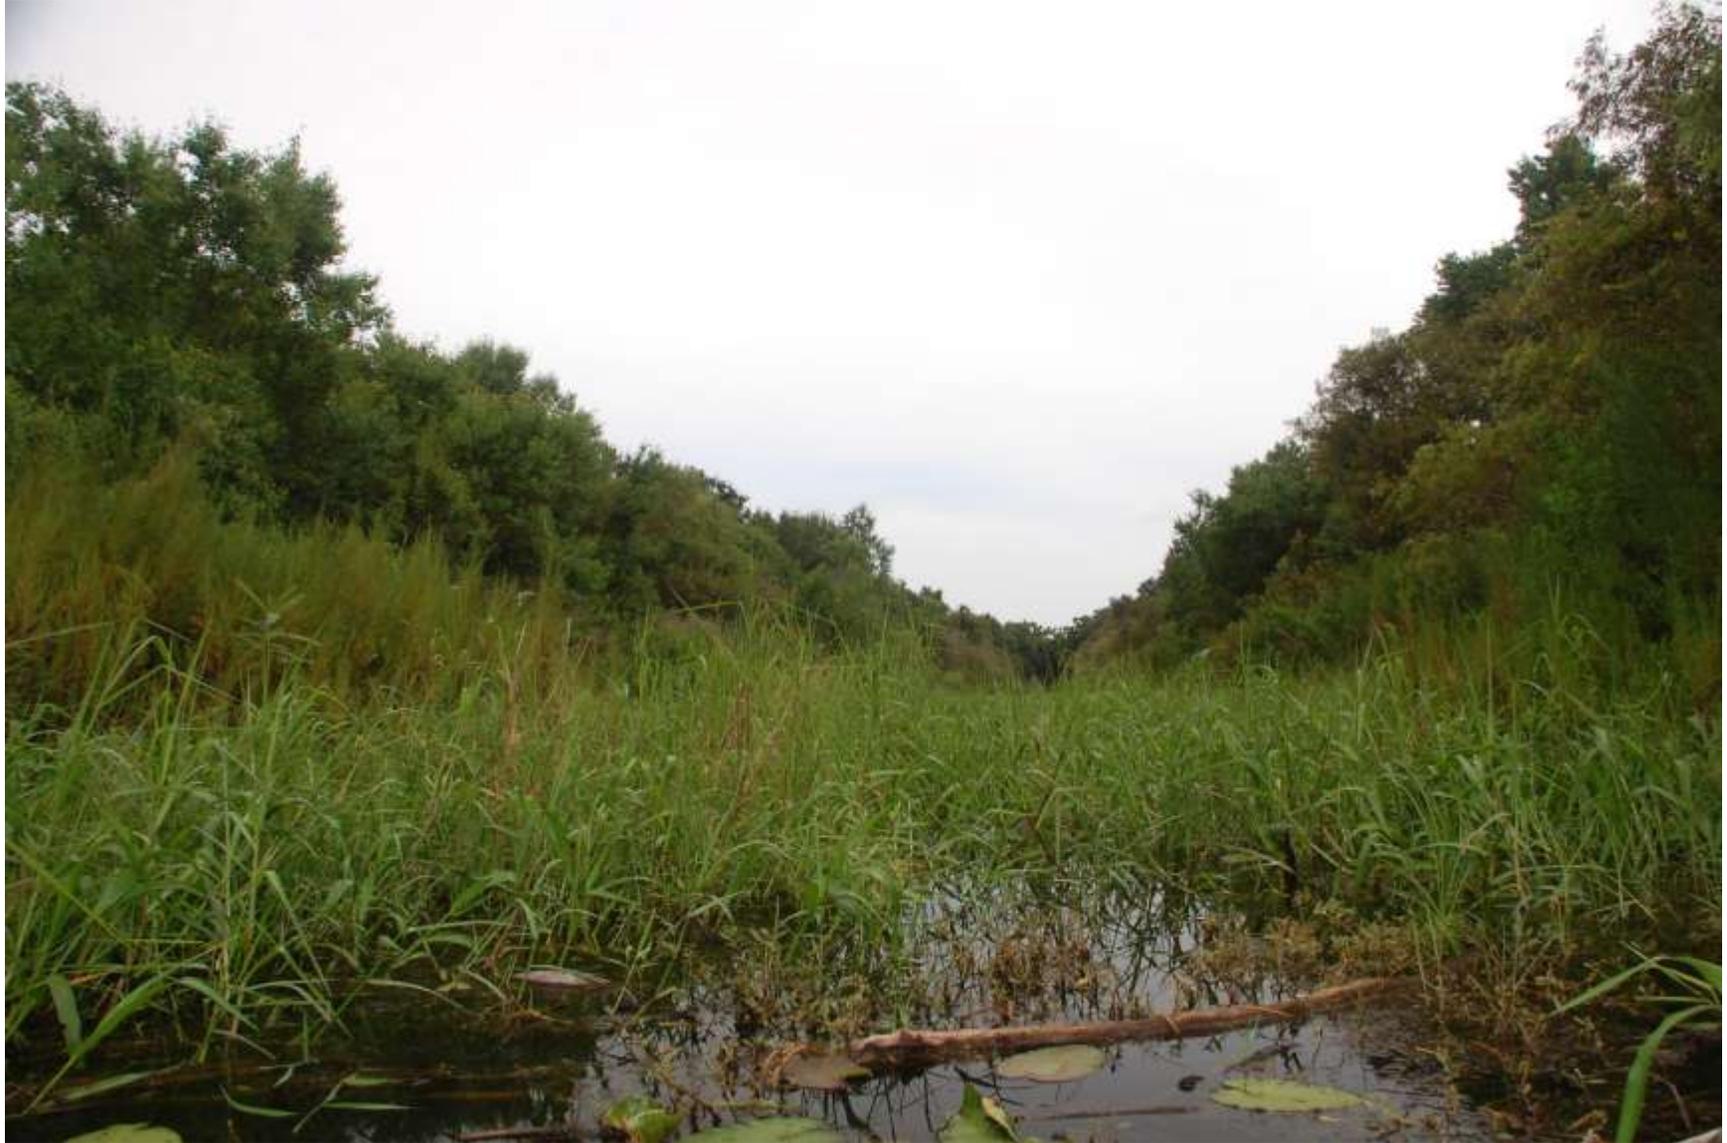
Figure 5. Photograph of emergent vegetation at field sample site three. The canals on Hickory Hammock Lake were inaccessible due to overgrowth of *Panicum maximum*, *Panicum dichotomiflorum*, and *Alternanthera philoxeroides*.

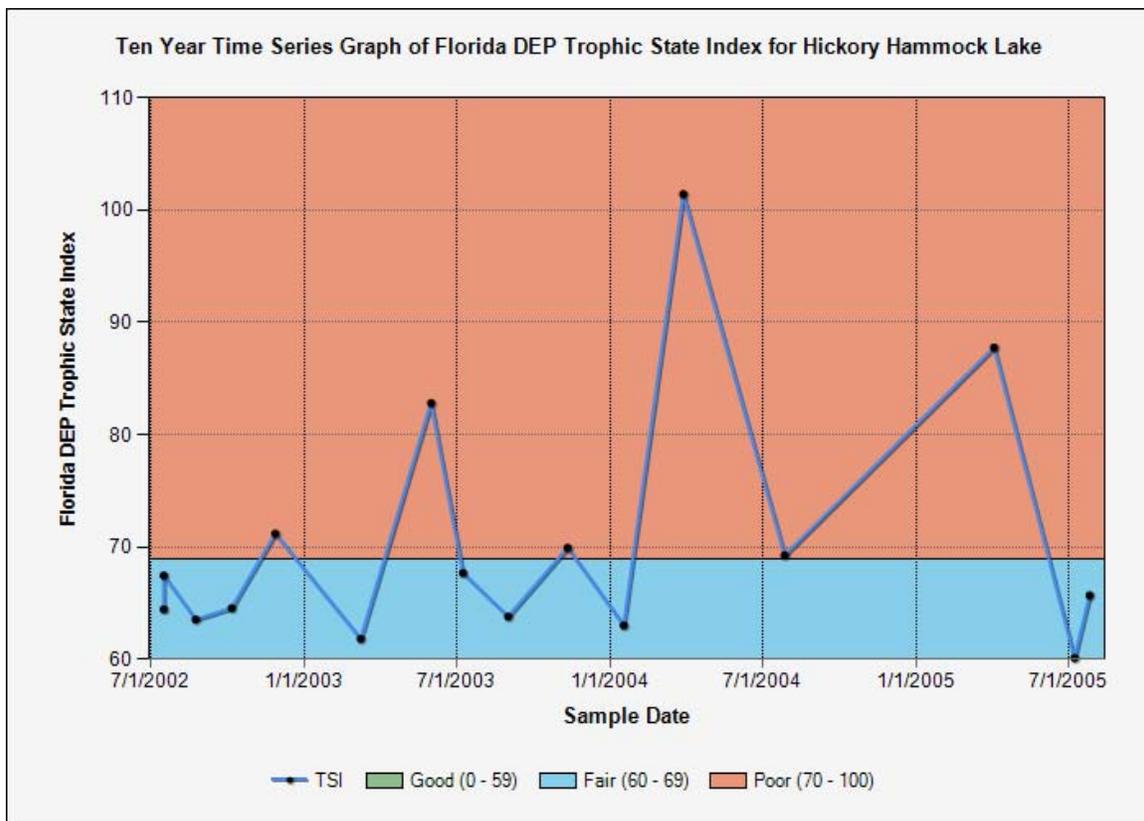
Figure 6. Recent Trophic State Index (TSI) graph from Hillsborough Watershed Atlas. For the latest data go to:

Note: The graph above includes benchmarks for using verbal descriptors of "good", "fair" and "poor". The verbal descriptors for these benchmarks are based on an early determination by stakeholders of the generally acceptable and understood terms for describing the state of lakes. The same benchmarks are used for nutrient graphs (Nitrogen and Phosphorus), chlorophyll graphs and trophic state index (TSI) graphs. The TSI is a calculated index of lake condition based on nutrient and chlorophyll (a) concentrations (please see "Learn more about Trophic State Index"). The benchmarks are established based on the TSI range that relates to a specific descriptor. The source for the TSI concentration relationships is the Florida Water Quality Assessment, 1996, 305(b) (Table 2-8).

As part of the lake assessment the physical water quality and chemical water chemistry of a lake are measured. These data only indicate a snap shot of the lakes water quality; however they are useful when compared to the trend data available from LAKEWATCH or other sources. Table 6 contains the summary water quality data and index values and adjusted values calculated from these data. The total phosphorus (TP), total nitrogen (TN) and chlorophyll (a) water chemistry sample data are the results of chemical analysis of samples taken during the assessment and analyzed by the Hillsborough County Environmental Protection Commission laboratory. These data compare reasonably well with the mean data from the LAKEWATCH data set for the lake. However, the last LAKEWATCH volunteer sample data set for the lake is for 2005 so it is difficult to compare these data directly. The assessment TSI (Table 6) of 63.95 compares reasonably well with the 2005 samples and may indicate a slightly lower TSI exists now than during the period 2002 – 2005.

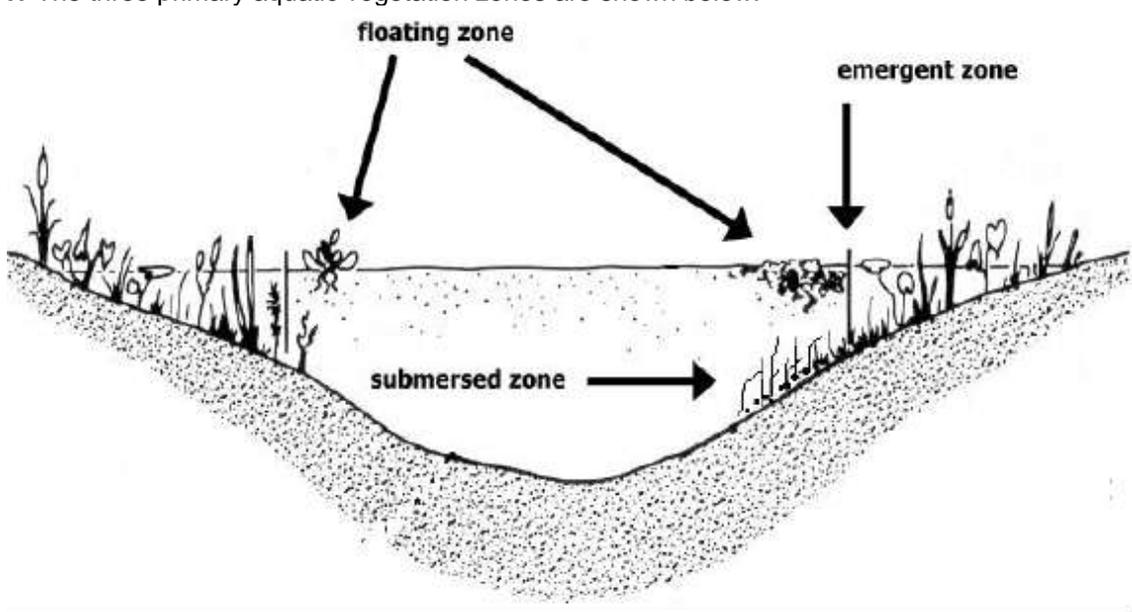
iv The three primary aquatic vegetation zones are shown below:
