LAKE ASSESSMENT REPORT FOR LAKE KEENE IN HILLSBOROUGH COUNTY FLORIDA

Date Assessed: August 8, 2007
Assessed by: Sarah Koenig and David Eilers
Reviewed by: Jim Griffin, Ph.D.

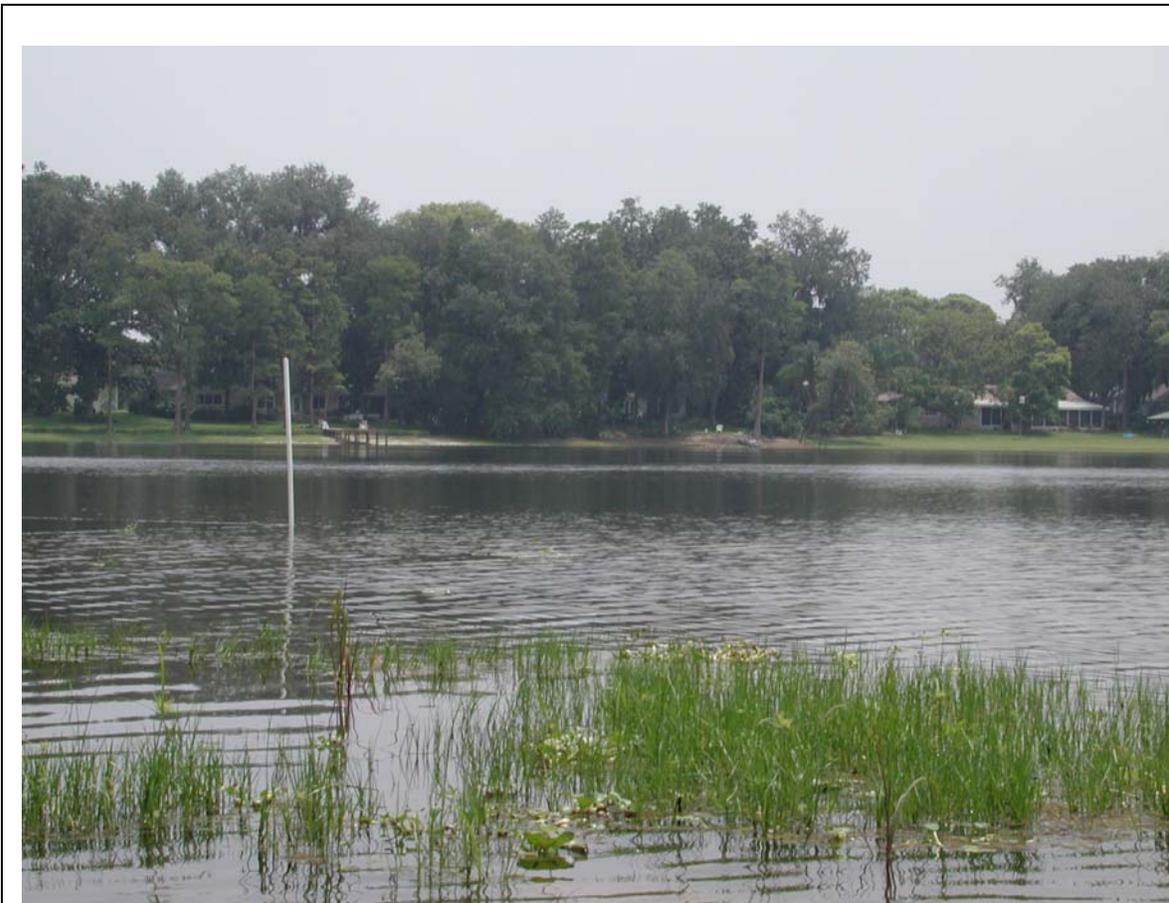
Figure 1. General Photograph of Lake Keene taken on August 8, 2007.

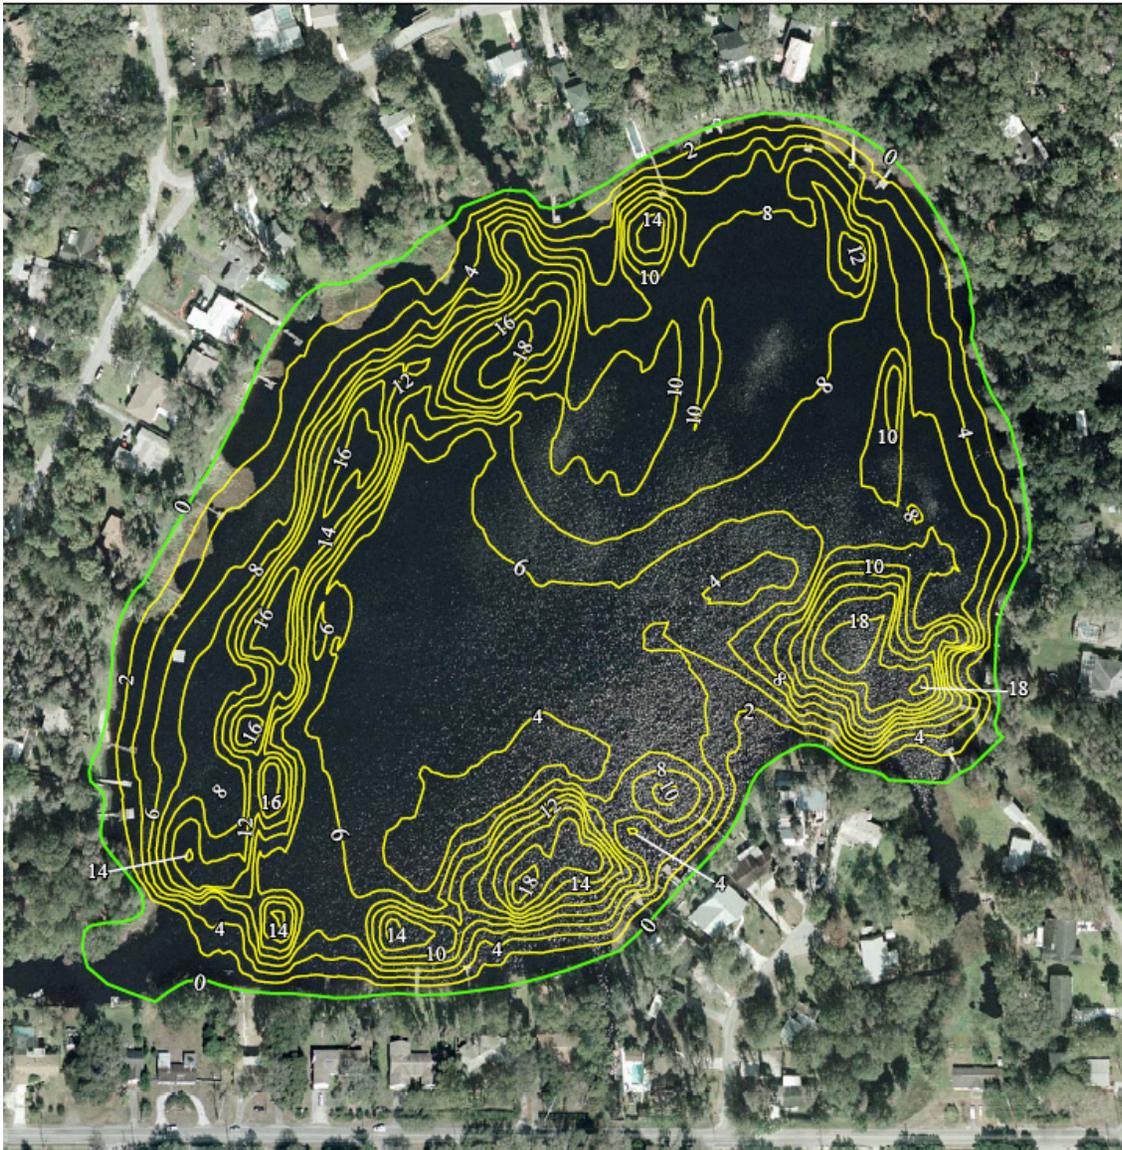
Lake Keene

EXPLANATION:
Survey Date: January 26, 2006.

Lake water level was 62.1 feet
above sea level at time of assessment.
Contours are expressed in absolute depth
below this level.

Figure 1. Contour map for Lake Keene. The mapping technique used in 2006 employs a standard DGPS for horizontal position and a fathometer for depth.

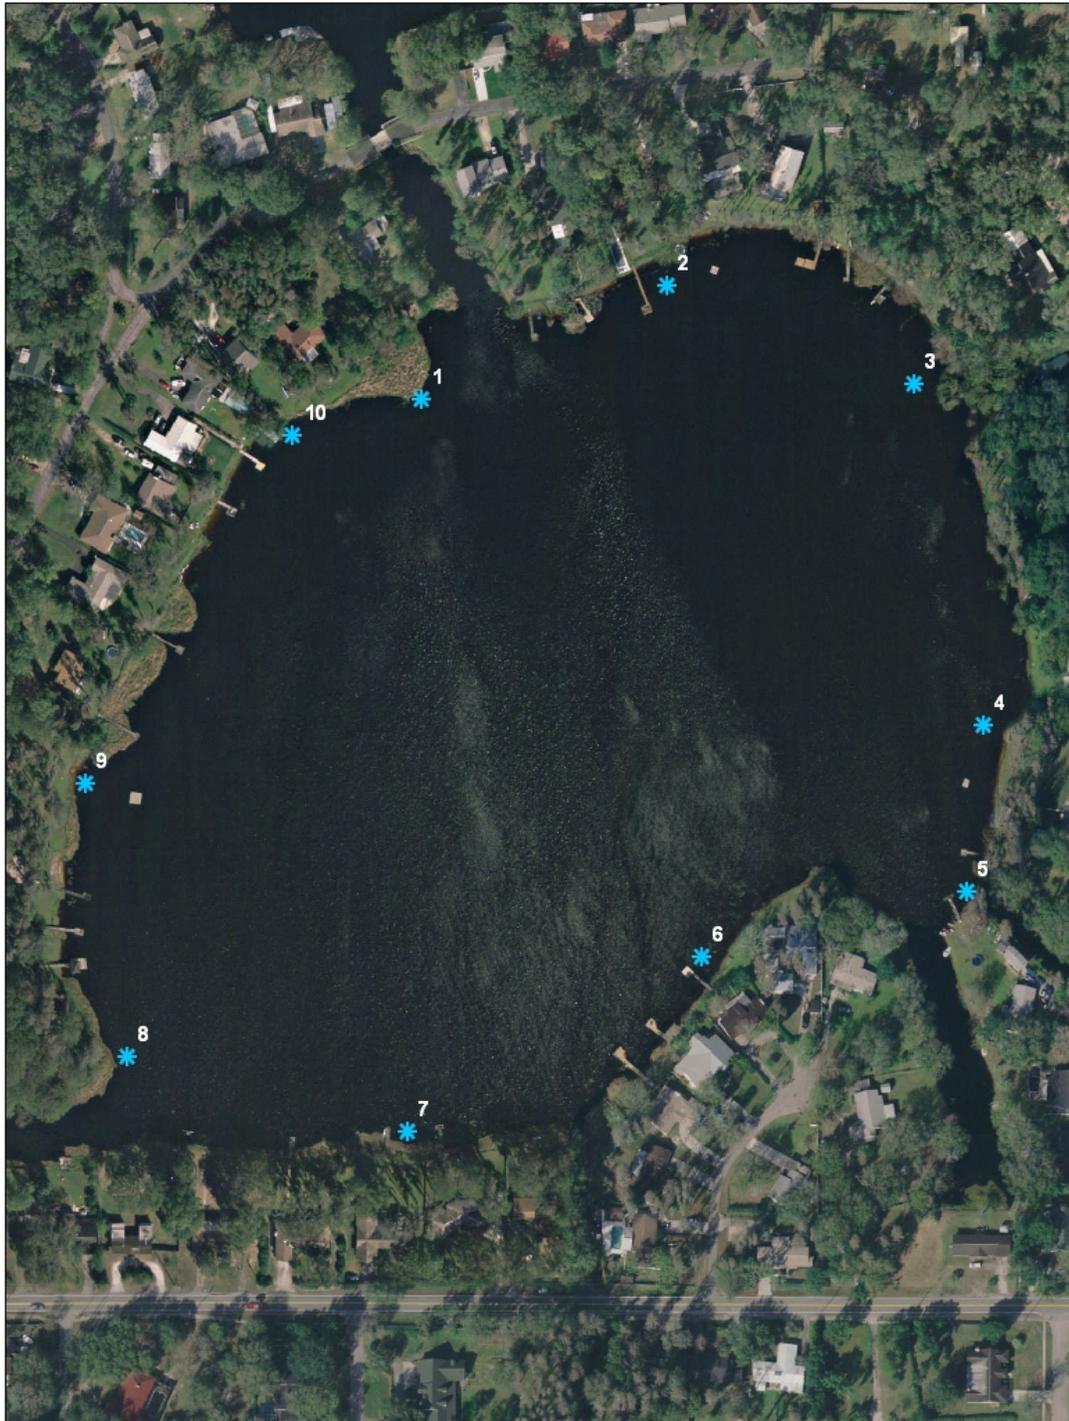
The lake's apparent vegetative cover and shoreline detail are evaluated using the latest lake aerial photograph as shown in Figure 3 and by use of WAAS enabled GPS. Submerged vegetation is determined from the analysis of bottom returns from the Lowrance 26c HD combined GPS/fathometer described earlier. As depicted in Figure 3, ten vegetation assessment sites were chosen for intensive sampling based on the *Lake Assessment Protocol* (copy available on request) for a lake of this size. The site positions are set using GPS and then loaded into a GIS mapping program (ArcGIS) for display. Each site is sampled in the three primary vegetative zones (emergent, submerged and floating)^{iv}. The latest aerials high resolution aerial photos are used to provide shore details (docks, structures, vegetation zones) and to calculate the extent of surface vegetation coverage. The primary indices of submerged vegetation cover and biomass for the lake, percent area coverage (PAC) and percent volume infestation (PVI), are determined by transiting the lake by boat and employing a fathometer to collect "hard and soft return" data. These data are later analyzed for presence and absence of vegetation and to determine the height of vegetation if present. The PAC is determined from the presence and absence analysis of 100 sites in the lake and the PVI is determined by measuring the difference between hard returns (lake bottom) and soft returns (top of vegetation) for sites (within the 100 analyzed sites) where plants are determined present.

Figure 3. 2006 six-inch resolution aerial photograph showing location of vegetation assessment sites on Lake Keene. Major emergent and floating vegetation zones as well as structures such as docks are also observable in this aerial.

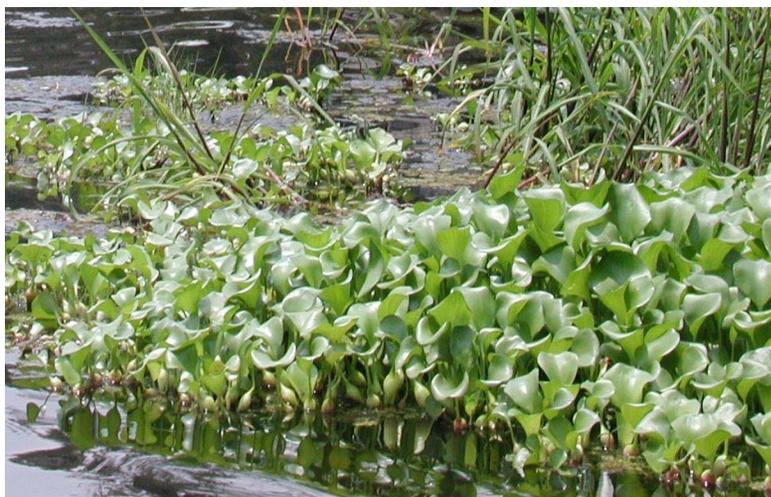
Figure 4. *Eichornia crassipes*, Water Hyacinth, is a non-native, invasive species from South America. This species is listed as one of the most productive plants on earth, capable of doubling its population in as little as a week. This species can reduce navigational ability in waterways, completely exclude native floating and submerged vegetation, and decrease dissolved oxygen.

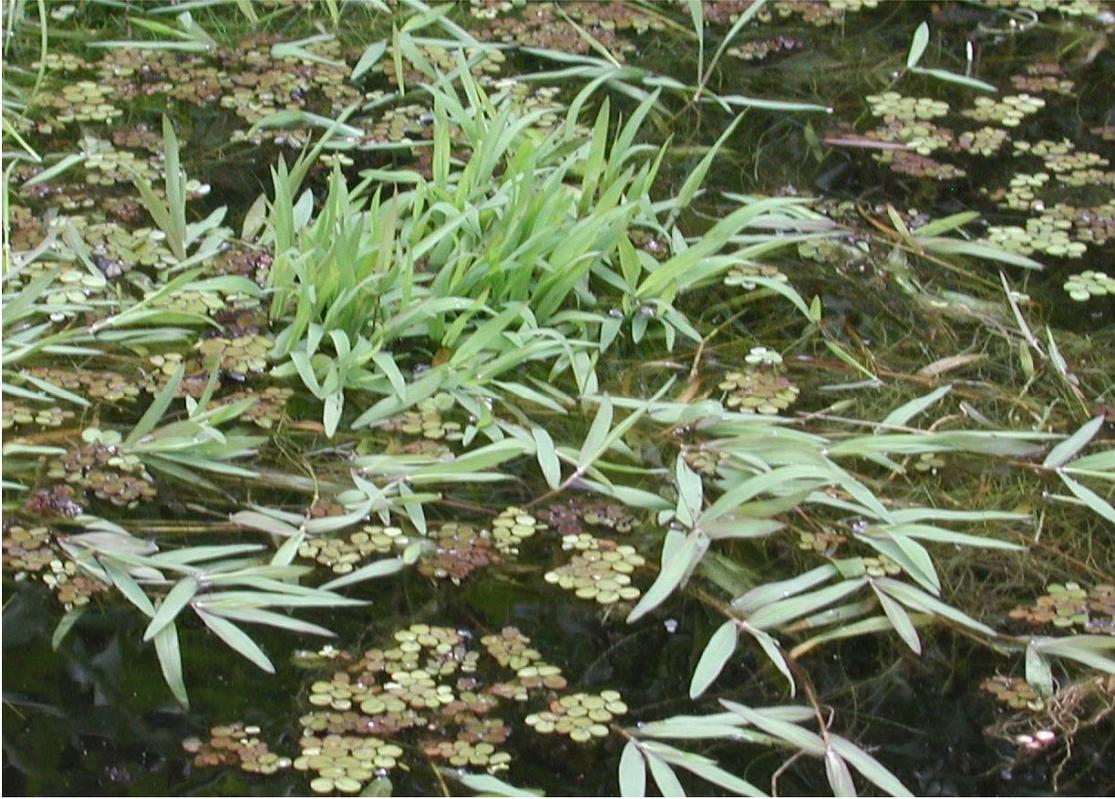
Figure 5. *Paspalum repens*, Water Paspalum, is an infrequently found native grass typically found in water or where it is frequently inundated by water.

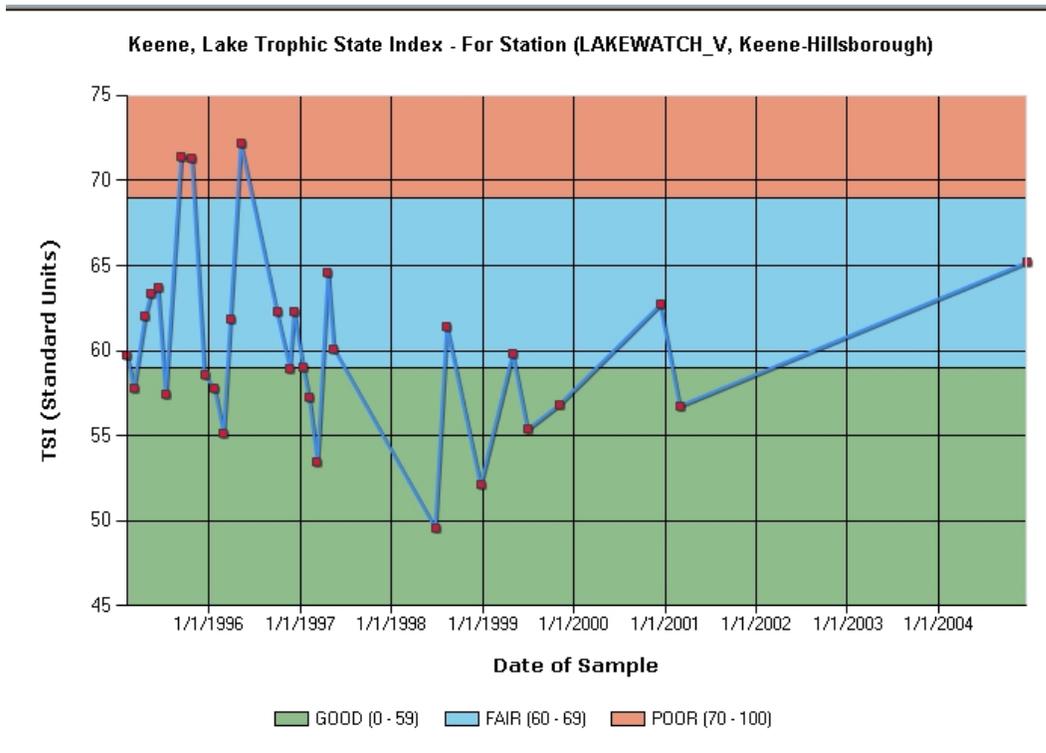
A critical element in any lake assessment is the long-term water chemistry data set. The primary source of water quality trend data for Florida Lakes is the Florida LAKEWATCH volunteer and the Florida LAKEWATCH water chemistry data. Hillsborough County is fortunate to have a large cadre of volunteers who have collected lake water samples for significant time period. These data are displayed and analyzed on the Water Atlas as shown in Figure 6 for Lake Keene. Additional data, when available, is also included on the Water Atlas; however, the LAKEWATCH data remains the primary source. By the trend data shown in the figure, the lake may be considered fair to poor health in terms of the trophic state index. This lake is a dark water lake (color > 40 pcu) and as such it must maintain a TSI of below 60 to not be considered impaired by the State of Florida guidelines^v. The lake's long term water quality data indicates enough violations of these criteria to be classified by Florida DEP as impaired. Unfortunately, the last LAKEWATCH data point is in 2004 so a recent trend is not available.

Figure 6. Recent Trophic State Index (TSI) graph from Hillsborough Watershed Atlas. For the latest date go to:

Note: The graph above includes benchmarks for using verbal descriptors of "good", "fair" and "poor". The verbal descriptors for these benchmarks are based on an early determination by stakeholders of the generally acceptable and understood terms for describing the state of lakes. The same benchmarks are used for nutrient graphs (Nitrogen and Phosphorus), chlorophyll graphs and trophic state index (TSI) graphs. The TSI is a calculated index of lake condition based on nutrient and chlorophyll (a) concentrations (please see "Learn more about Trophic State Index"). The benchmarks are established based on the TSI range that relates to a specific descriptor. The source for the TSI concentration relationships is the Florida Water Quality Assessment, 1996, 305(b) (Table 2-8).

useful when compared to the trend data available from LAKEWATCH or other sources. Table 8 contains the summary water quality data and index values and adjusted values calculated from these data. The total phosphorus (TP), total nitrogen (TN) and chlorophyll (a) water chemistry sample data are the results of chemical analysis of samples taken during the assessment and analyzed by the Hillsborough County Environmental Protection Commission laboratory. These data compare reasonably with the mean data from the LAKEWATCH data set for the lake. The trophic state index (TSI) calculated from the sample data (55.2) is significantly below the last (2004) LAKEWATCH data point (65.5); which may indicate improved conditions. Because this lake is presently listed as impaired, it is highly recommended that the LAKEWATCH sampling be resumed to better track conditions.

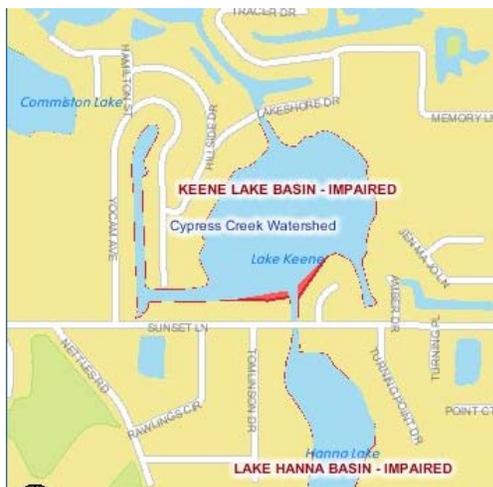
Figure 7. Lake Keene is classified as Impaired by FDEP as shown on Water Atlas.

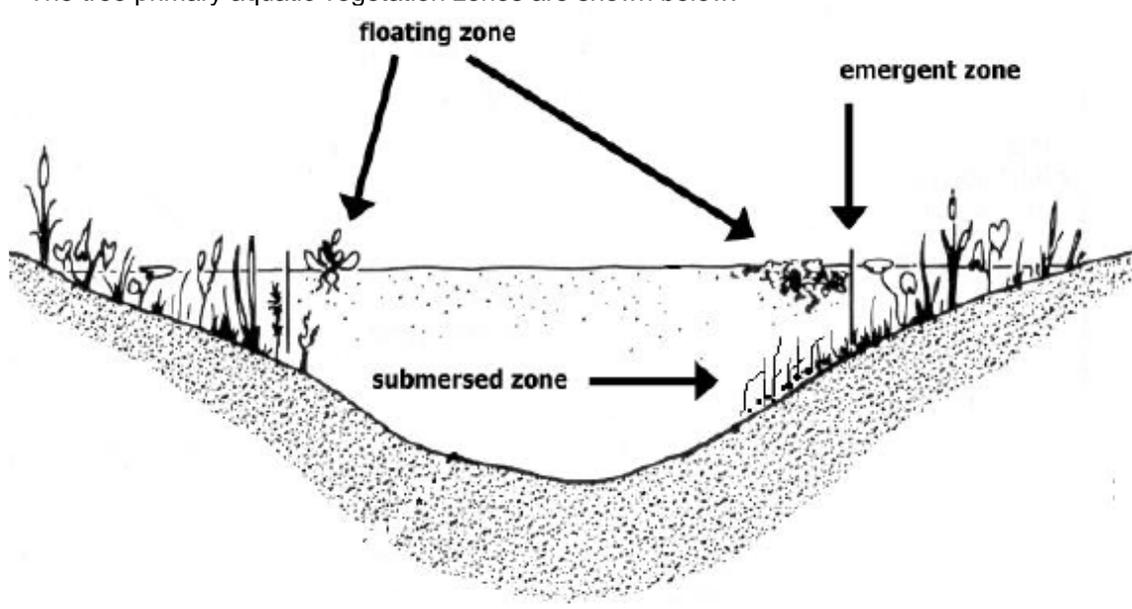
iv The tree primary aquatic vegetation zones are shown below:
