# LAKE ASSESSMENT REPORT FOR LAKE HIAWATHA IN HILLSBOROUGH COUNTY FLORIDA

Date Assessed: August 15, 2007

Assessed by: Sarah Koenig and David Eilers

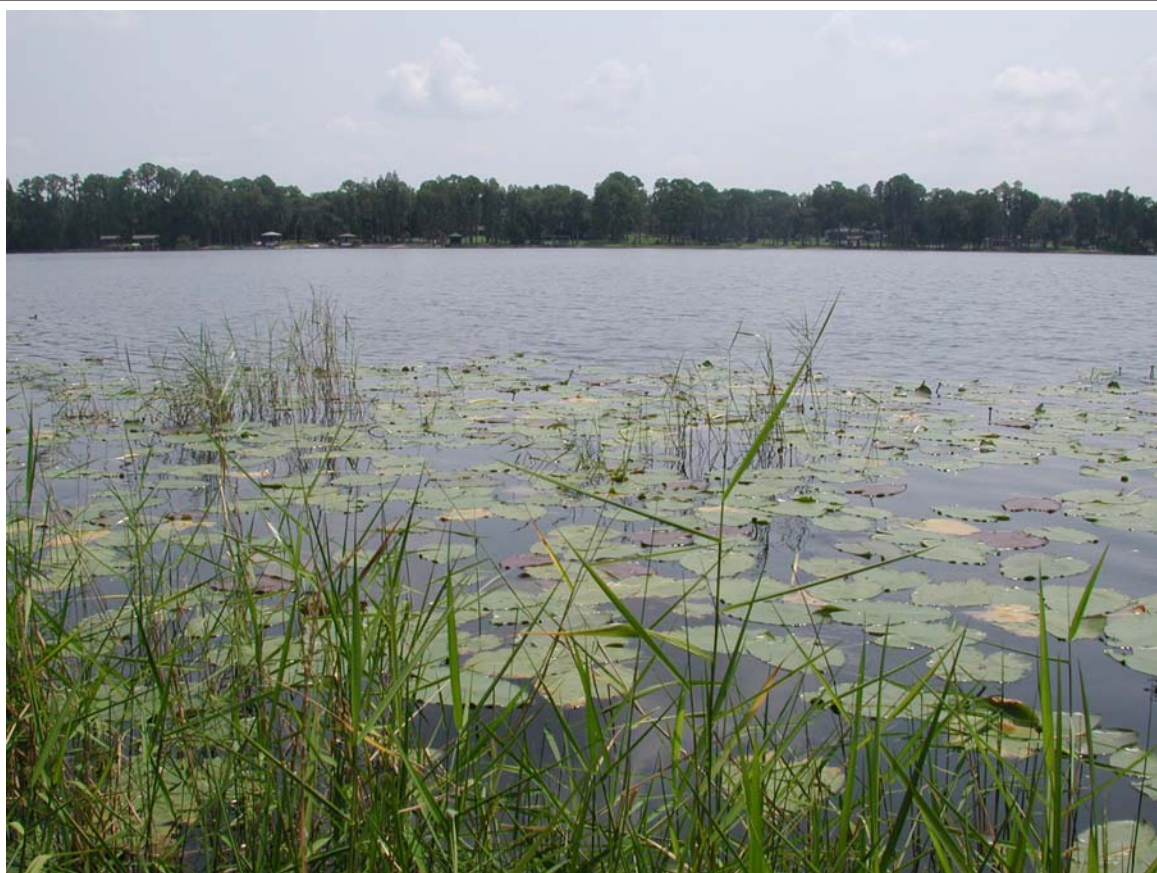
**Figure 1. General Photograph of Lake Hiawatha taken on August 15, 2007.**

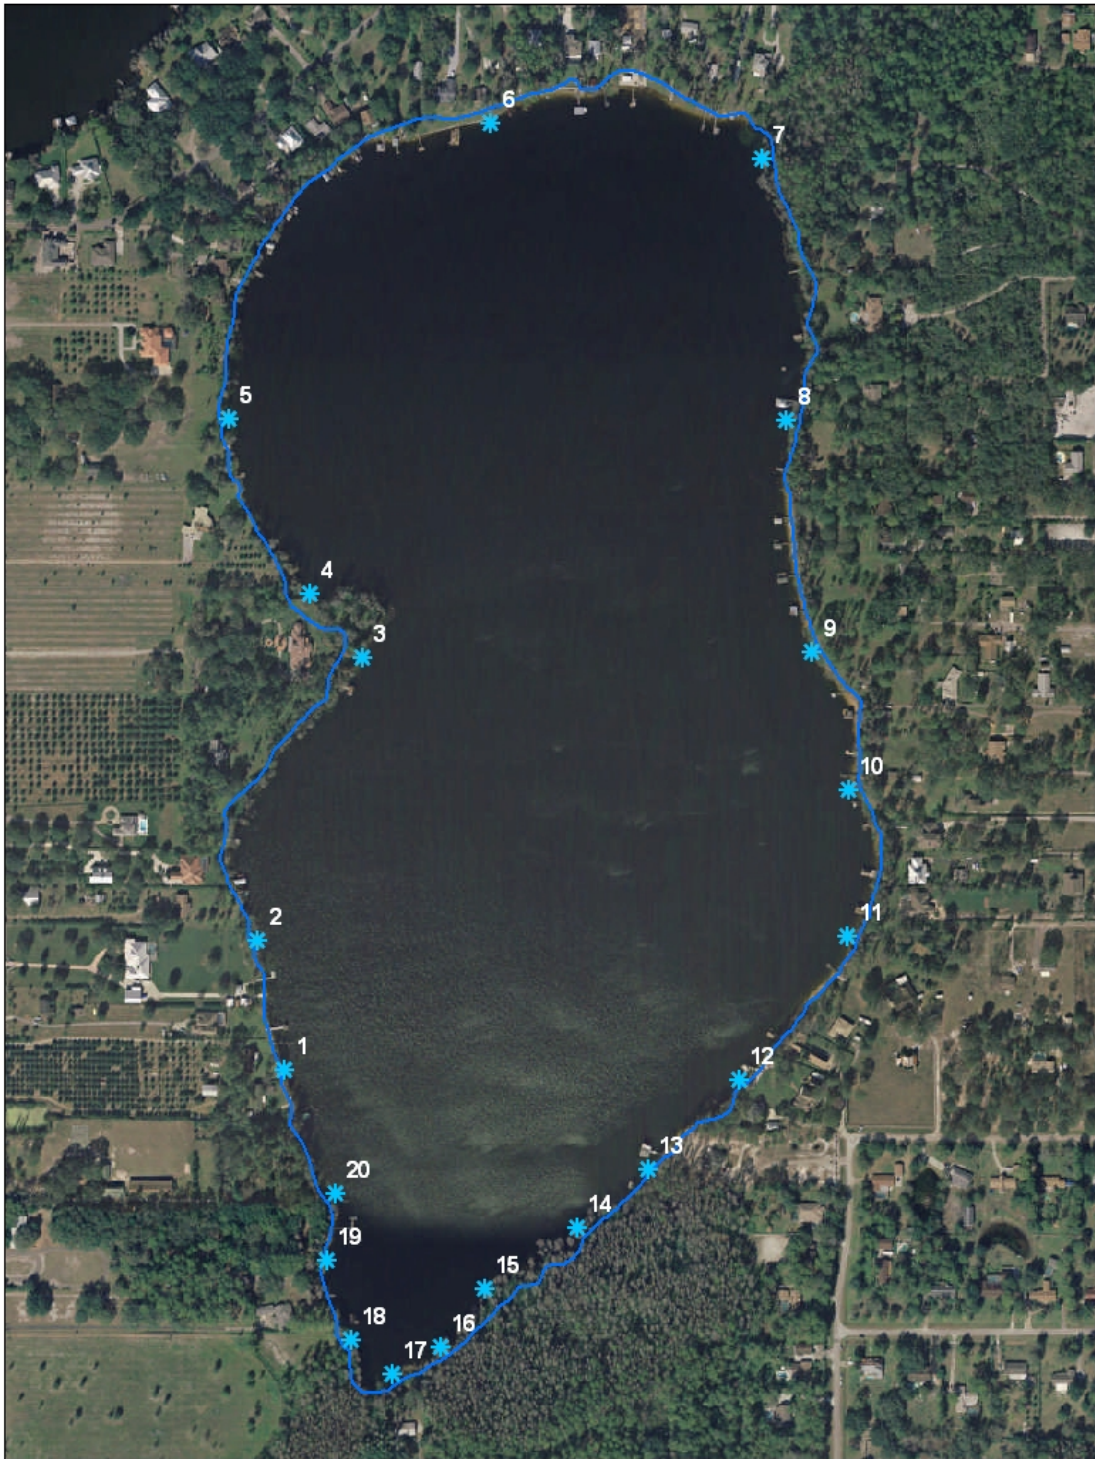
**Figure 3. 2006 six-inch resolution aerial photograph showing location of vegetation assessment sites on Lake Hiawatha. Major emergent and floating vegetation zones as well as structures such as docks are also observable in this aerial.**

The lake's apparent vegetative cover and shoreline detail are evaluated using the latest lake aerial photograph as shown in Figure 3 and by use of WAAS enabled GPS. Submerged vegetation is determined from the analysis of bottom returns from the Lowrance 26c HD combined GPS/fathometer described earlier. As depicted in Figure 3, twenty vegetation assessment sites were chosen for intensive sampling based on the *Lake Assessment Protocol* (copy available on request) for a lake of this size. The site positions are set using GPS and then loaded into a GIS mapping program (ArcGIS) for display. Each site is sampled in the three primary vegetative zones (emergent, submerged and floating)<sup>iv</sup>. The latest aerials high resolution aerial photos are used to provide shore details (docks, structures, vegetation zones) and to calculate the extent of surface vegetation coverage. The primary indices of submerged vegetation cover and biomass for the lake, percent area coverage (PAC) and percent volume infestation (PVI), are determined by transiting the lake by boat and employing a fathometer to collect "hard and soft return" data. These data are later analyzed for presence and absence of vegetation and to determine the height of vegetation if present. The PAC is determined from the presence and absence analysis of 100 sites in the lake and the PVI is determined by measuring the difference between hard returns (lake bottom) and soft returns (top of vegetation) for sites (within the 100 analyzed sites) where plants are determined present.

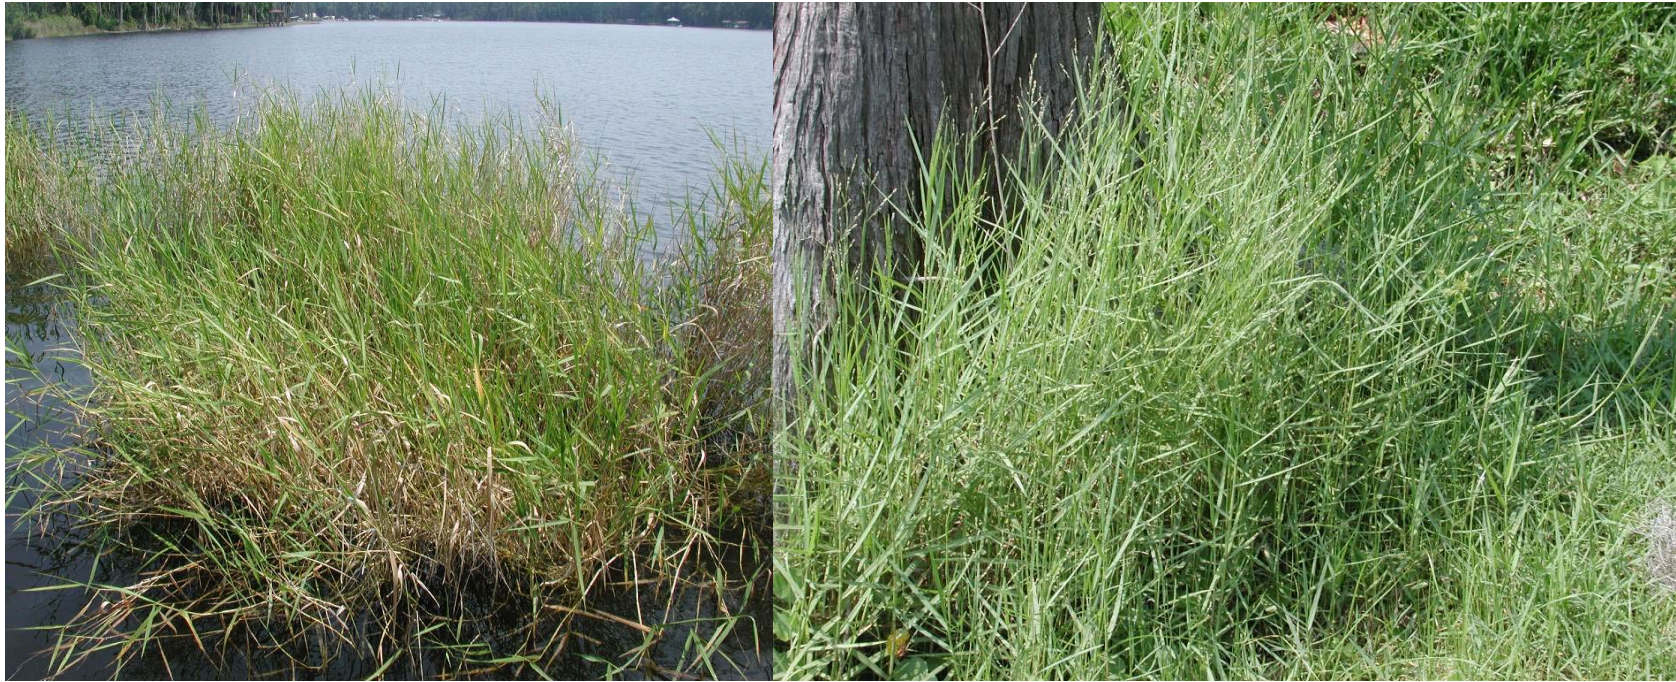
**Figure 5.** *Panicum repens*, Torpedo Grass (right), and *Panicum hemitomon*, Maidencane (left), are both common grasses along lake shores in Florida. *Panicum repens* is a non-native, invasive species that occupies the vegetation zone where the native *Panicum hemitomon* would normally occupy. *Panicum repens* typically will be the first grass to establish in an area that has been disturbed by vegetation removal. *Panicum hemitomon* is a species of importance for native juvenile fish and invertebrates as a source of shelter from predators.
