FORENSIC METHODS FOR CHARACTERIZING
WATERCRAFT FROM WATERCRAFT-INDUCED
WOUNDS ON THE FLORIDA MANATEE
(*TRICHECHUS MANATUS LATIROSTRIS*)

ABSTRACT

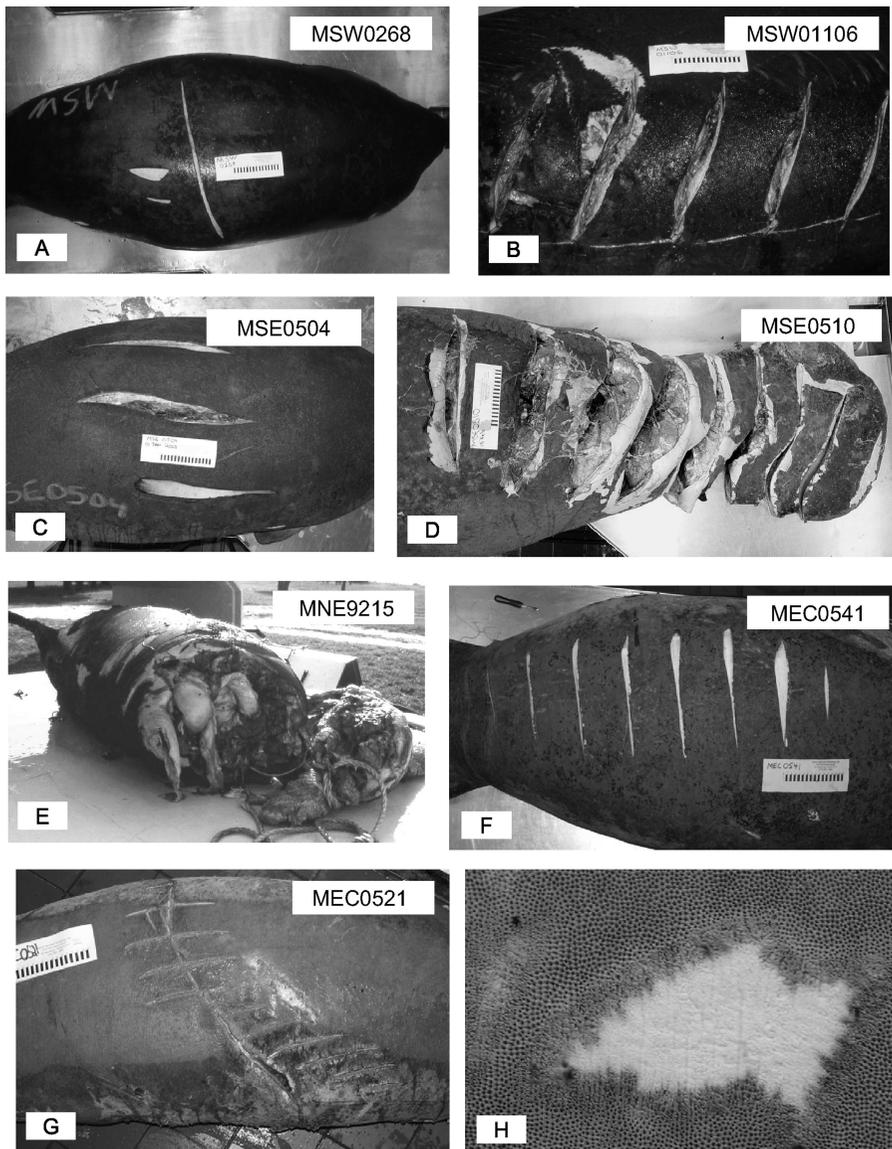
Figure 1. Photographs illustrating externally visible watercraft-caused ante-mortem trauma on manatee carcasses; 15 cm scale. (A) A long superficial linear wound and two smaller superficial crescentic propeller wounds. (B) Five propeller wounds each of which penetrated the skin (epidermis & dermis) and some of the underlying tissues. (C) Three propeller wounds, the middle one of which penetrated the skin and underlying tissues, the others of which only penetrated the epidermis. (D) Deeply penetrating propeller wounds some of which partially transected the peduncle and fluke. (E) Adult carcass transected by a very large propeller (carcass diameter at cut, approximately 70 cm [27.6 in.]). (F) Eight superficial propeller wounds, which only penetrated the epidermis. (G) Resolving propeller wounds and associated linear lesion. (H) Healed scar (note the smooth texture of the scar in contrast to the dimpled appearance of the adjacent epidermis).

Watercraft can inflict both sharp- and blunt-force trauma. Sharp-force trauma involves injuries from sharp skegs, fins, and propeller blades (Fig. 1A–G). Blunt-force

Linear cuts or scrapes (Fig. 1A, 3A) roughly parallel to the direction of vessel travel are caused by watercraft projections (Fig. 2) that are dragged across the manatee. Interestingly, speedometer pickups and twin engine rudders are typically positioned off center, whereas keels and single engine skegs are commonly on center. Twin drive configurations have twin skegs that are off center. Propeller-driven watercraft may be configured with outboard engines (Fig. 2A), sterndrives (Fig. 2B), or fixed propeller shaft inboard engines (Fig. 2C). Each configuration has a propulsion system that varies in design and size (Snyder 1992).

Scars—Scars (as used here) are grossly visible dermal lesions that are in the process of healing or are healed (Fig. 1G, H), and which are unlikely to be associated with the proximate cause of death. However, in chronic cases, the original incident is defined as the cause of death.

Healing scars may have rough or granular margins and a pink, white, or yellow color. Most healing scars repigment unless the wound was initially very deep or very wide. Older scars can be recognized by their texture and striated appearance (Fig. 1H).

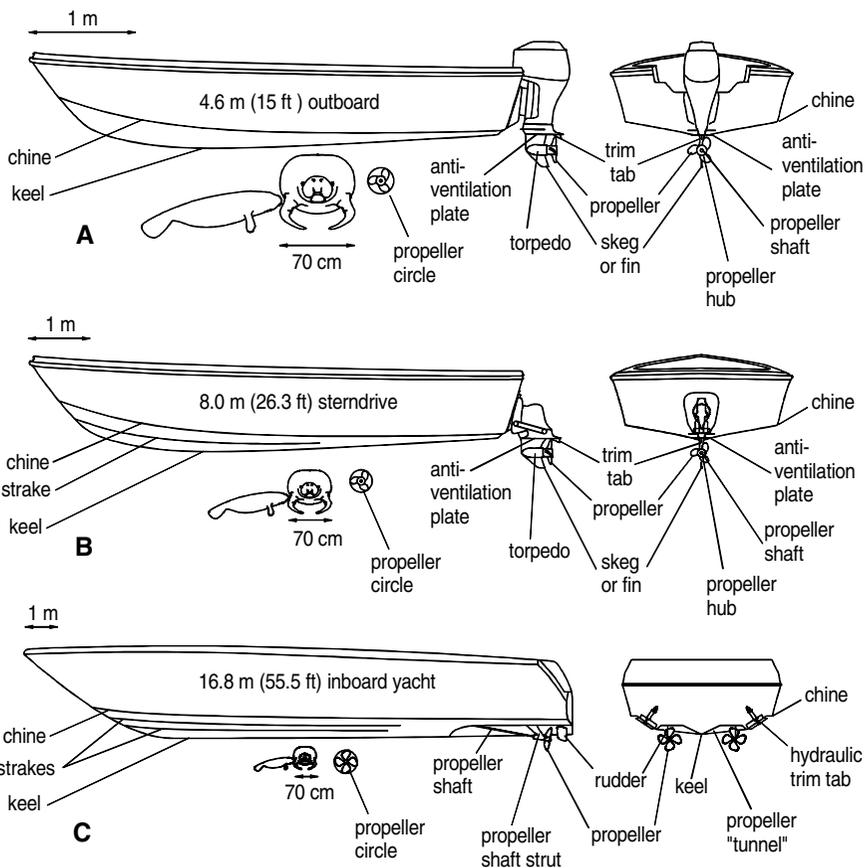
Figure 2. Watercraft hulls, propulsion units, and structures extending from them that can inflict wounds on manatees. A, B, and C watercraft with lengths of 4.6 m (15 ft), 8 m (26.3 ft), and 16.8 m (55.5 ft), respectively. An adult manatee (70 cm [27.6 in.] in diameter) with a nursing calf (130 cm [51.2 in.] in length) are illustrated in each drawing to provide scale for each of the watercraft and propellers shown.

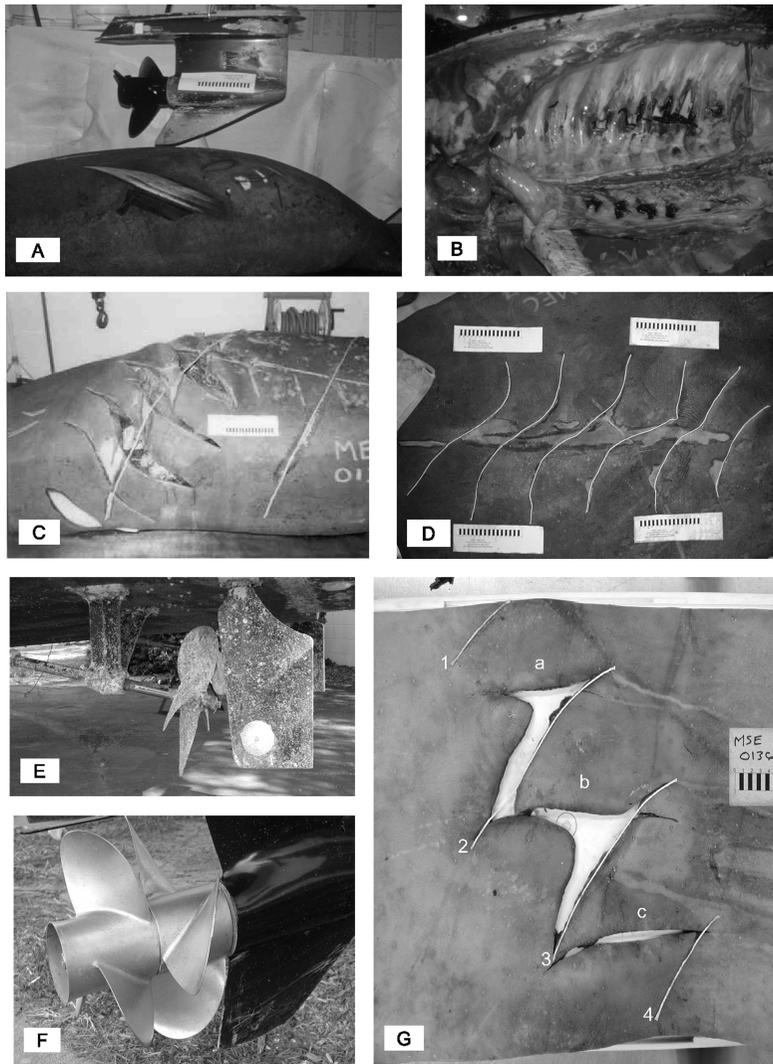
Figure 3. Analysis of skeg and propeller wounds. (A) Photograph of the surface scrapes found on carcass MSW0079. The vessel that struck this manatee was a 6.7-m (22 ft) sterndrive, traveling at 11.2 m/s (25 mph) in 3 m (10 ft) of water. A lower unit similar to that causing the wounds is suspended above the carcass. (B) Photograph of some of the internal injuries (broken ribs, lacerated lung, lacerated parietal pleura, blood clots, hemorrhage) associated with the apparently superficial wounds (the head is to the left, the damaged lung is reflected to the opposite side). (C) Photograph of a series of fresh propeller wounds made in manatee carcass MEC0127. (D) Photograph of the skin (placed on a flat surface) from the carcass in C. (Note that the skin may darken when it dries.) Strings were placed on the lesions to make them more visible. (E) One of a pair of large-diameter propellers with rudder, an example of a drive system consistent with the wounds illustrated in C & D. (F) A photograph of counter rotating propellers on a single shaft; a configuration similar to this caused the wounds illustrated in G. (G) The skin from the wound region of MSE0136 arranged on a flat surface to help analyze the wound pattern. The letters and numbers represent two sets of cuts, which were made during the same event.

The vessel that struck manatee MSW0079 (Fig. 3A) was 6.7 m (22 ft) with twin sterndrives (Table 1). During the collision it was traveling at 11.2 m/s (25 mph) in 2.7 m (9 ft) of water. In Figure 3B, note the five fractured ribs and corresponding lacerations of the lung; this damage was deep to the superficial scrape.

Manatee MEC0127 (Fig. 3C, D) provides an example of a complex wound pattern, including propeller cuts, rudder scrapes, and an offset keel scrape. The skinned section (Fig. 3D) highlights the shape of the propeller wounds. In this example, a right-handed propeller made the cuts (see Fig. 5C). The linear wound bisecting the cuts is consistent with a keel or ski boat turning fin (modern power boats rarely have sharp keels), propeller hub or shaft, or centered rudder. The linear lesion (indicated by string in Fig. 3C) offset to the right of the lethal part of the pattern is consistent with a keel, turning fin, or rudder. This lesion occurred at the same time as the pattern on the left, but because the head was deeper than the tail, the second propeller of the vessel did not touch the carcass.

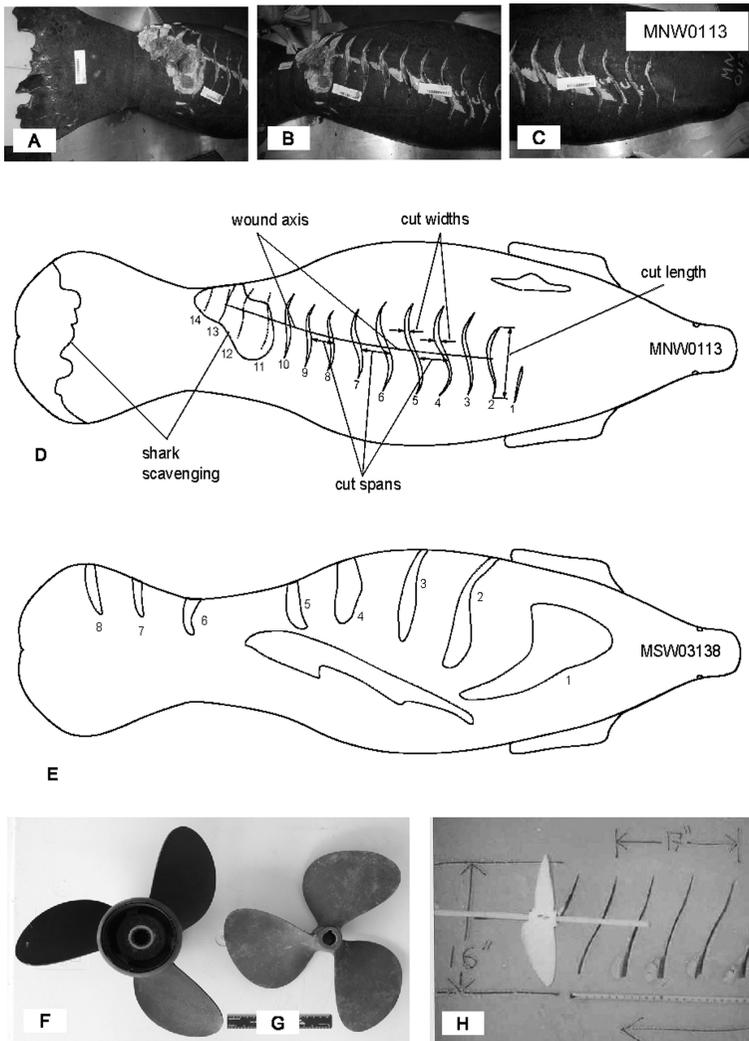
Figure 4. Propeller cut patterns and propellers. (A–C) Photographs of a watercraft-related wound (MNW0113) pattern consisting of, roughly equidistant lesions and a single linear lesion. In addition, sharks have scavenged the fluke and parts of the wound. (D) Wound sketch of MNW0113 drawn during necropsy. (E) Wound sketch of carcass MSW03138 illustrating that successive propeller cuts can have different spacing and orientation. Propeller blade shape and dimensions vary; even propellers of roughly the same diameter can have different shapes, depending on the application as illustrated in the next photographs. (F) Photograph of a fast, right-handed, exhaust-through propeller from an outboard engine. The engine exhaust exits in the region between the shaft and the outer hub (base of the blades). (G) Photograph of a slow, left-handed propeller from a sail boat. Because of the large diameter of the hub, the propeller on the left will have a smaller percentage of the overall diameter in blade length than the propeller on the right. (H) Photograph of impressions in sand made by a right-handed propeller, illustrating how rotation and pitch influence propeller patterns. The three-bladed propeller with diameter 16 in (40.6 cm), pitch 17 in (43.2 cm), has moved from the right to the left. Note that each entry cut (top of pattern) is cleaner than the exit cut (bottom of pattern).

Pitch and slip—Propeller *pitch* is the distance that a propeller (or screw) travels through a soft solid during one complete revolution (Avallone and Baumeister 1996; Fig. 4H). Much like a screw through wood, the distance traveled per revolution by a propeller screw in a soft solid is independent of the speed at which the propeller is turned. This is because pitch, not propeller RPM or vessel speed, most determines the spacing between successive penetrating propeller wounds (cut span; Fig. 4D).

parts of the pattern. The cut spans between successive lacerations of the pattern are inconsistent except in the tail where the propeller blades entered the flesh. These cuts (labeled 6–8 in Fig. 4E) through the tissues of the tail are evenly spaced and reflect the pitch (and some unknown amount of slip) of the propeller. In front of these cuts are five other wounds (labeled 1–5 in Fig. 4E) that are progressively farther apart (because of the narrowing of the body there is a “missing” cut—not numbered—between 5 and 6). Direction of propeller travel can be inferred from the manner in which the epidermis was scraped from the underlying dermis at the wound margins. The wound labeled #1 in Figure 4E occurred first and wound labeled #8 occurred last. The animal may have rotated on its axis and flexed its body as part of its reaction to the watercraft strike, thus contributing to pattern complexity.

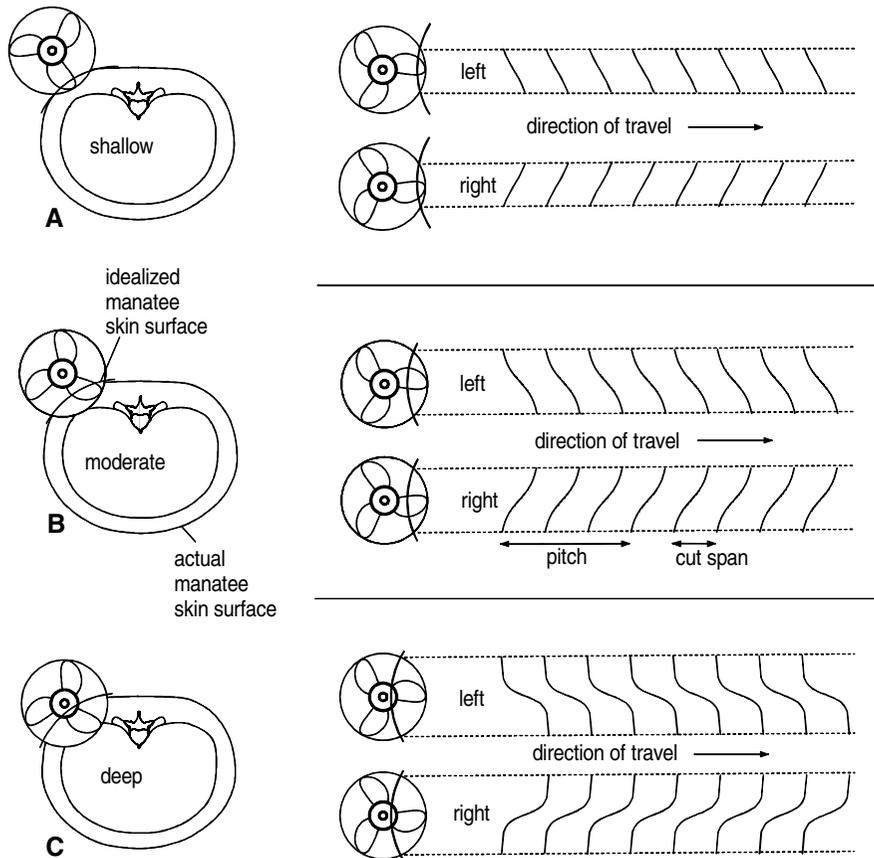
Figure 5. Schematic illustrations generated using projective geometry of the trajectories made by propeller cuts with different depths of penetration. The shape of the cuts made by a propeller will be proportional to the depth of penetration. (A) Shallow (10%); (B) Moderate (20%); and (C) Deep penetration (40%); the percentages were computed from the depths of blade penetration divided by the diameter of the propeller. Shallow penetration produces relatively straight lines. Deeper penetration produces more sigmoid cuts. The patterns are of a propeller diameter that is half the diameter of the manatee. Patterns produced by right- and left-handed rotations are illustrated. These patterns were generated for a manatee that is circular in cross-section; noncircular regions will have slightly different patterns.

have considerable variation in cut spans within a single pattern (Fig. 4A–E), and wound patterns can vary considerably depending on depth of propeller penetration (Fig. 5) and propeller characteristics (Fig. 6). Other complicating factors are muscle contraction, body curvature, and differences in penetration and orientation of projecting elements of the watercraft in the water at the moment of collision (Fig. 1C, D). Compression of the manatee's hide and underlying tissues by a torpedo, propeller shaft (Fig. 3C, D), or propeller blade could potentially increase the wound length.

A propeller can produce wounds of different shapes depending on the depth and angle of penetration (Fig. 5). The radius of curvature of the animal will influence the wound depth distribution (Fig. 4D, E); however, propeller circle templates can be fitted into wounds to overcome this problem (Fig. 7).

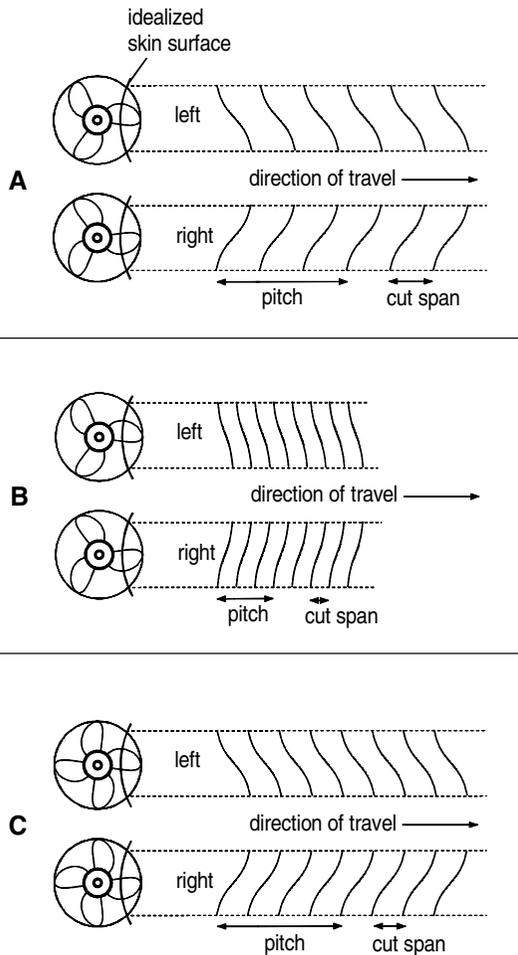
Figure 6. Schematic illustration, generated using projective geometry and assuming zero slip, of the influence of pitch and blade number on wound spacing (cut span). The depth of penetration, 10% of propeller diameter, is depicted on the left side of the illustration; on the right side of the illustration is the idealized pattern for two complete revolutions of the propeller. Left-handed rotation is labeled left, right-handed rotation is labeled right. (A) Three-bladed 35.6 cm (14 in.)-diameter, 53.3-cm (21 in.)-pitch propeller. (B) Three-bladed 35.6-cm (14 in.)-diameter, 21.6-cm (9 in.)-pitch propeller. (C) Four-bladed 35.6-cm (14 in.)-diameter, 53.3-cm (21 in.)-pitch propeller.

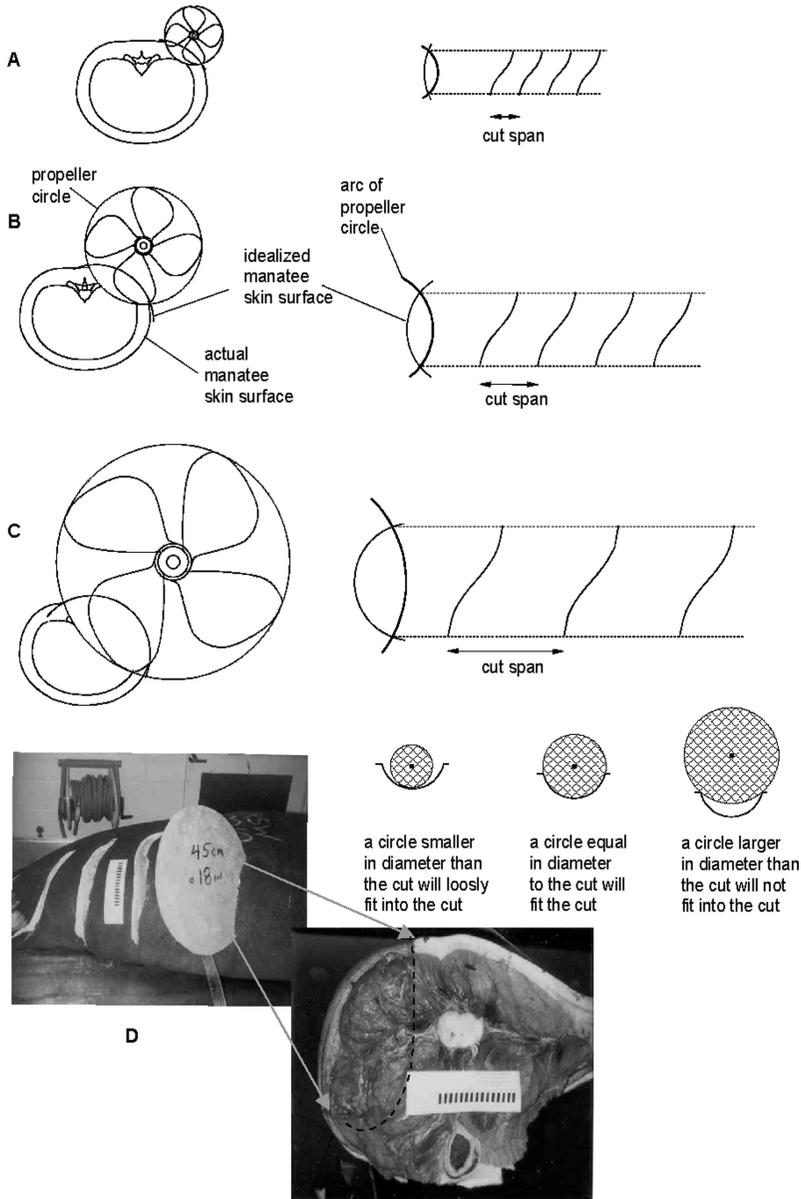
Figure 7. Together, wound depth and length can help determine propeller size. Schematic illustration, generated using projective geometry, of the influence of propeller diameter, relative to manatee diameter on wound shape and size. The examples illustrate different propeller sizes for the same diameter manatee and depth of penetration. (A) Propeller diameter equal to half of manatee diameter. (B) Propeller diameter equal to manatee diameter. (C) Propeller diameter equal to twice that of manatee. (D) Disks or arcs of a circle inserted into a wound can represent the margins of a cut made by a rotating propeller. Photographs illustrating the fit of a 45-cm (17.7 in.)-diameter disk in a manatee lesion created by a propeller approximately 18 in. (45.7 cm) in diameter.

be fitted to the wound (Fig. 7D). Flexible (plastic and thin sheet metal) templates facilitate fitting in wounds that are not straight. The MMPL has a number of circle templates representing different propeller diameters. These templates can be used without chord length and chord depth of a cut to approximate propeller diameter by finding the best circular fit.

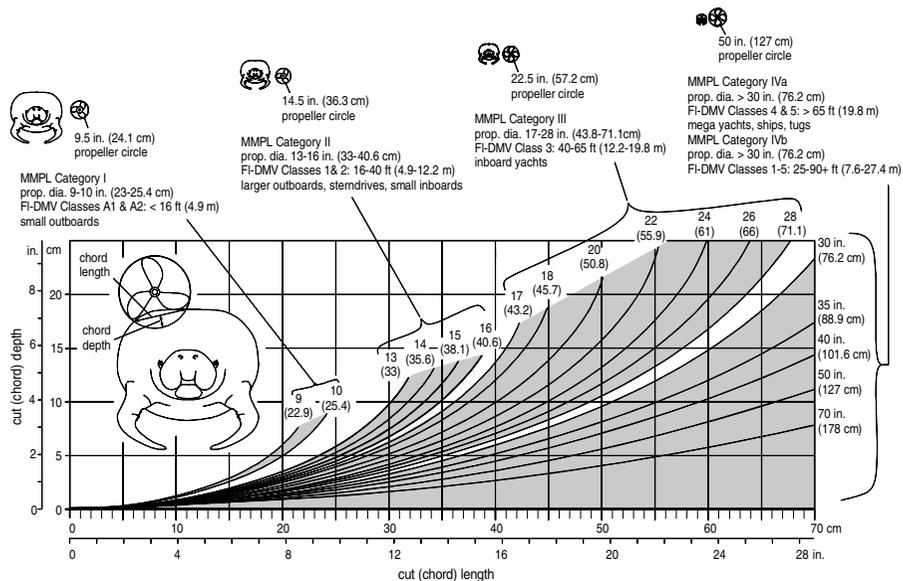
Figure 8. Marine Mammal Pathobiology Lab (MMPL) propeller size categories based on commonly used propellers and the FL-DMV resident watercraft registration classes. Cut-length *vs.* cut-depth curves computed for propeller diameters 22.9–178 cm (9–70 in.). With these curves, propeller diameter can be approximated (assuming little deformation of the manatee's body) using both the cut-length and cut-depth of an individual propeller lesion. Category I = small outboards; Category II = larger outboards, sterndrives, small inboards; Category III = medium to large inboards; Category IV = very large inboards (mega yachts, ships, and tugs). All these categories contain recreational and commercial use vessels. The numerical values along the margins of each curve are propeller diameters in inches/centimeters.

One can approximate, assuming little deformation of the manatee's hide, the propeller diameter using both the length and depth of an individual propeller cut (Fig. 8). In this graph, length is used as the chord of the propeller circle and the depth as the maximum distance between the chord and the circle perimeter. If the cut length used is chord length (Fig. 8) and the cut depth used is chord depth, then the principle can be applied to curved or flat regions⁷ of the manatee. It is therefore more appropriate to always use chord length and chord depth. Large-diameter propellers produce relatively shallow cuts for their lengths, whereas small-diameter propellers produce deeper cuts for the same lengths. Cuts made by the same propeller that have similar cut lengths will be deeper in smaller-diameter manatees than in larger-diameter manatees or in body regions of smaller radii of curvature. The safest and most accurate method currently employed at MMPL uses propeller-circle templates⁸ that can

⁷ At small depths, there is relatively larger potential error when interpreting the graph in Figure 8 due to deformation of the skin (skin thickness is between 2 and 3 cm on the dorsum) and measurement error, thus we have found that a minimum penetration of 1.4 cm (0.6 in.) is required for chord-depth measurements.

Propeller size categories are not absolute and are therefore used only as a guide for forensic analysis. The MMPL propeller categories (Table 2; Fig. 8) described below are based on the vessel registration classes used by the Florida Department of Motor Vehicles¹¹ (FL-DMV) and the most common propeller sizes found on watercraft in U.S. waters.
