LAKE ASSESSMENT REPORT FOR SADDLEBACK LAKE IN HILLSBOROUGH COUNTY FLORIDA

Date Assessed: June 14, 2007
Assessed by: Sarah Koenig and David Eilers
Reviewed by: Jim Griffin, Ph.D.

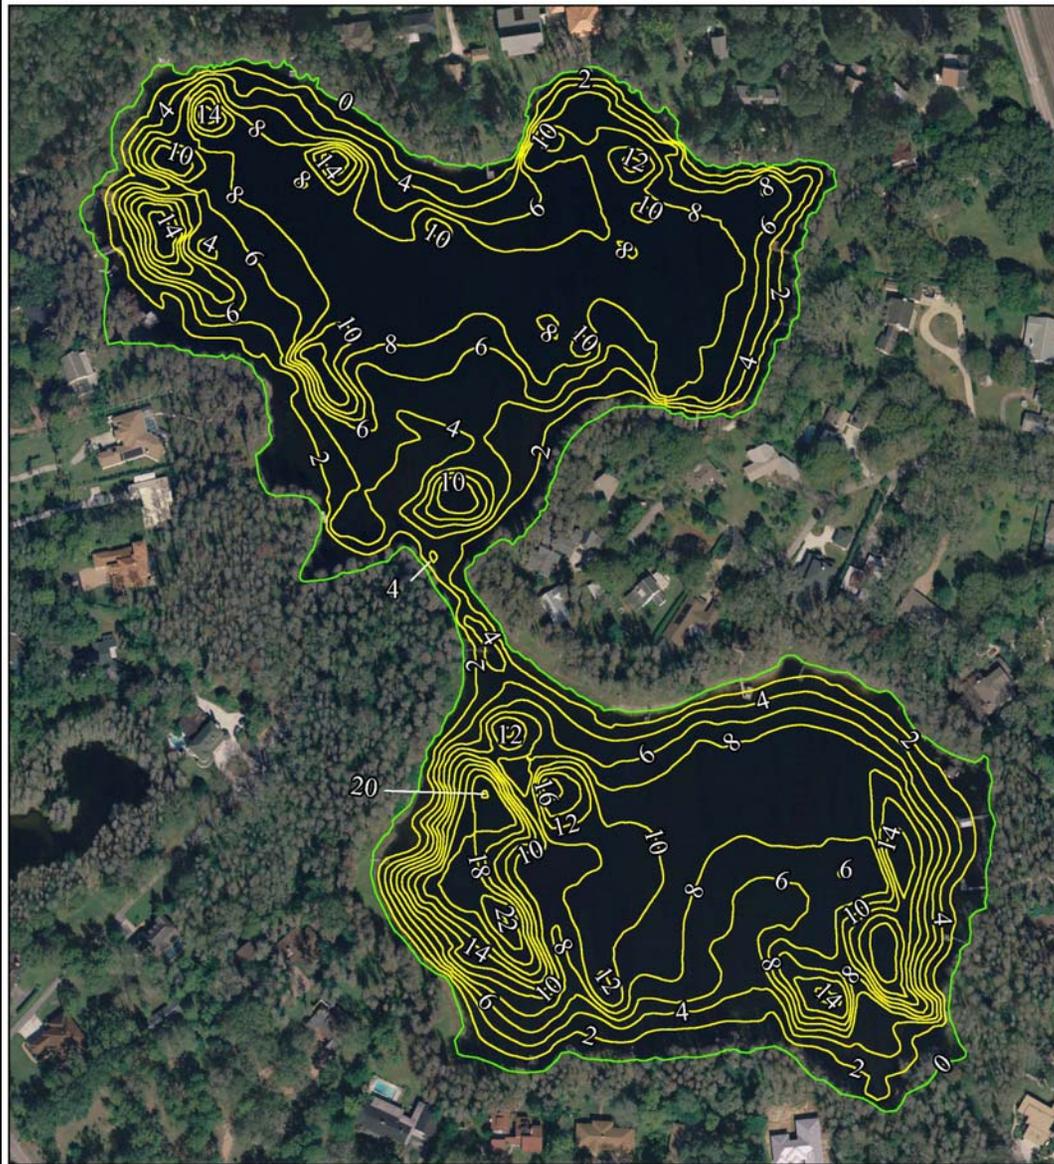
Survey Date: June 14, 2007
 Lake water level was 52.40 ft
 above sea level at time of assessment.
 Contours are expressed in absolute depth
 below this level.

Perimeter 8,023.8 ft;
 Area 31.6 Acres;
 Mean Depth 6.68 ft;
 Volume 208.2 Acre-ft, (67,855,773 gallons);
 Deepest point 22.24 ft

Figure 2. Contour map for Saddleback Lake. The mapping technique used in 2007 employs a standard DGPS for horizontal position and a fathometer for depth.

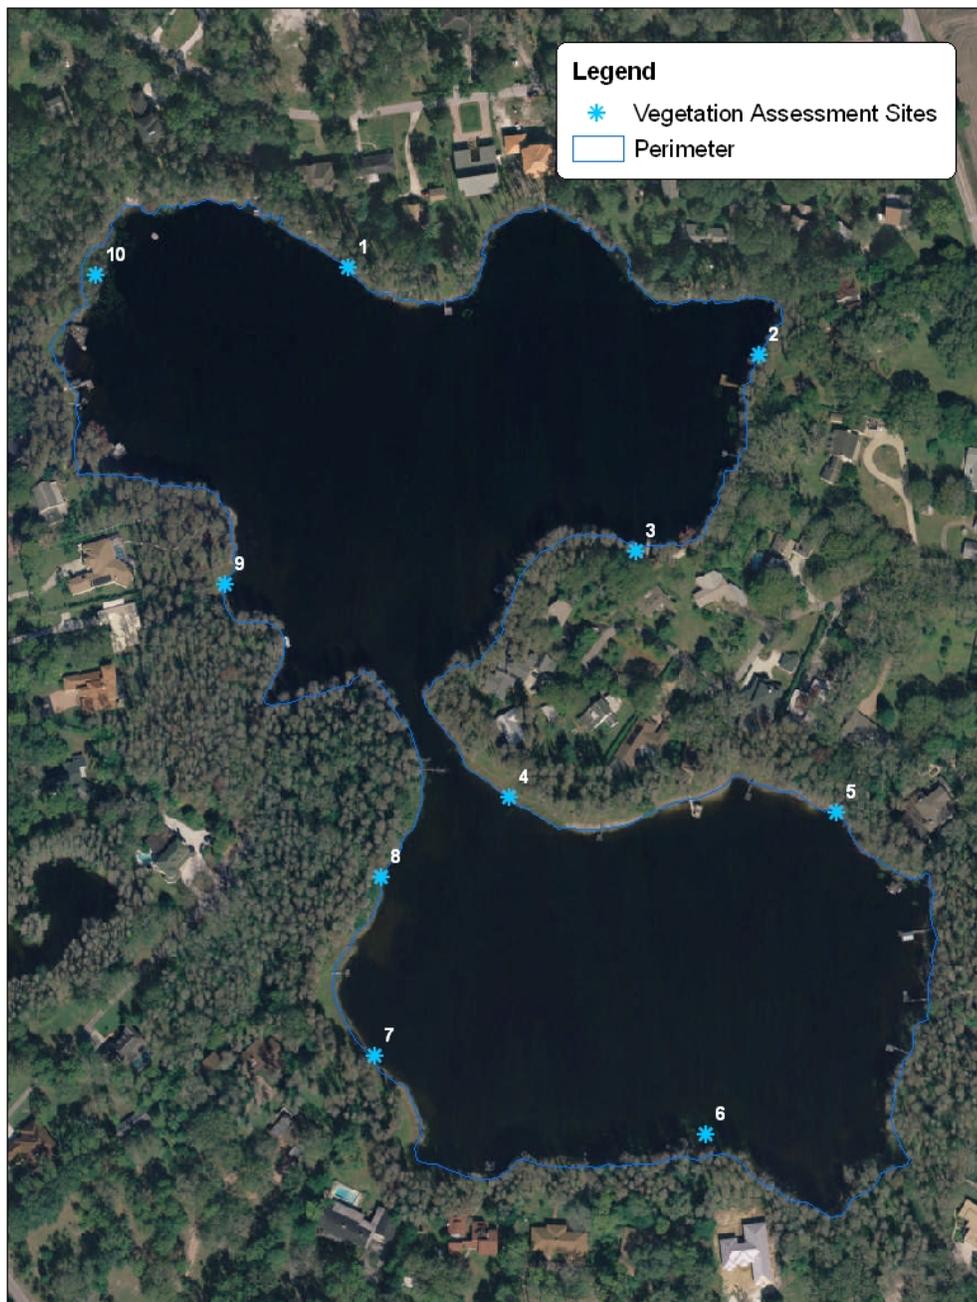
Figure 3. 2006 six-inch resolution aerial photograph showing location of the vegetation assessment sites on Saddleback Lake. Major emergent and floating vegetation zones as well as structures such as docks are also observable in this aerial.

The lake's apparent vegetative cover and shoreline detail are evaluated using the latest lake aerial photograph as shown in Figure 3 and by use of WAAS enabled GPS. Submerged vegetation is determined from the analysis of bottom returns from the Lowrance 26c HD combined GPS/fathometer described earlier. As depicted in Figure 3, ten vegetation assessment sites were chosen for intensive sampling based on the *Lake Assessment Protocol* (copy available on request) for a lake of this size. The site positions are set using GPS and then loaded into a GIS mapping program (ArcGIS) for display. Each site is sampled in the three primary vegetative zones (emergent, submerged and floating)^{iv}. The latest aerials high resolution aerial photos are used to provide shore details (docks, structures, vegetation zones) and to calculate the extent of surface vegetation coverage. The primary indices of submerged vegetation cover and biomass for the lake, percent area coverage (PAC) and percent volume infestation (PVI), are determined by transiting the lake by boat and employing a fathometer to collect "hard and soft return" data. These data are later analyzed for presence and absence of vegetation and to determine the height of vegetation if present. The PAC is determined from the presence and absence analysis of 100 sites in the lake and the PVI is determined by measuring the difference between hard returns (lake bottom) and soft returns (top of vegetation) for sites (within the 100 analyzed sites) where plants are determined present.

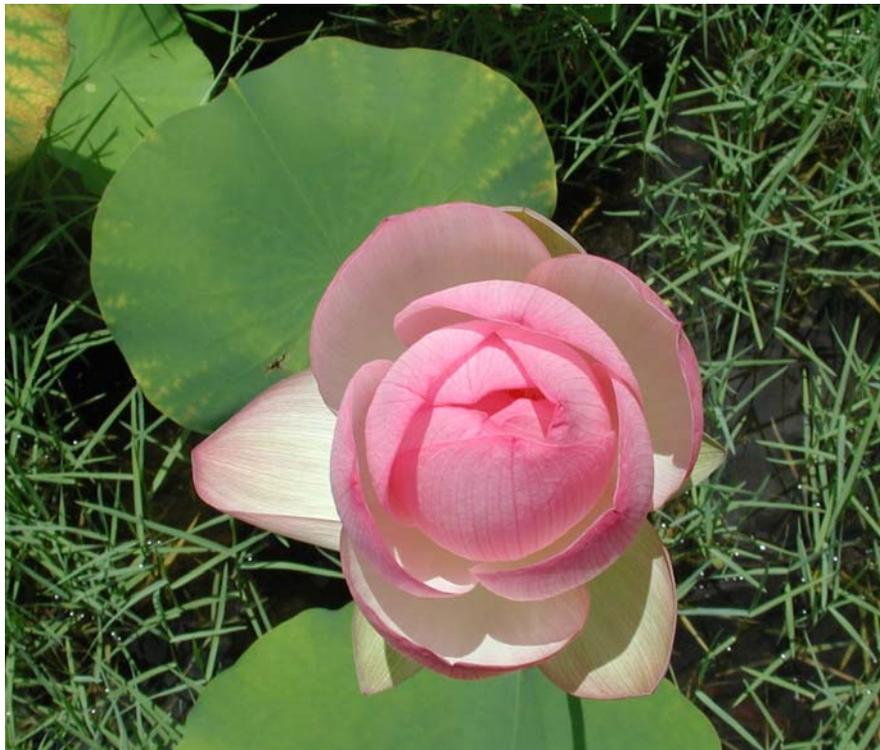
Figure 4. *Nelumbo nucifera*, Pink water lotus, is a non-native plant which is extremely aggressive and should be planted in containers if planted in a water garden to prevent them from escaping into natural environments, as this example shows on Lake Saddleback. Once established in soil in natural environments it can be a challenge to remove or control. The native species, *Nelumbo lutea*, is a very similar species with yellow flowers.

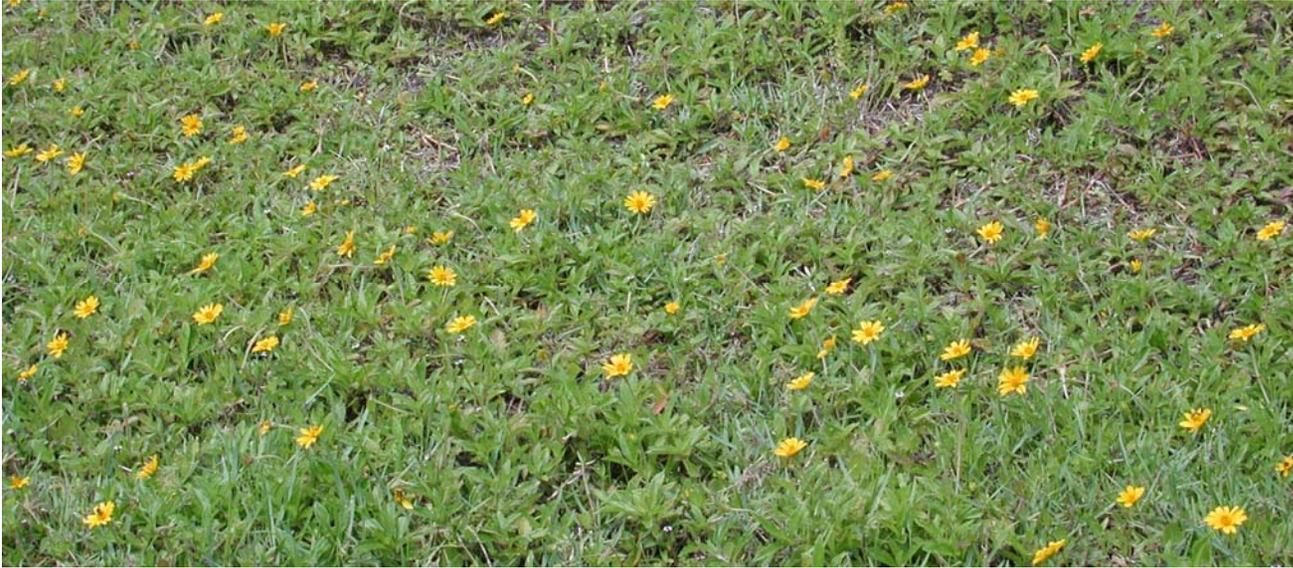
Figure 6. *Sphagneticola (Wedelia) trilobata*, Creeping Oxeye, is a non-native, invasive species which can cover large areas of lake shores. This species is commonly used as a ground cover in landscaping projects, but should not be used near wetlands due to the risk of escaping.

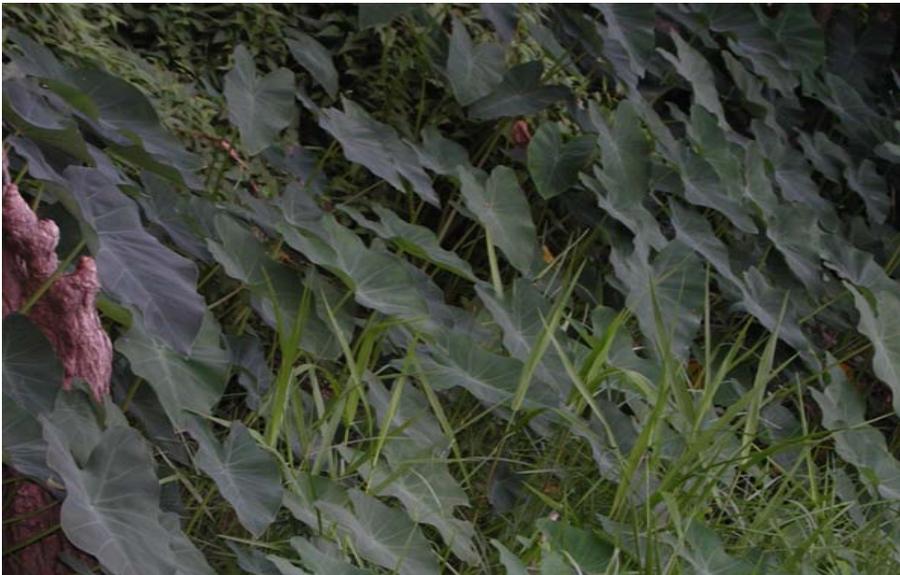
Figure 7. *Colocasia esculenta*, Wild Taro, is a non-native, invasive species that can dominate the shorelines of Florida lakes, displacing native emergent vegetation particularly after an area has been disturbed.

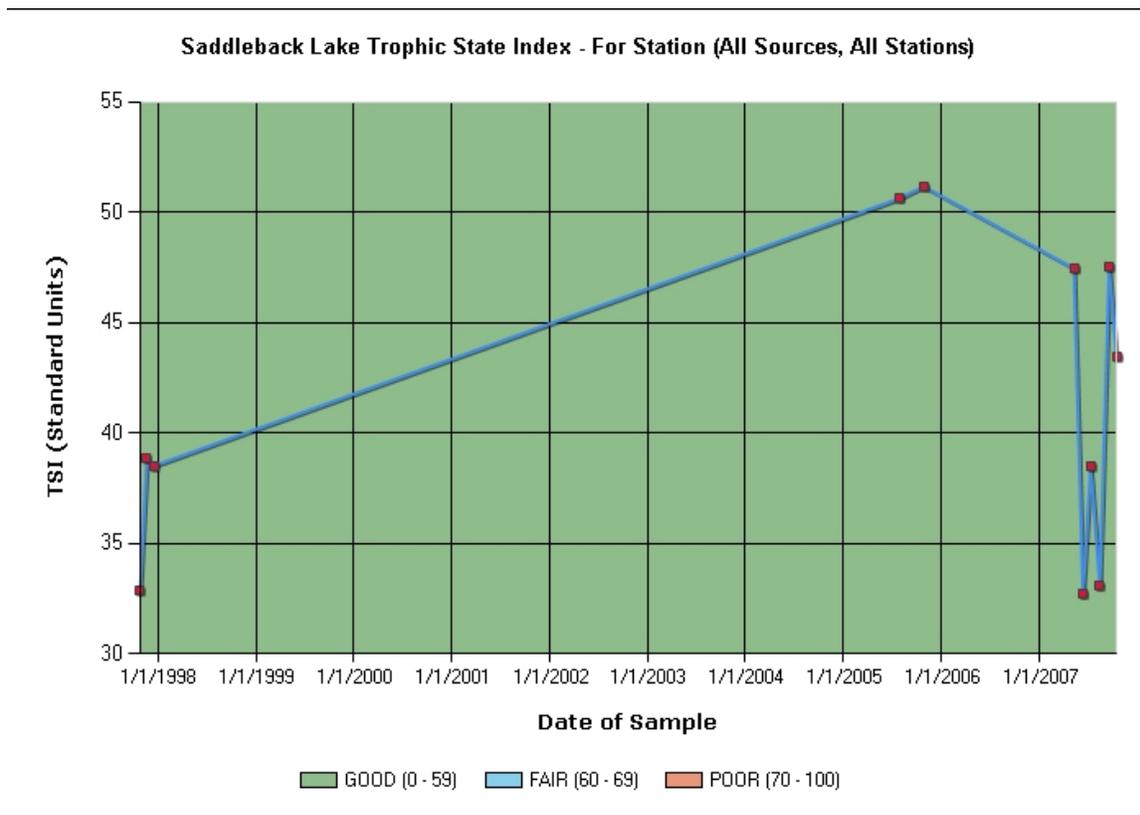
Figure 8. Recent Trophic State Index (TSI) graph from Hillsborough Watershed Atlas. For the latest date go to:

Note: The graph above includes benchmarks for using verbal descriptors of "good", "fair" and "poor". The verbal descriptors for these benchmarks are based on an early determination by stakeholders of the generally acceptable and understood terms for describing the state of lakes. The same benchmarks are used for nutrient graphs (Nitrogen and Phosphorus), chlorophyll graphs and trophic state index (TSI) graphs. The TSI is a calculated index of lake condition based on nutrient and chlorophyll (a) concentrations (please see "Learn more about Trophic State Index"). The benchmarks are established based on the TSI range that relates to a specific descriptor. The source for the TSI concentration relationships is the Florida Water Quality Assessment, 1996, 305(b) (Table 2-8).

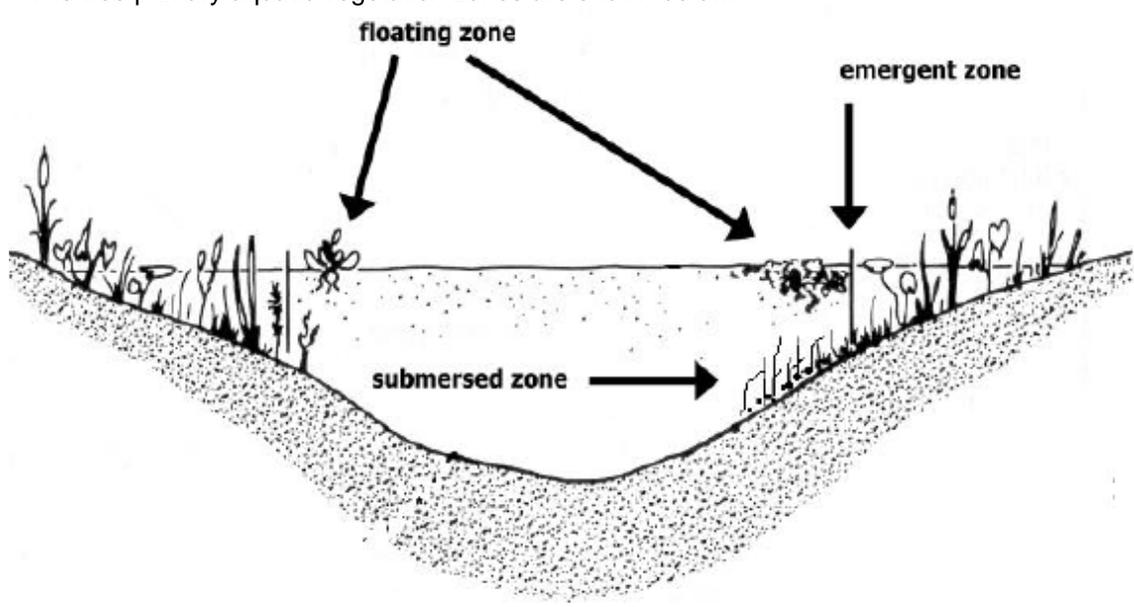
iv The tree primary aquatic vegetation zones are shown below:
