## Seagrass Scar Imaging Project Report: Cockroach Bay Seagrass Scar Tracking Project

*Prepared For*  
*Hillsborough County Environmental Protection Commission*  
*By Florida Center for Community Design and Research*  
*University of South Florida*  
*Prepared March 17, 2011*  
*Study Period: October 2009 – January 2011*

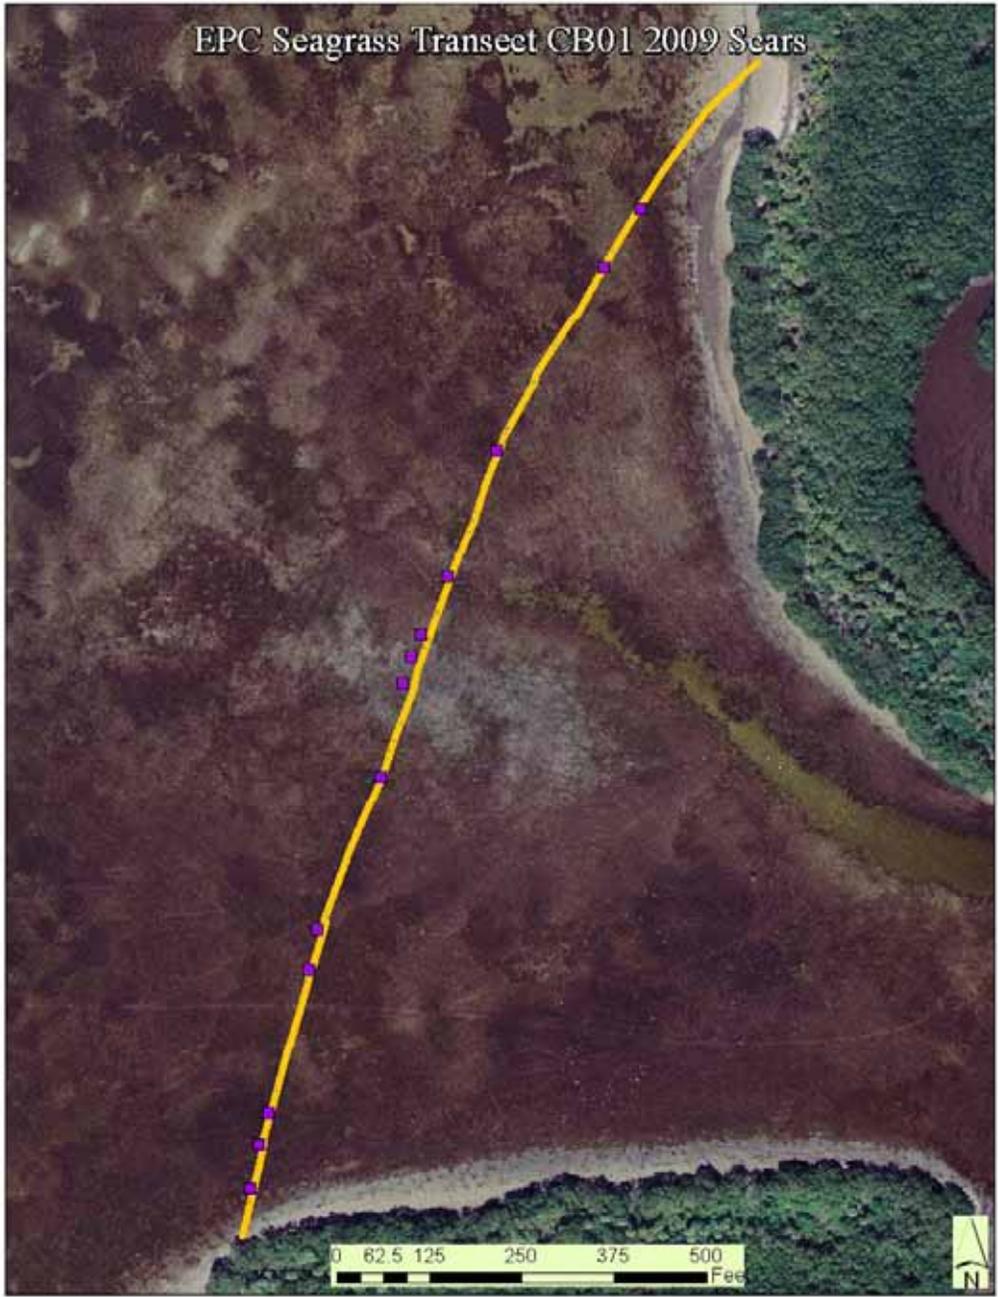
**Figure 3 Map showing the locations of the 13 seagrass scars found on transect CB01 during the October 2009 monitoring effort.**

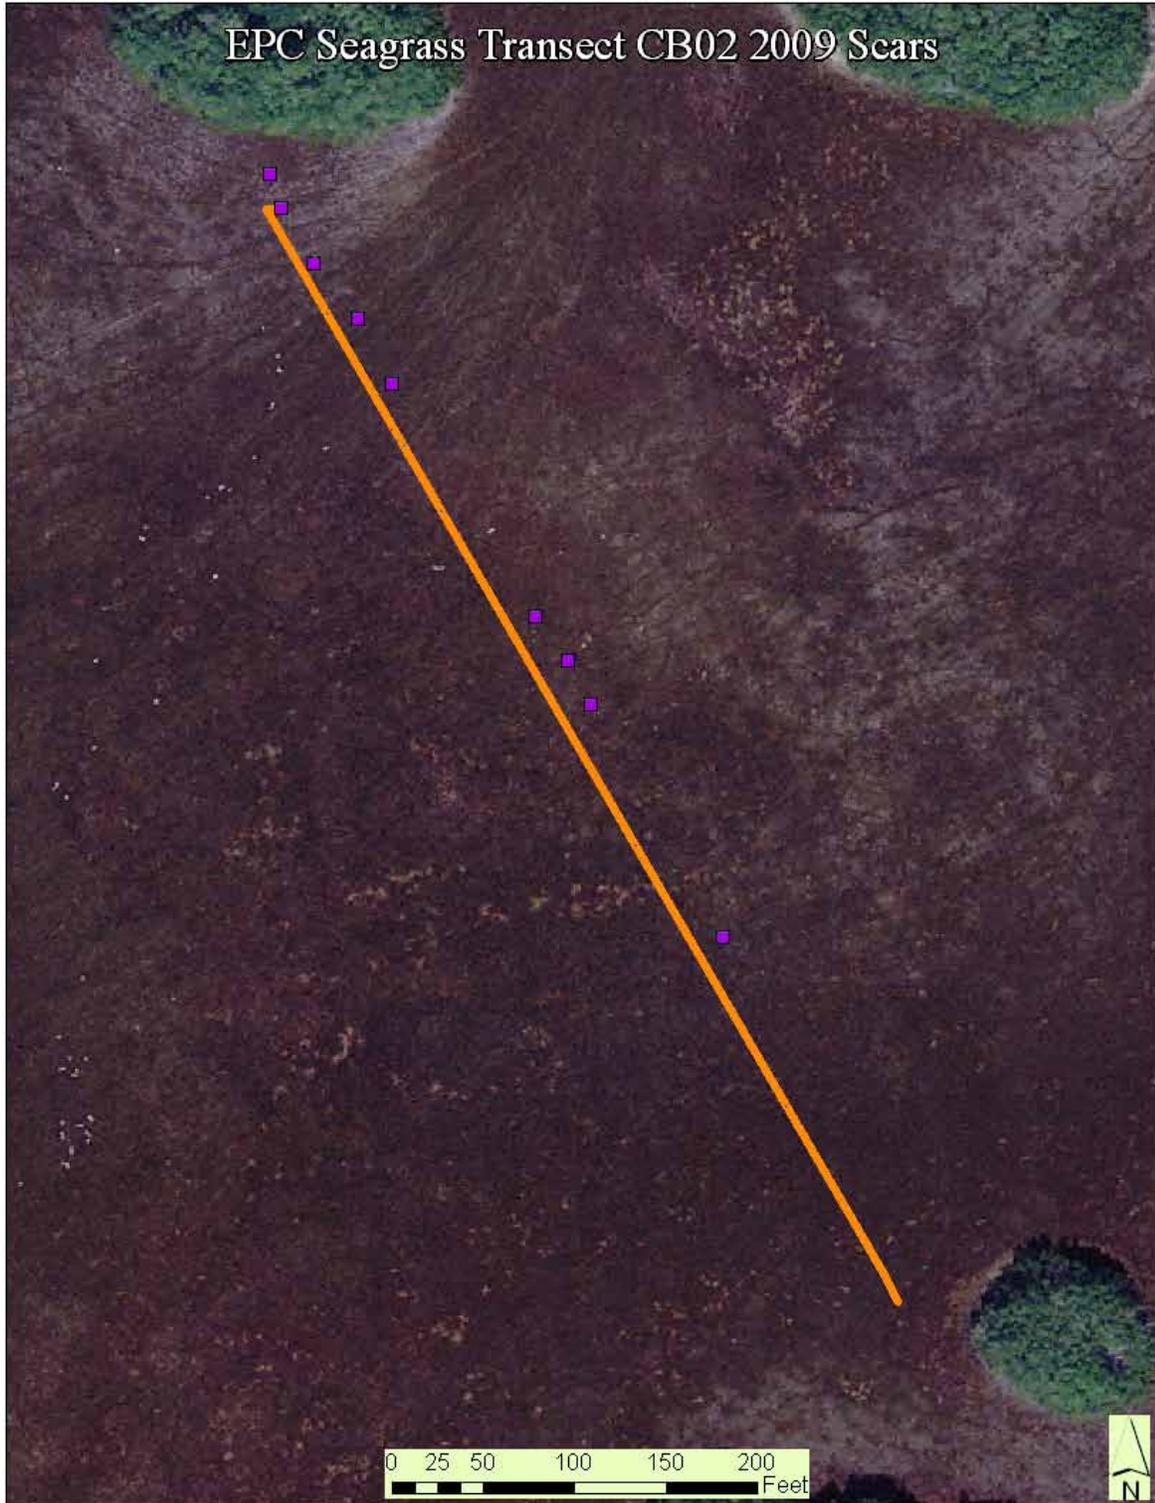
**Figure 4. Map showing the locations of the 9 seagrass scars found on transect CB02 during the October 2009 monitoring effort.**

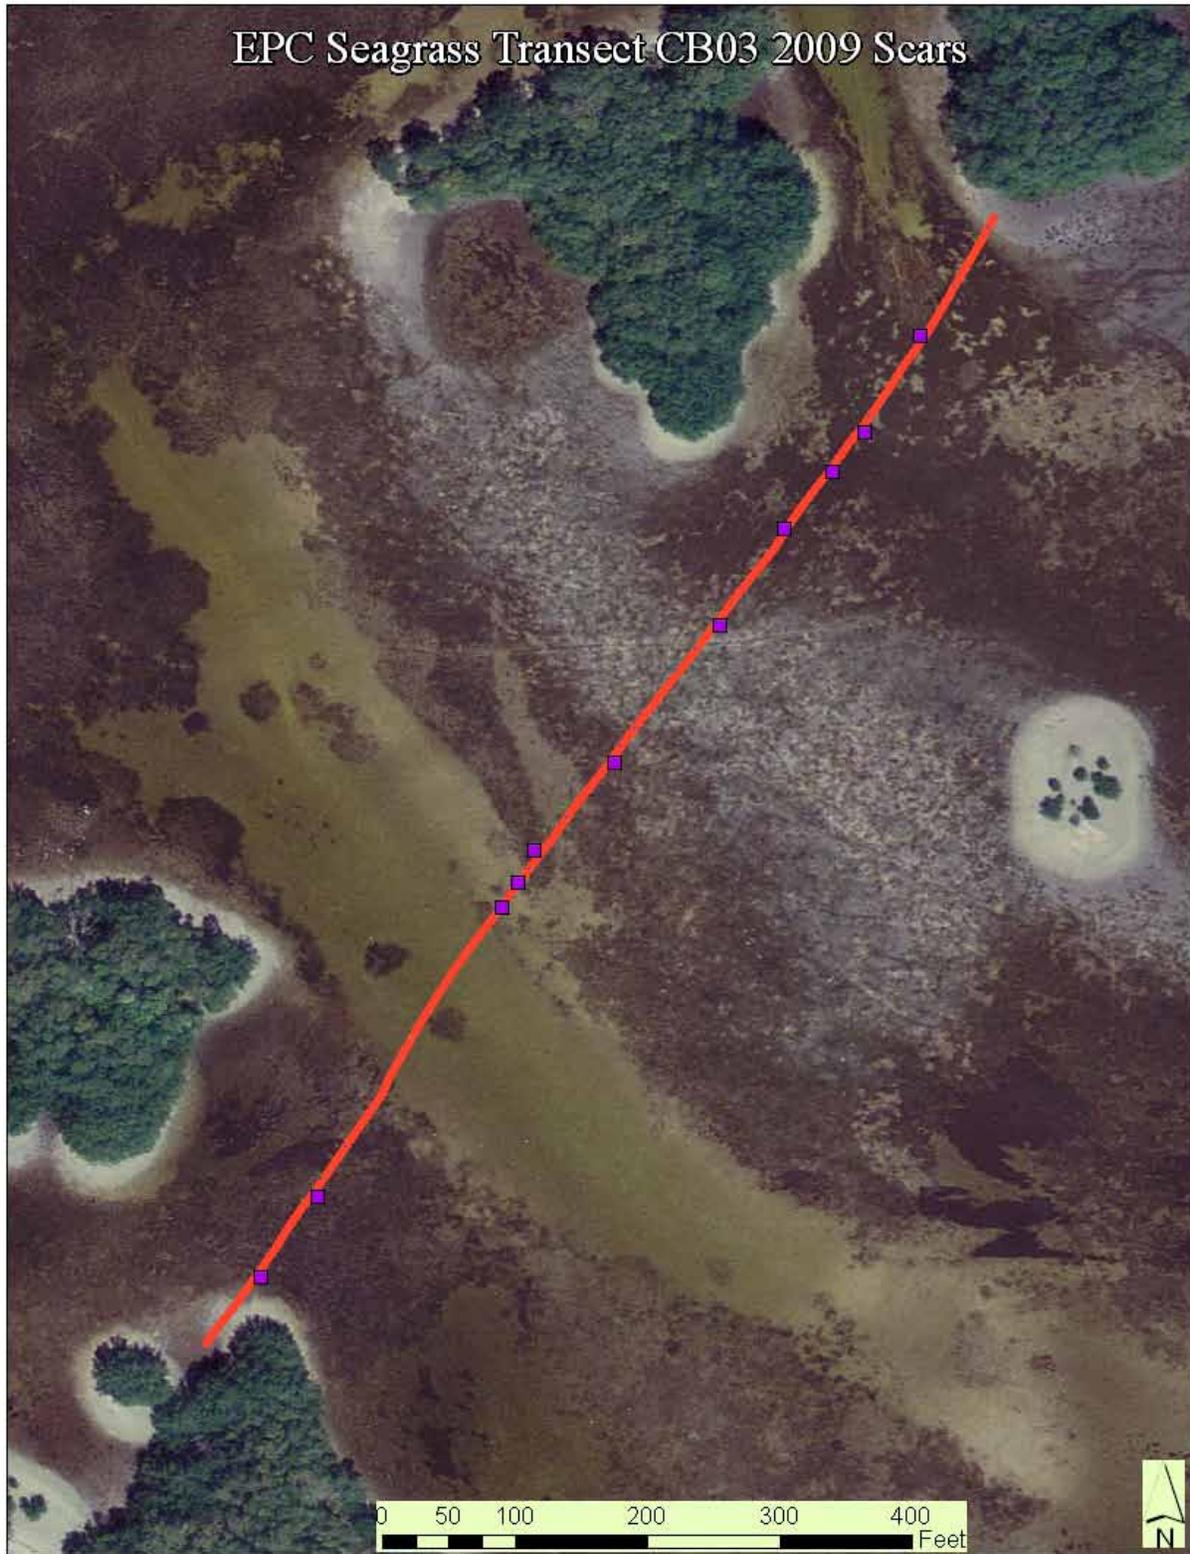
**Figure 5 Map showing the locations of the 11 seagrass scars found on transect CB03 during the October 2009 monitoring effort.**

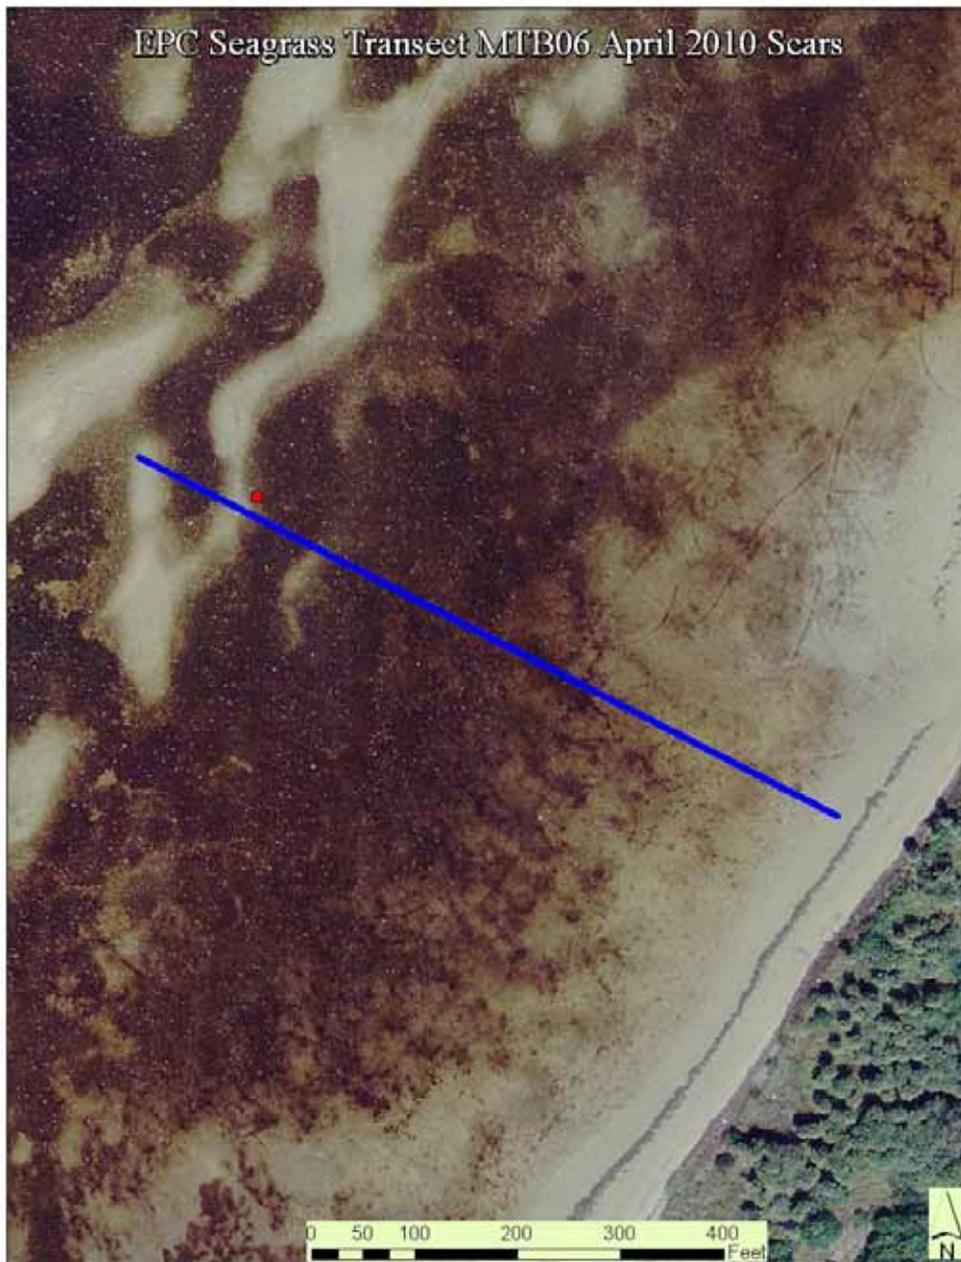
**Figure 7. Map showing the locations of the 1 seagrass scar found on transect MTB06 during the April 2010 monitoring effort.**

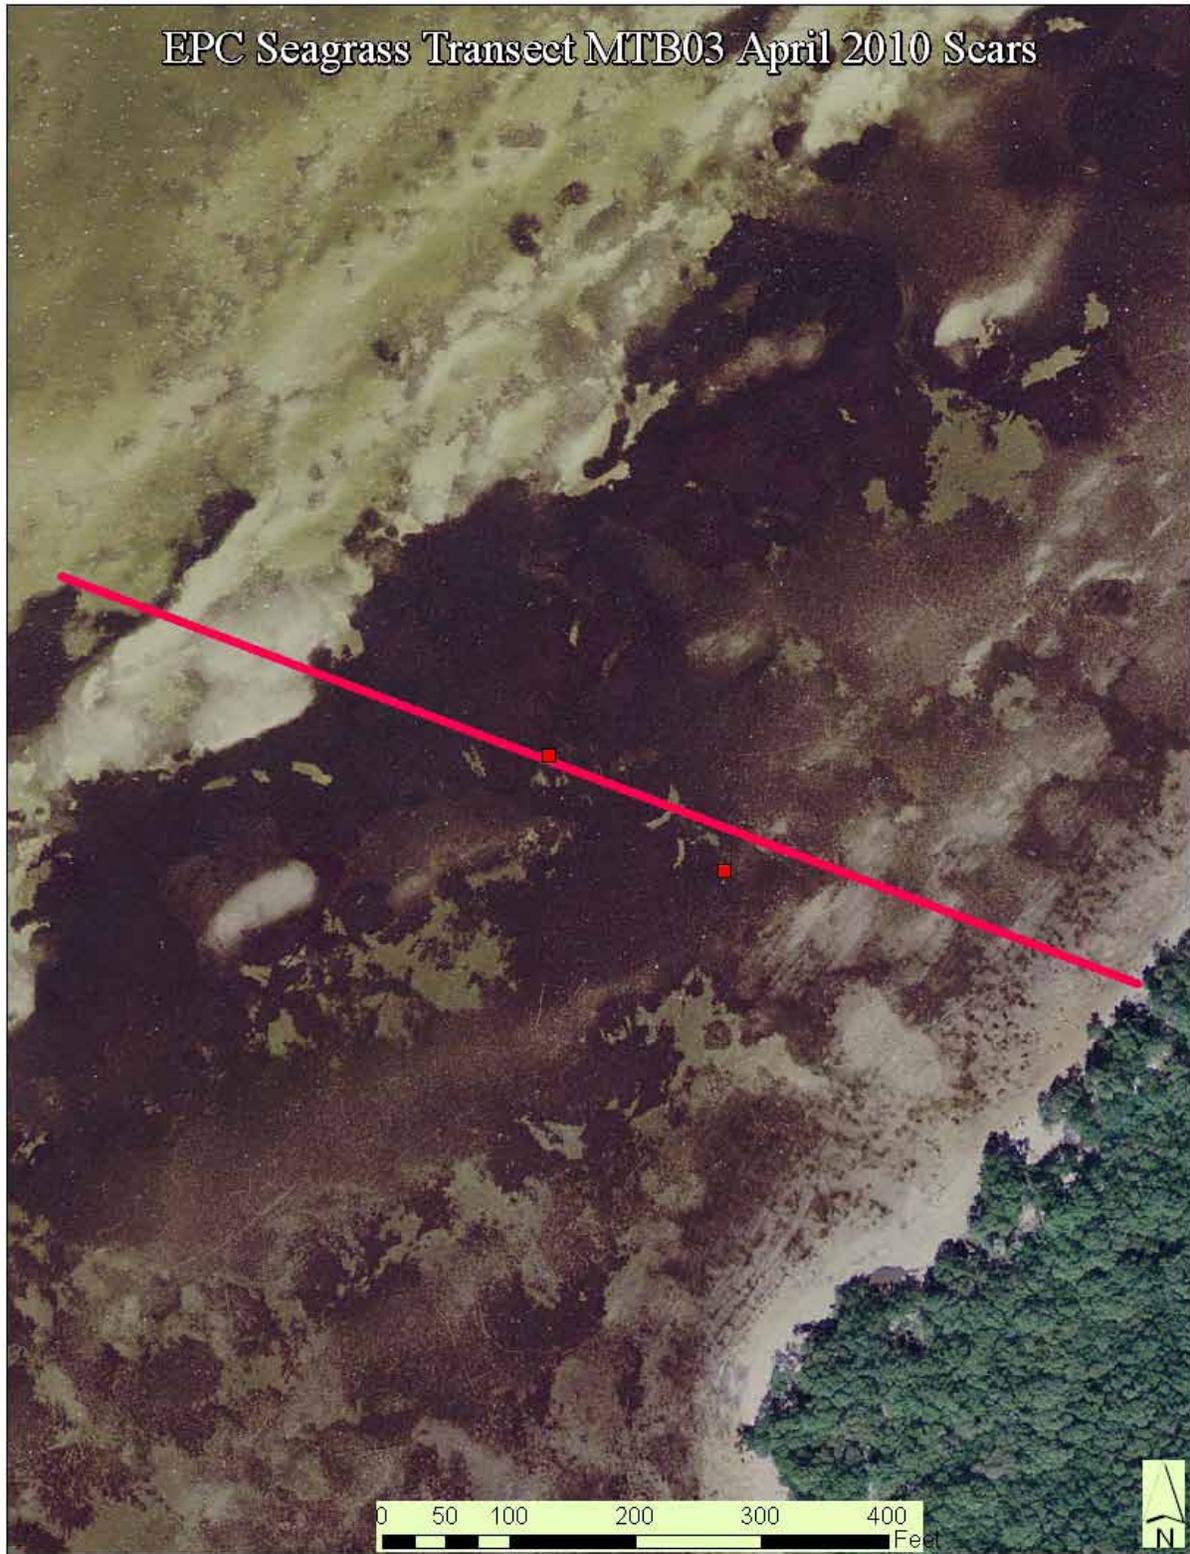
**Figure 10. Map showing the locations of the 2 seagrass scars found on transect MTB03 during the April 2010 monitoring effort.**

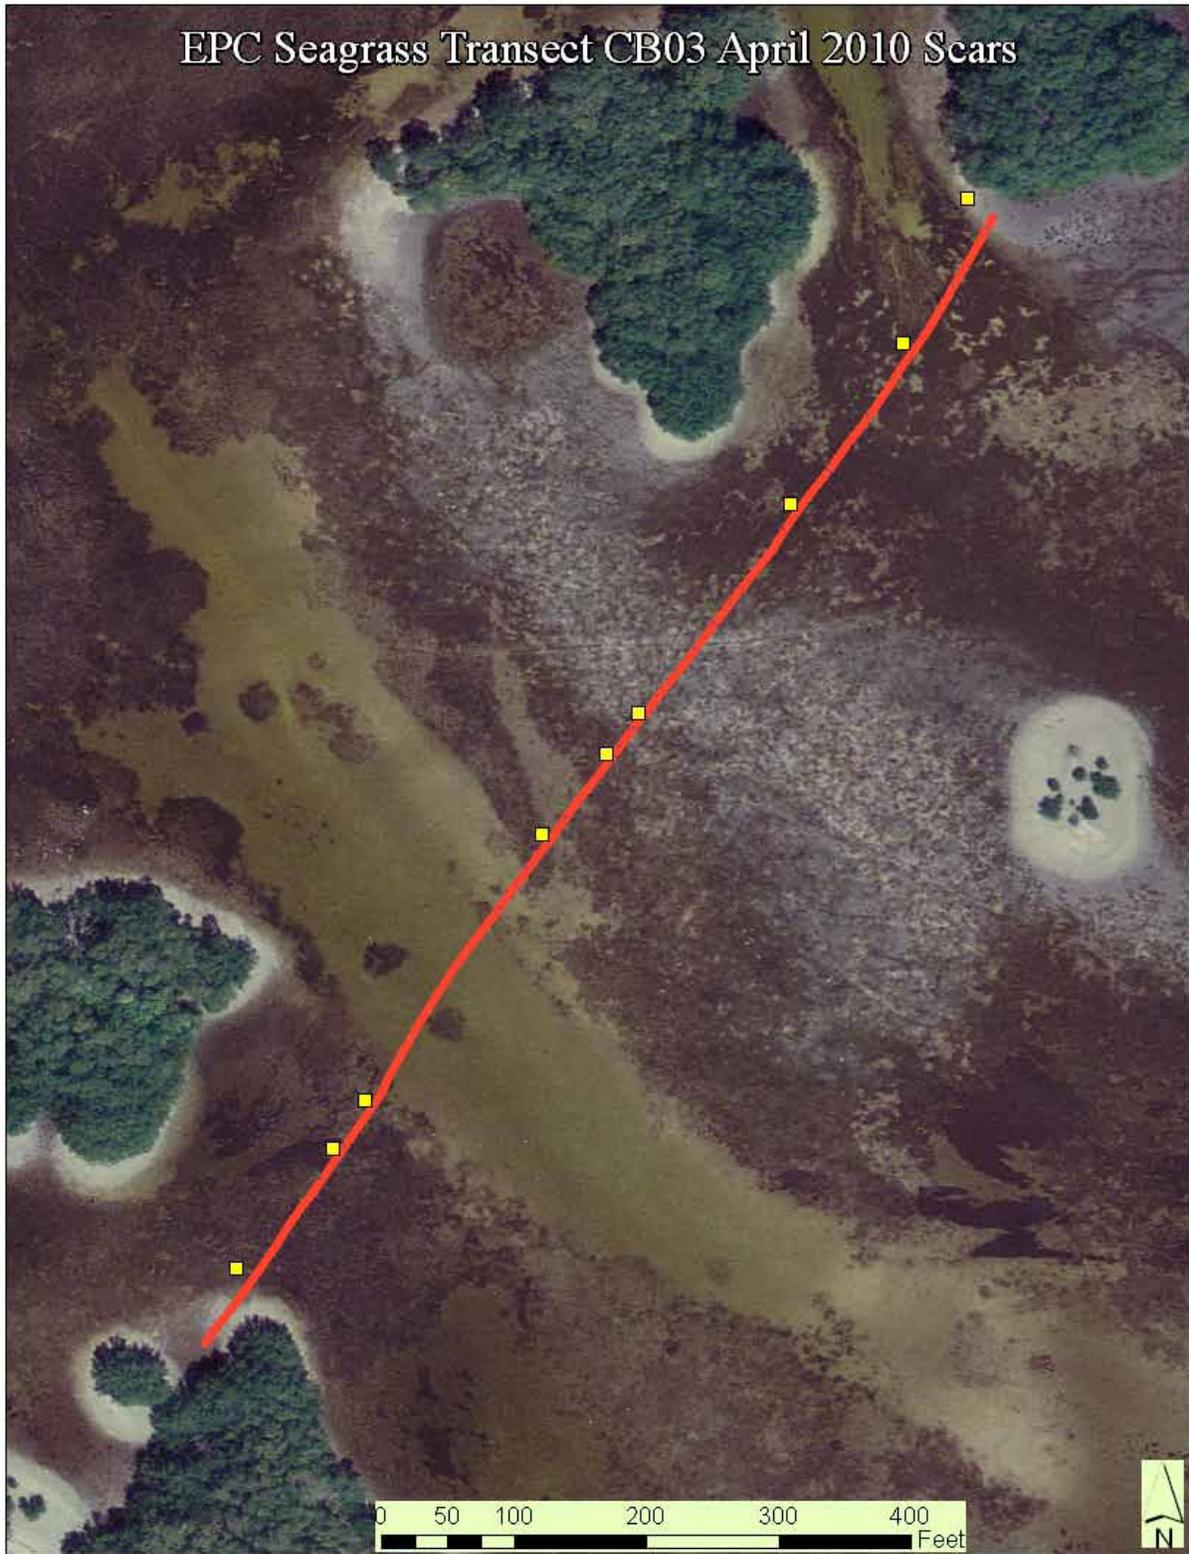
**Figure 11. Map showing the locations of the 9 seagrass scars found on transect CB03 during the April 2010 monitoring effort.**

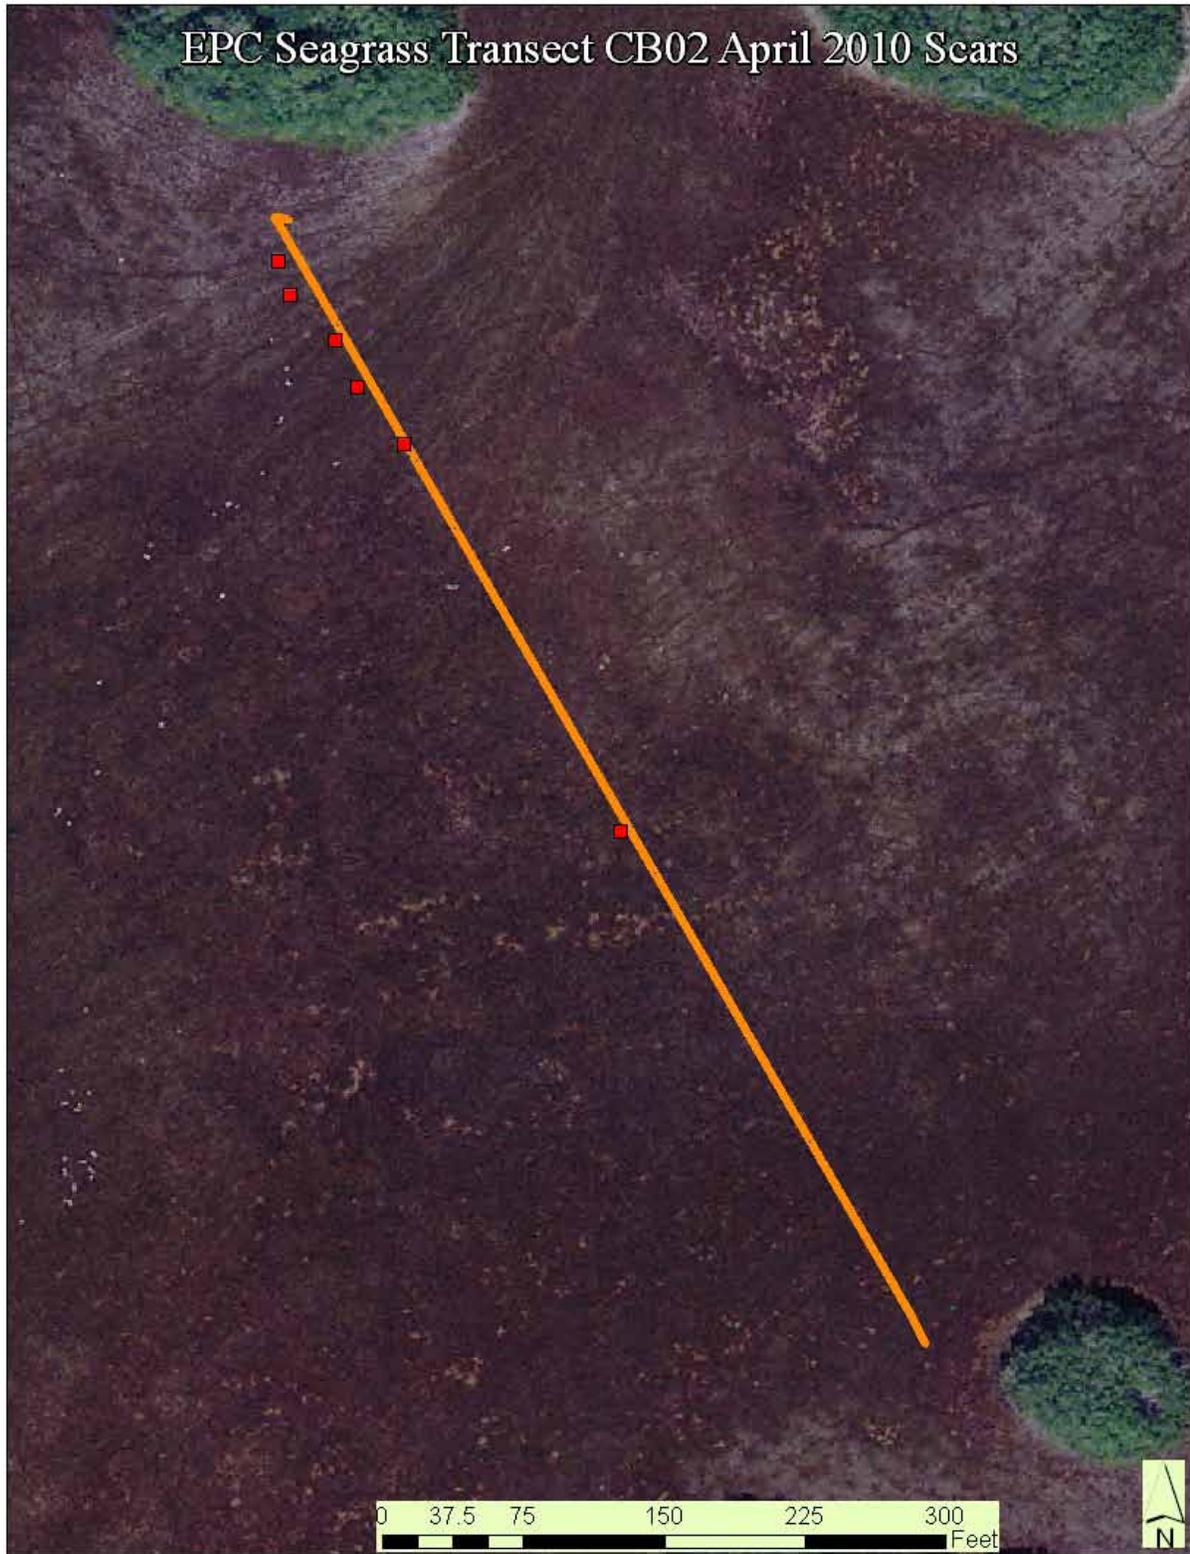
**Figure 12. Map showing the locations of the 7 seagrass scars found on transect CB02 during the April 2010 monitoring effort.**

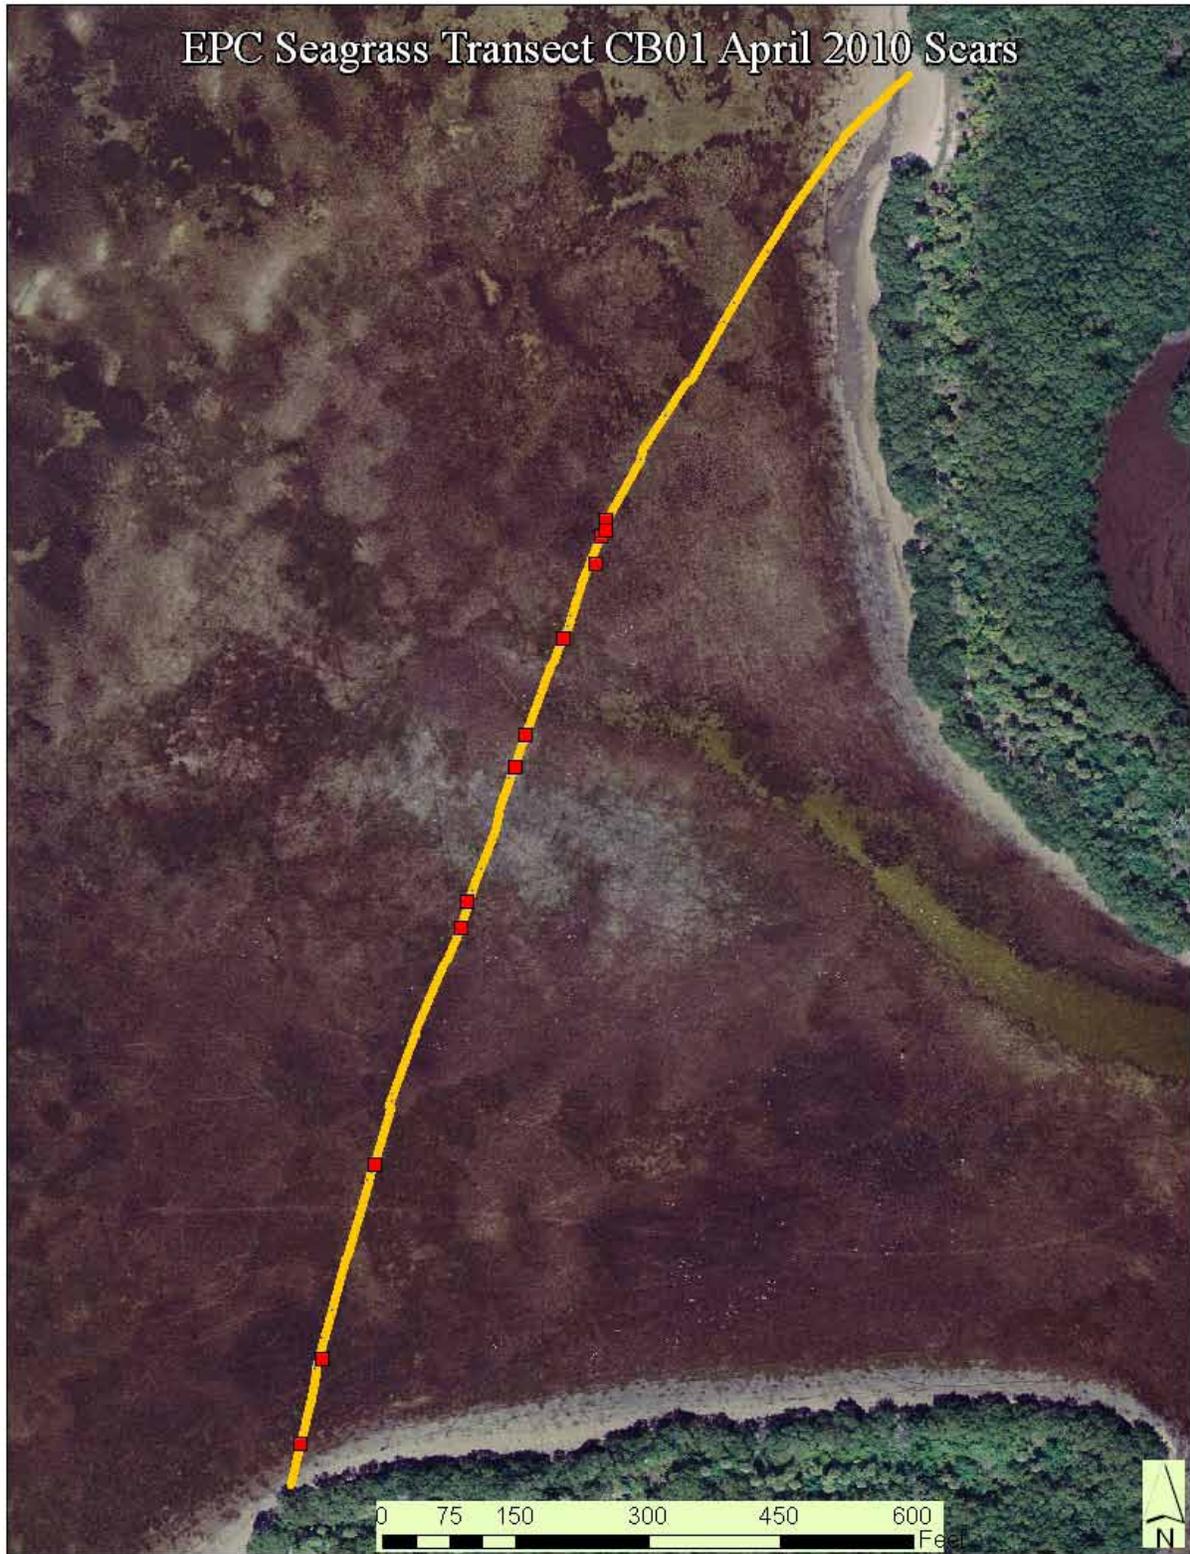
**Figure 13. Map showing the locations of the 12 seagrass scars found on transect CB01 during the April 2010 monitoring effort.**

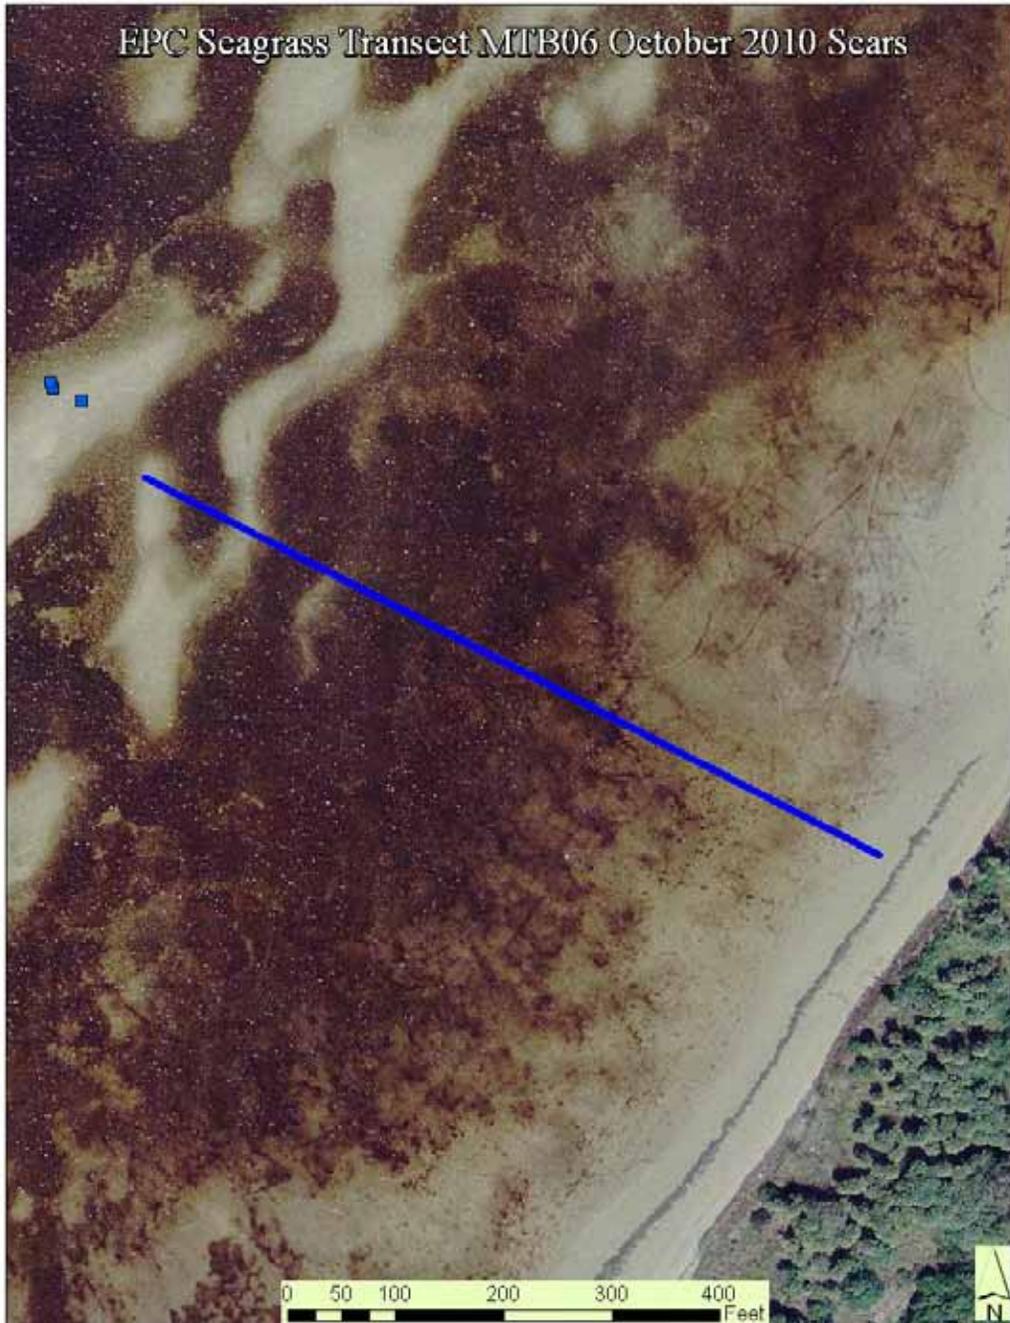
**Figure 15. Map showing the locations of the 3 seagrass scars found on transect MTB06 during the October 2010 monitoring effort.**

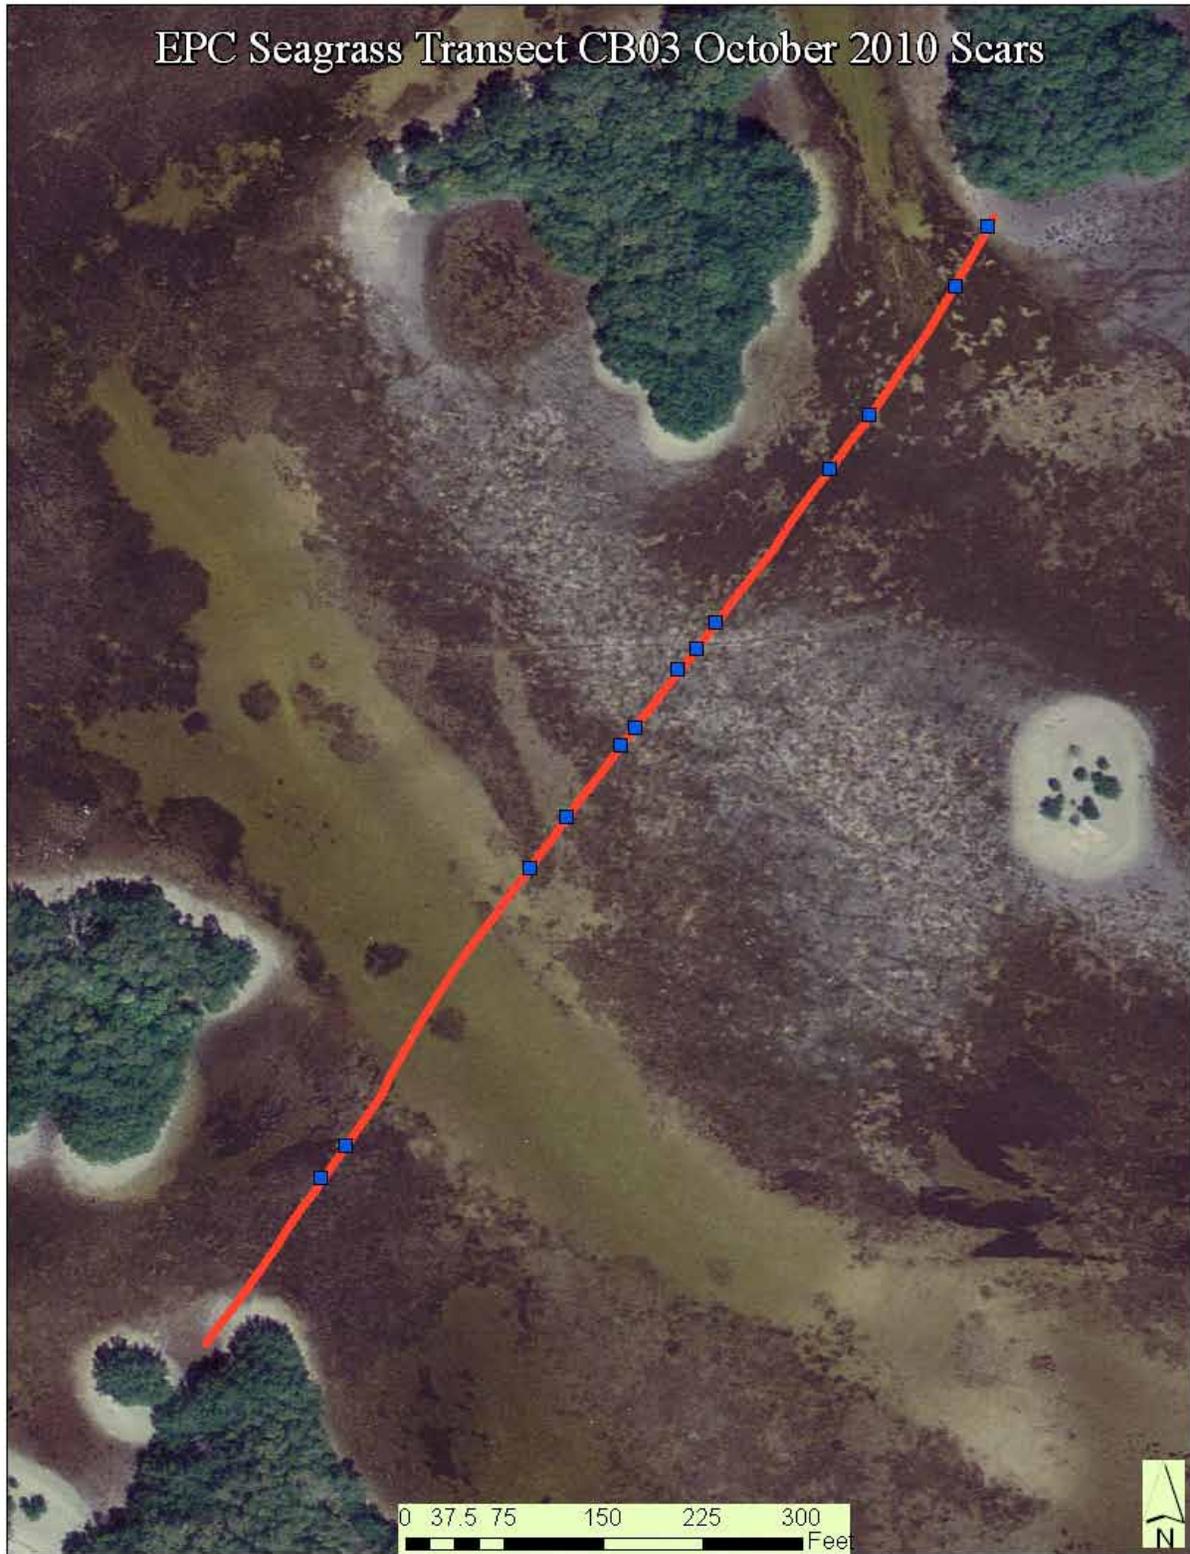
**Figure 19. Map showing the locations of the 13 seagrass scars found on transect CB03 during the October 2010 monitoring effort.**

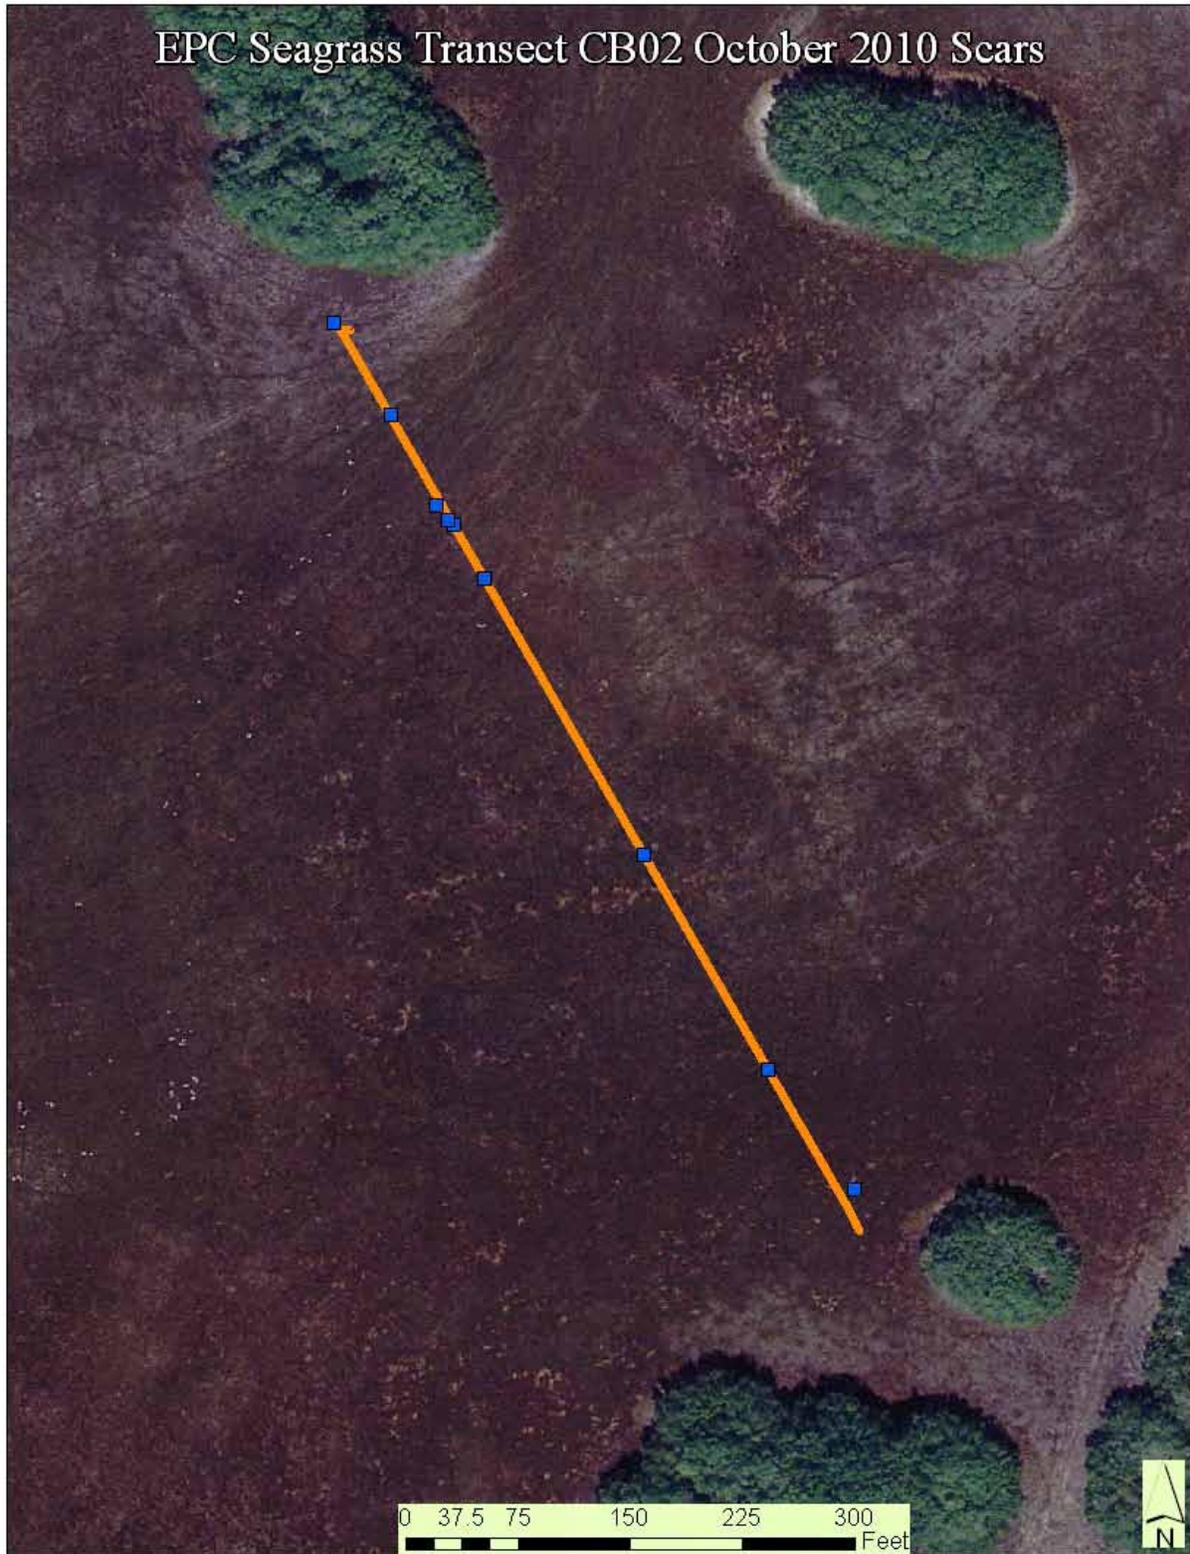
**Figure 20. Map showing the locations of the 9 seagrass scars found on transect CB02 during the October 2010 monitoring effort.**

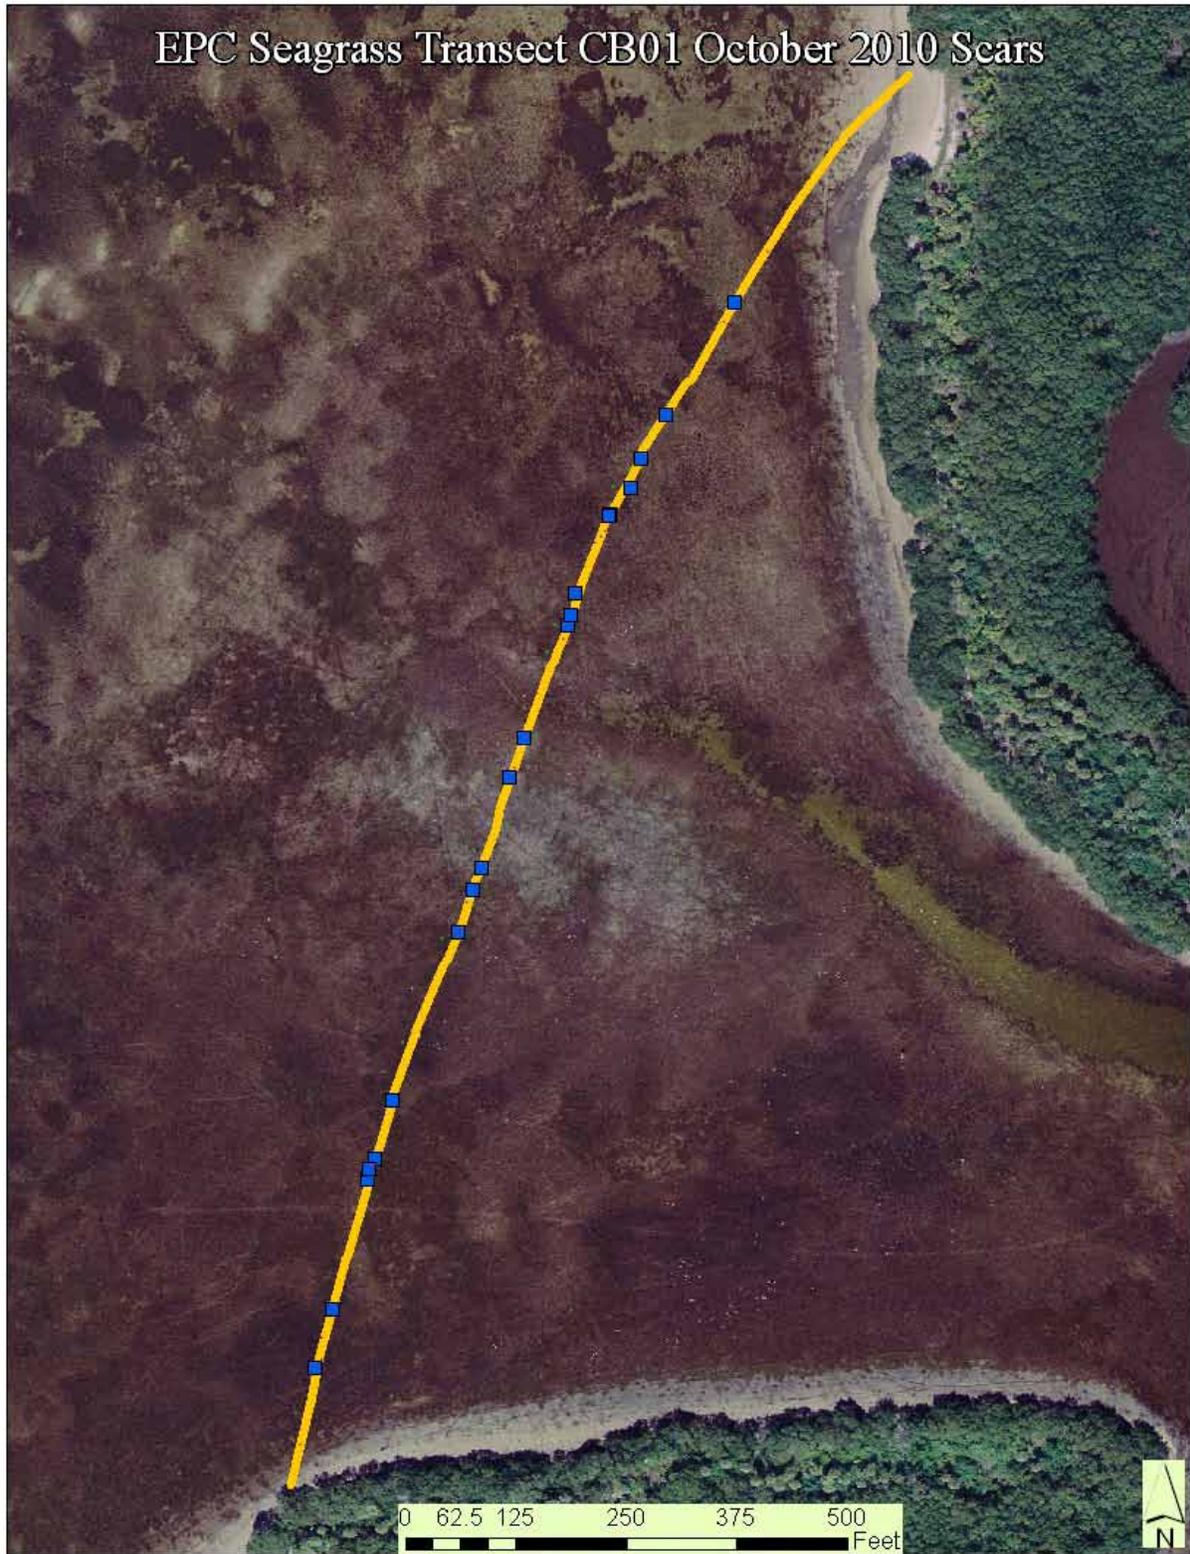
**Figure 21. Map showing the locations of the 20 seagrass scars found on transect CB01 during the October 2010 monitoring effort.**

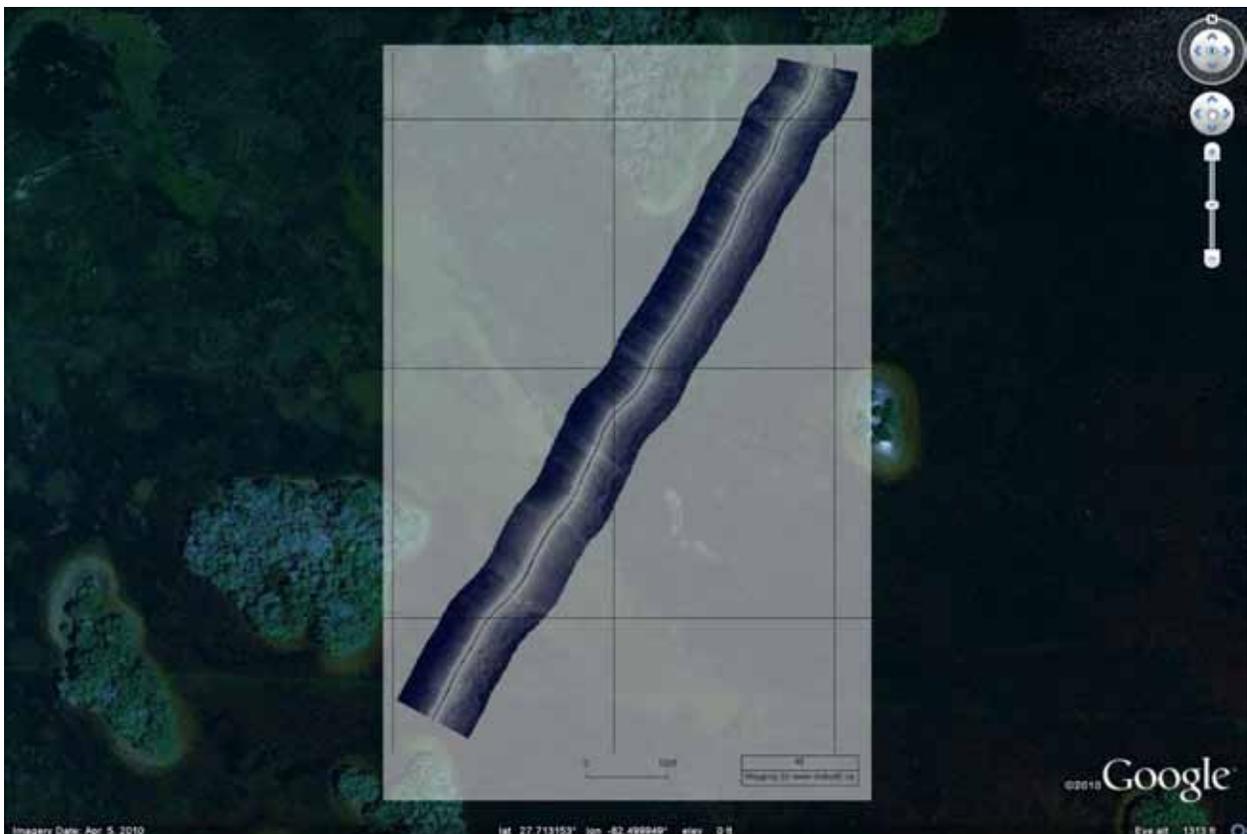
Dr. Depth is a sonar-data analysis application, developed in Sweden which allows among other things the creation of a mosaic of sidescan charts and to overlay these data in a spatially accurate manner in Google Earth. Development and Implementation of this software for seagrass scar monitoring is still under way by the Florida Center for Community Design and Research at this time. The long term goal for this effort would be to map the entire area surrounding the transect to get a highly accurate count of seagrass scars and to allow the measurement of scar length and direction. This software also shows promise for creating visually appealing displays for the data collected during the monitoring events.

**Figure 23. The output of a sidescan assessment of CB03 transect. The chart analyzed with the Dr. Depth software and displayed as a KML feature in Google Earth.**
