## Seagrass Scar Imaging Project Report: Cockroach Bay Seagrass Scar Tracking Project

*Prepared For*  
*Hillsborough County Environmental Protection Commission*  
*By Florida Center for Community Design and Research*  
*University of South Florida*  
*Prepared March 17, 2011*  
*Study Period: October 2009 – January 2011*

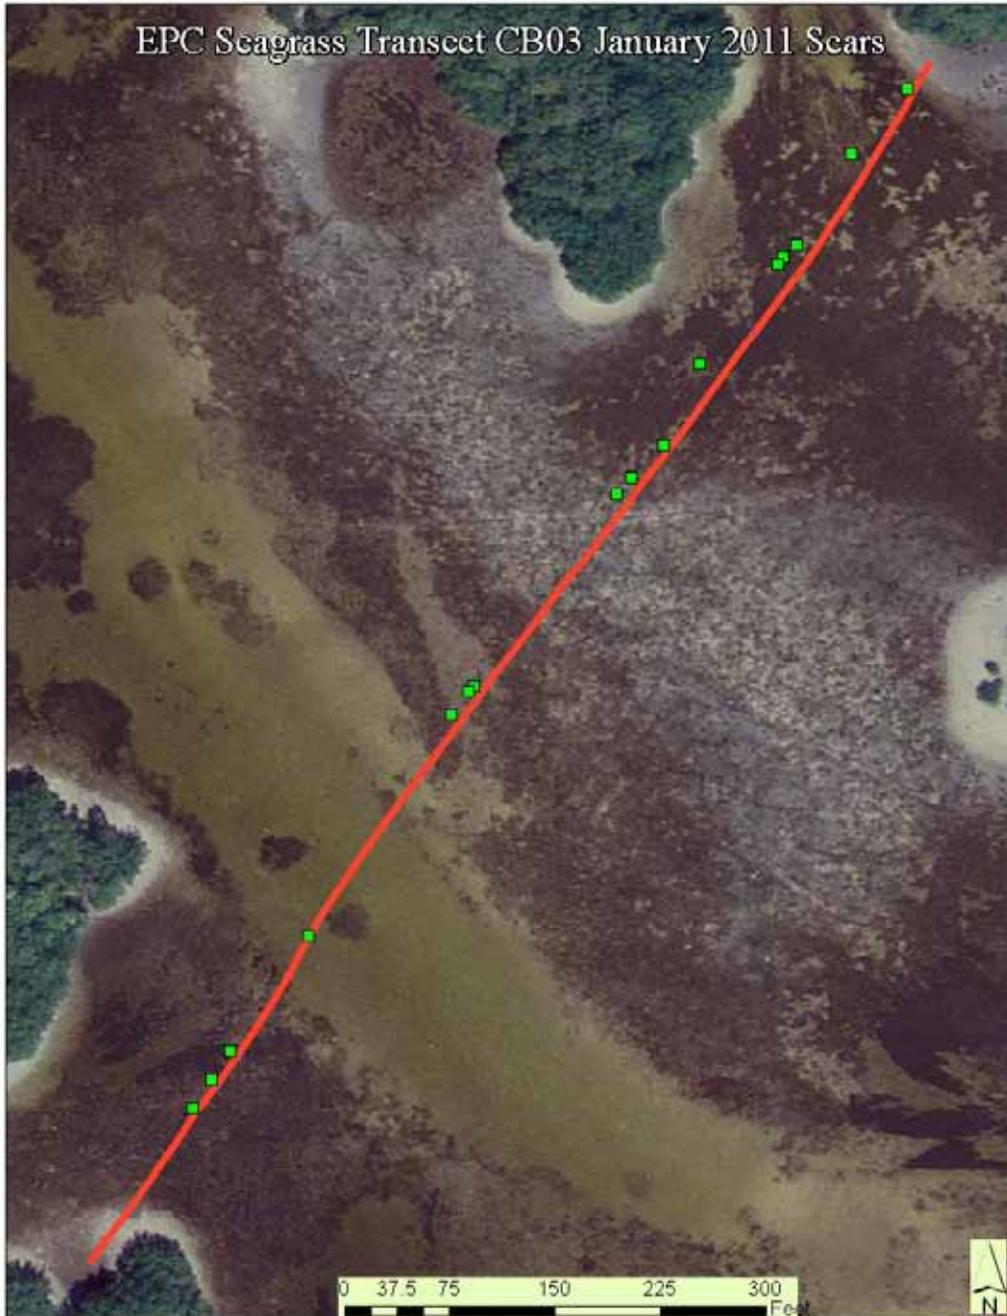
A second goal of the January 2011 monitoring effort was to quality check the results of the Humminbird recordings when the HumViewer software is used. This effort was focused on transect CB03 and showed some varying results. Of the 16 scar features identified through chart analysis on HumViewer, 9 were confirmed as scars, 3 were fully recovered scars with no trough but the canopy height of the seagrasses had not recovered to full extent of the surrounding area, and the remaining 4 scars were results of the seagrass bed changing in density or species. These results show some advantages of the combined Humminbird/HumViewer application and some possible issues which need to be addressed. We are now evaluating a new software package with the potential of exploiting these new categories of scar images.

Figure 24. Map showing the locations of the 16 seagrass scars found on transect CB03 during the January 2011 monitoring effort.

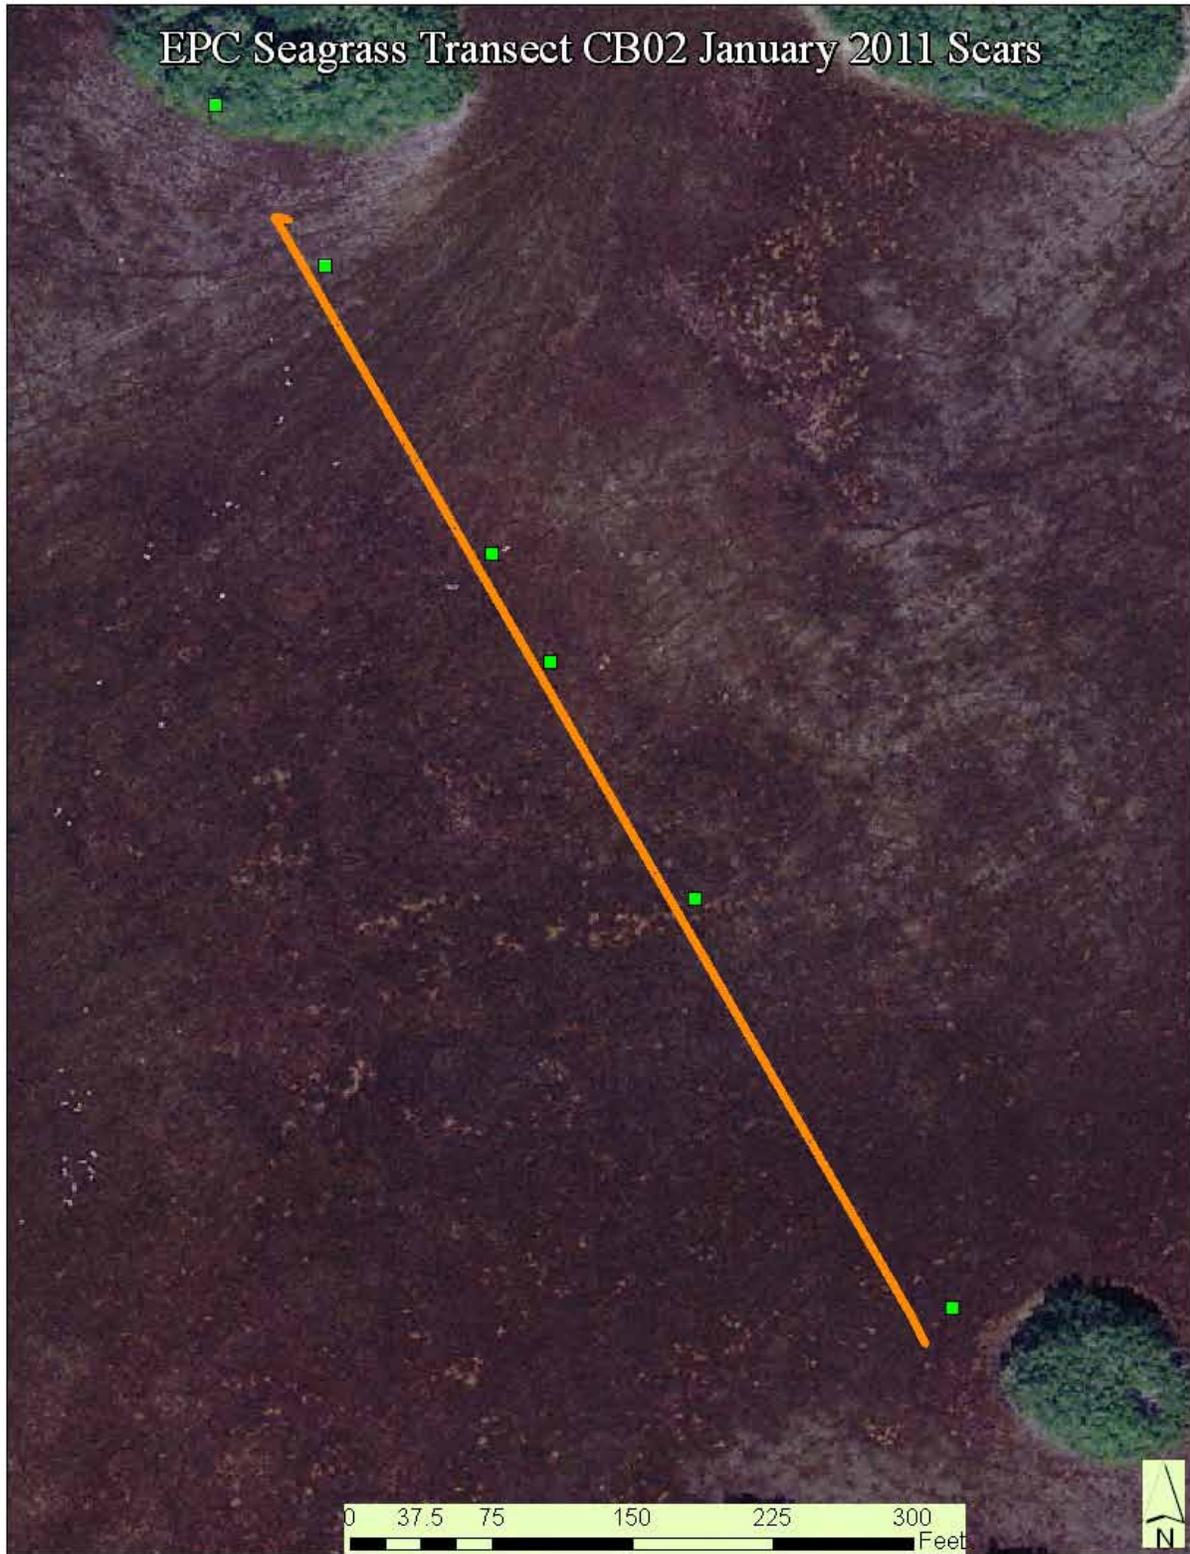
Figure 25. Map showing the locations of the 6 seagrass scars found on transect CB02 during the January 2011 monitoring effort.

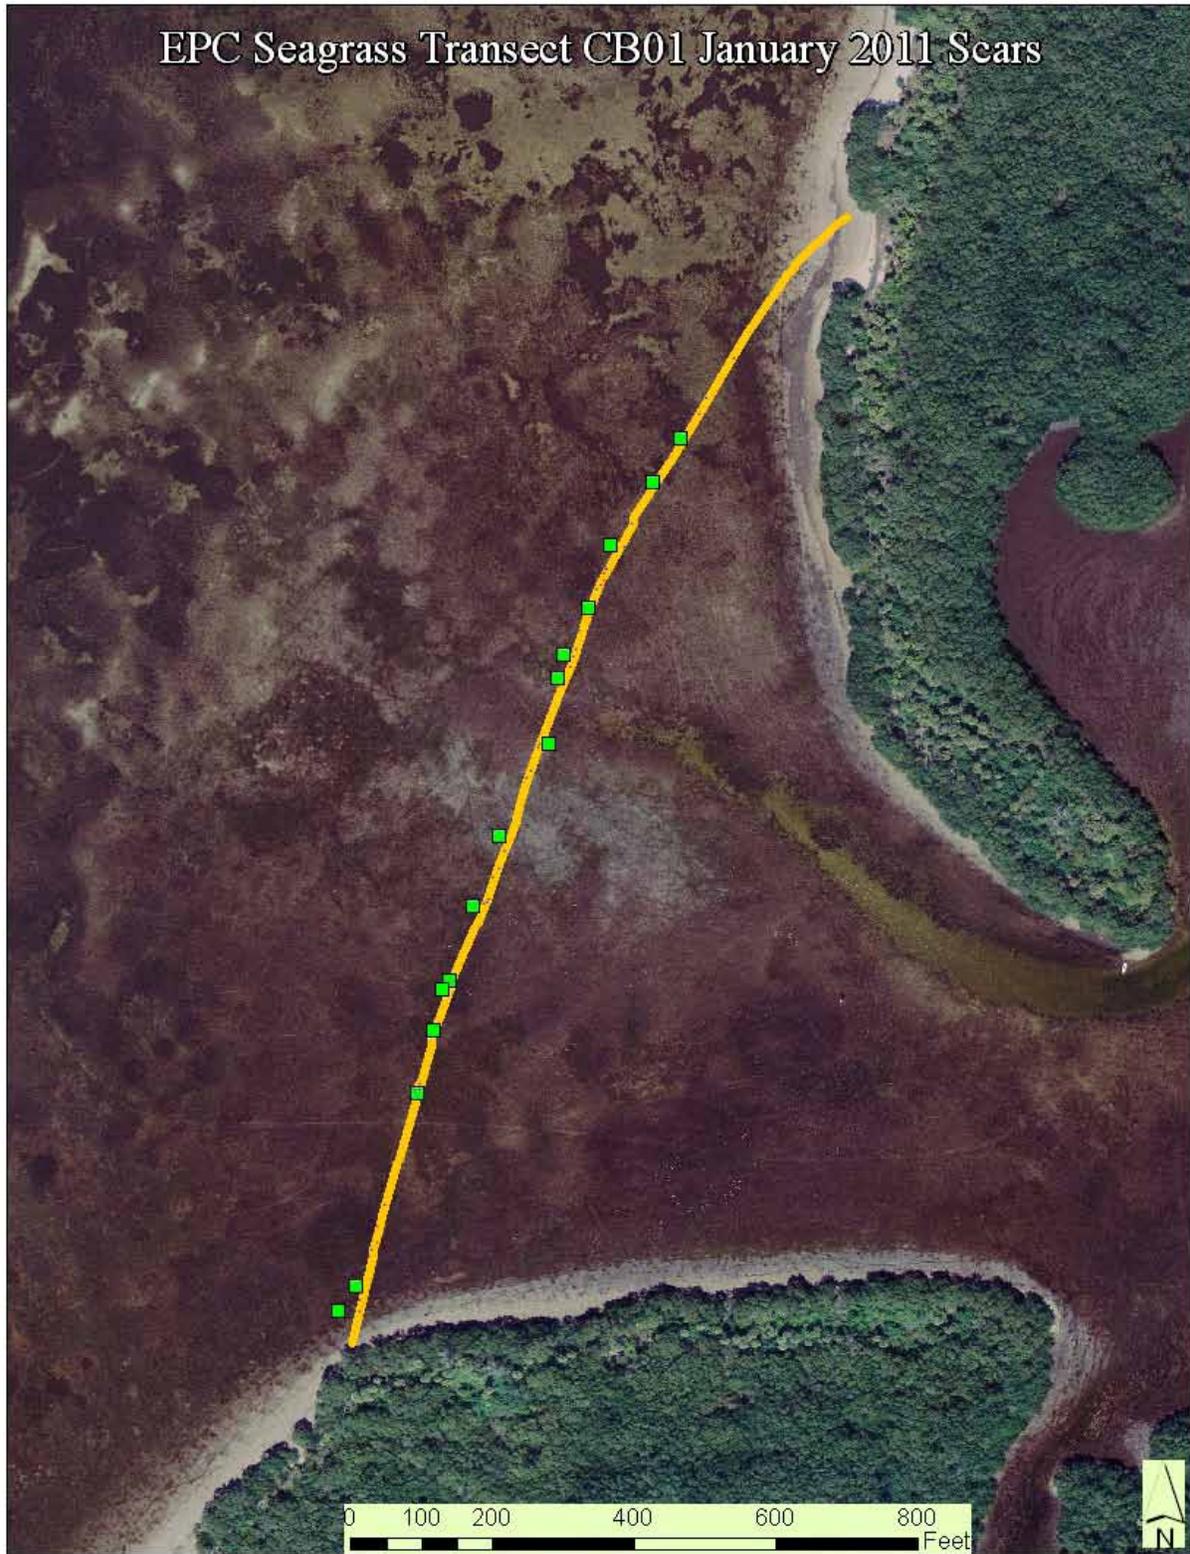
Figure 26. Map showing the locations of the 15 seagrass scars found on transect CB01 during the January 2011 monitoring effort.
