LAKE ASSESSMENT DOCUMENT

Heather Lake 8/17/99 Watershed: Rocky/ Brushy Creek

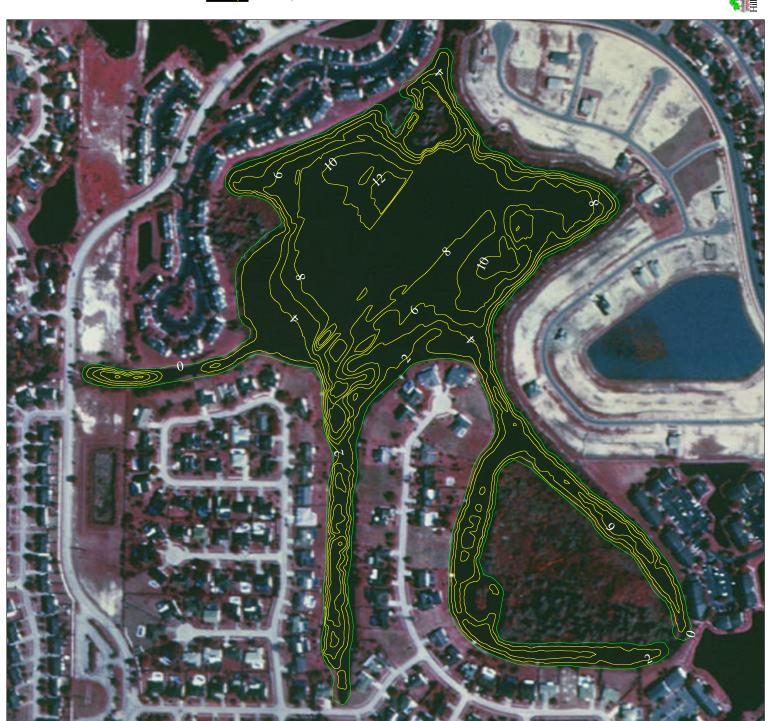
Heather Lake

Contour Lines Expressed in 2-Foot Intervals

Survey Date: August 17, 1999

was unavailable when the lake was surveyed. Contours are expressed in absolute depth below this level. Lake water level above sea level

Digital orthophotos by United States Geological Survey. All contours generated by Florida Center for Community Design and Research based on survey data provided by the Hillsborough County Lake Management Program.

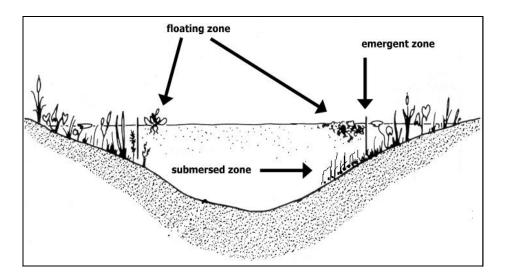
In addition to an overall survey of the types of plants on a lake, an estimate of the standing crop (biomass) of the lake has been obtained for many lakes. This was done by calculating the average weight of the vegetation within a quarter-meter square quadrat tossed haphazardly into three zones (see Figure) at each sampling site around the lake: (1) the emergent zone, (2) the floating zone and (3) the submersed zone. The average weight of the plants (Table 4) from all sampling sites and the dominant type of vegetation (Table 5) are provided. If data tables are not shown, no standing crop estimates were obtained for this lake.
