LAKE ASSESSMENT REPORT FOR LAKE JUANITA IN HILLSBOROUGH COUNTY FLORIDA

Date Assessed: July 5, 2006
Assessed by: Sarah Koenig and David Eilers
Reviewed by: Jim Griffin

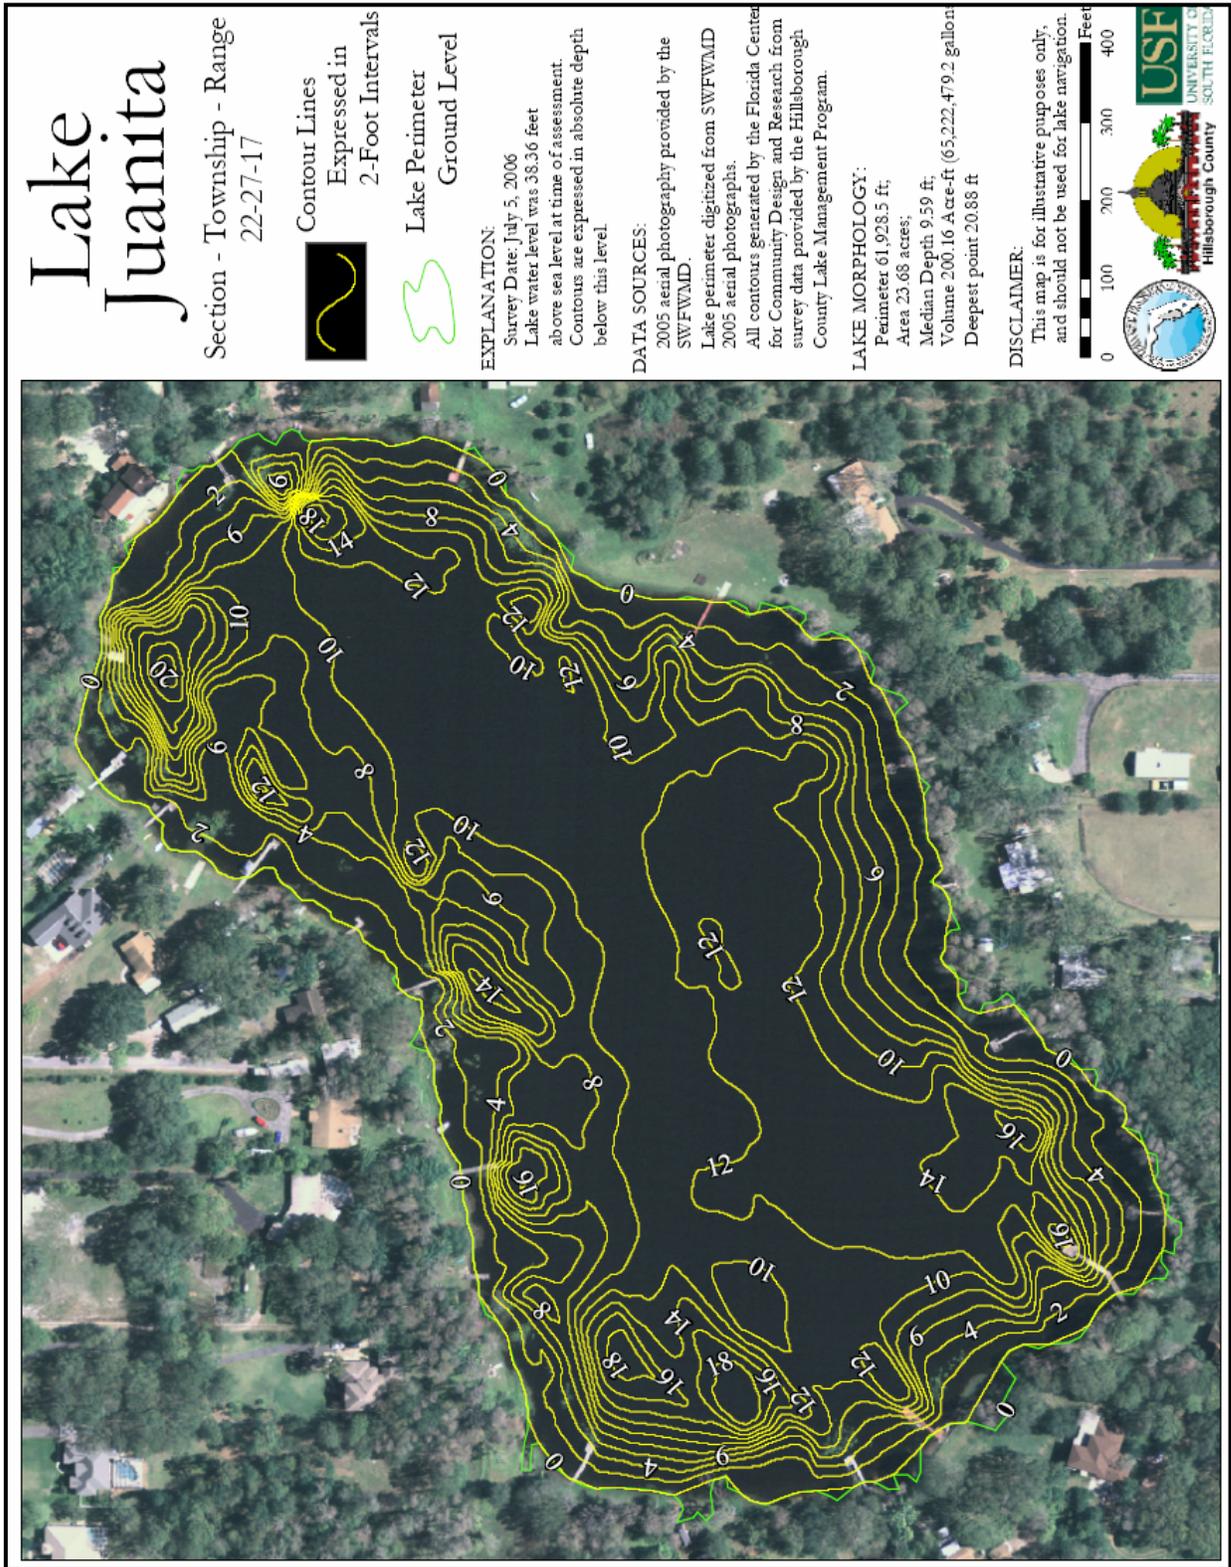
Figure 2. Contour map for Lake Juanita. The lake was mapped during the 2006 lake assessment project. A differential global positioning system and fathometer combination instrument was used to obtain simultaneous horizontal and vertical measurements.

Bathymetric Mapⁱⁱ. The bottom of the lake was mapped using a Lowrance LCX 26C HD Wide Area Augmentation System (WAAS)ⁱⁱⁱ enabled Global Positioning System (WAAS-GPS) with fathometer (bottom sounder) to determine the boat’s position, and bottom depth in a single measurement. The result is an estimate of the lake’s area, mean and maximum depths, and volume and the creation of a bottom contour map (Figure 1). Besides pointing out the deeper fishing holes in the lake, the morphologic data derived from this part of the assessment can be valuable to overall management of the lake vegetation as well as providing flood storage data for flood models. Table 1 provides the lake’s morphologic parameters in various units.

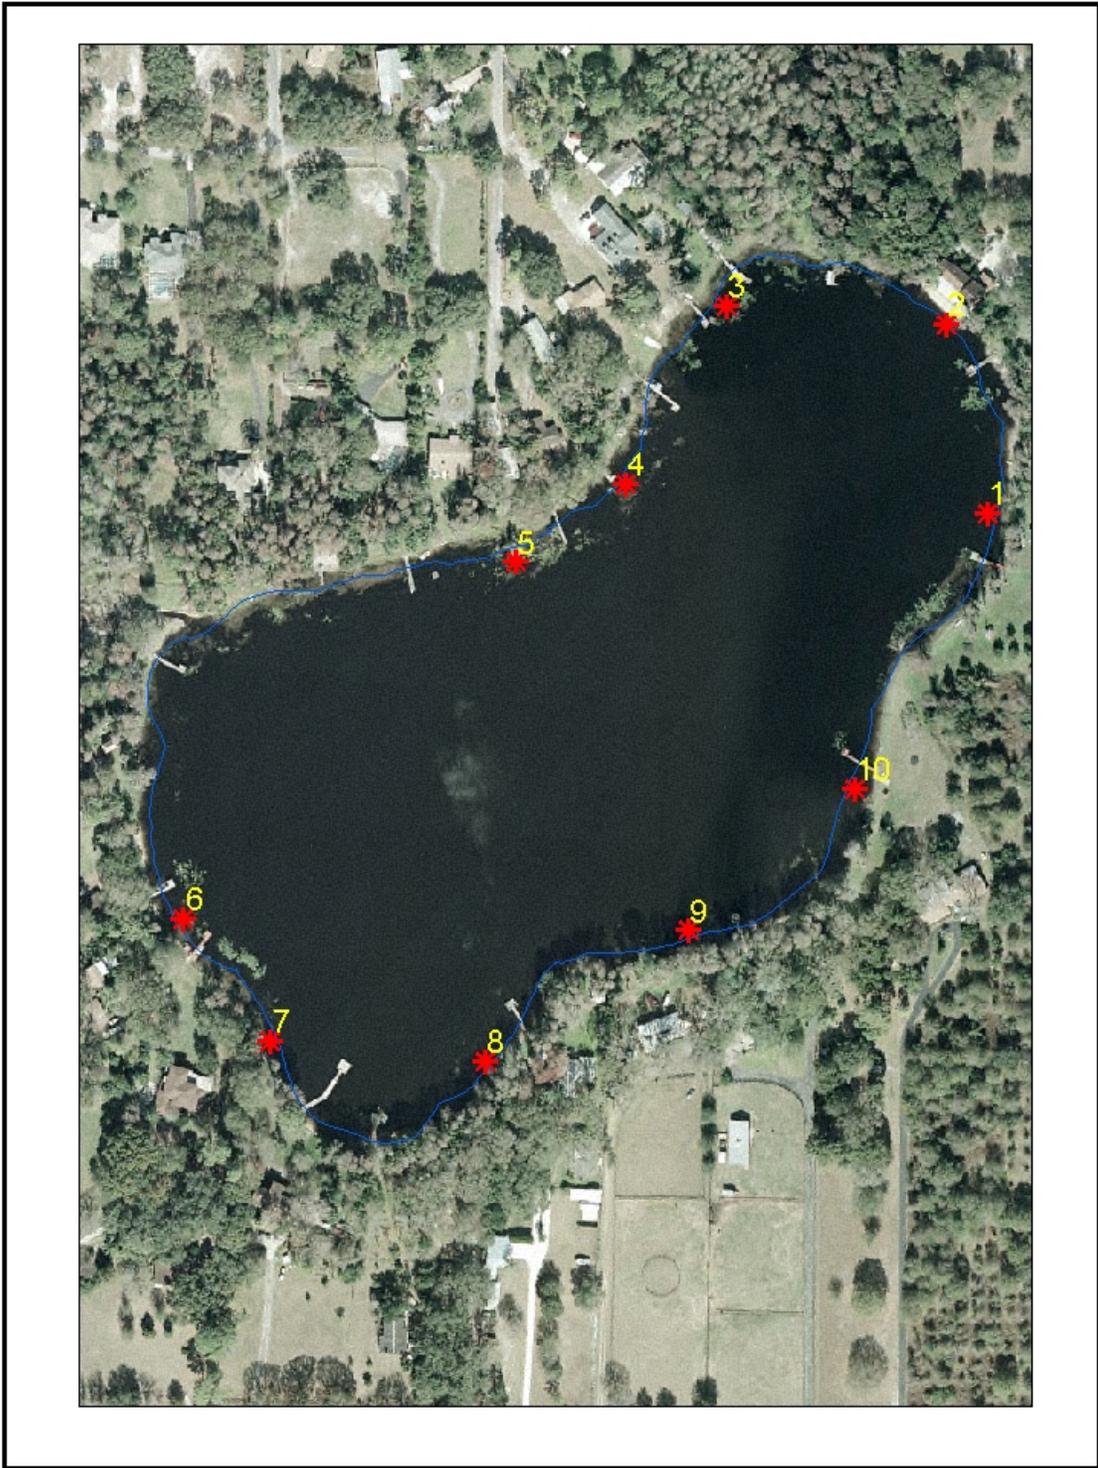
Figure 3. 2005 six inch resolution aerial and vegetation assessment sites on Lake Juanita.

The lake's apparent vegetative cover and shoreline detail are evaluated using the aerial shown in Figure 3 and by use of GPS. Submerged vegetation is determined from evenly spaced contours sampled using a Lowrance 26c HD, combined DGPS/fathometer described earlier. Ten vegetation assessment sites were used for Lake Juanita (Figure 3) as dictated by the *Lake Assessment Protocol* (copy available on request) for a lake of this size. The site positions are set using a DGPS and then loaded into a GIS mapping program (ArcGIS) for display. Each site is field sampled in the three primary vegetative zones (emergent, submerged and floating). The latest aerials (2005, 6 inch resolution, SWFWMD aerials) are used to provide shore details (docks, structures, vegetation zones) and to calculate the extent of surface vegetation coverage. The primary indices of submerged vegetation cover and biomass for the lake, percent area coverage (PAC) and percent volume infestation (PVI), are determined by transiting the lake by boat and employing a fathometer to collect "hard and soft return" data. These data are later analyzed for presence and absence of vegetation and to determine the height of vegetation if present. The PAC index is determined from the presence and absence analysis of 100 sites in the lake and the PVI index is determined by measuring the difference between hard returns (lake bottom) and soft returns (top of vegetation) for sites (within the 100 analyzed sites) where plants are determined present.

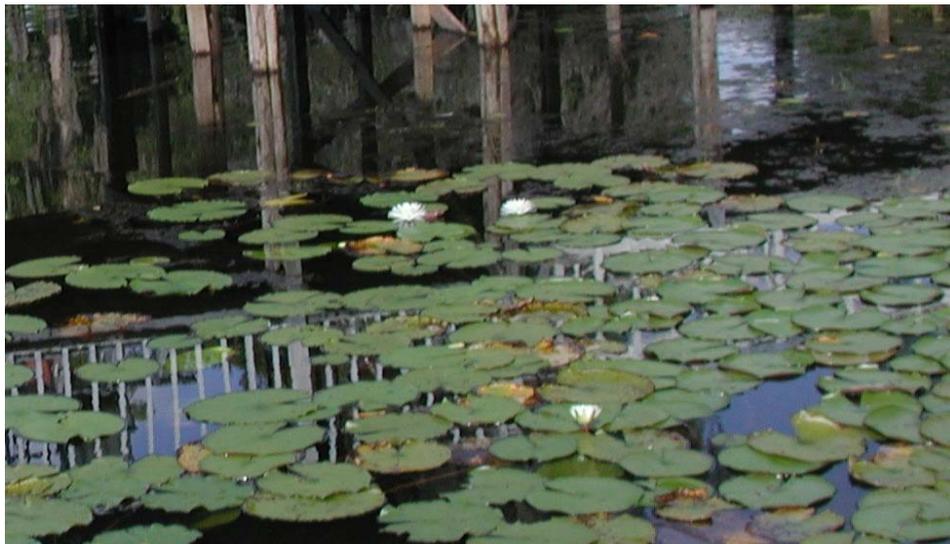
Figure 4. Fragrant Water Lily (*Nymphaea odorata*) is very common on Lake Juanita.

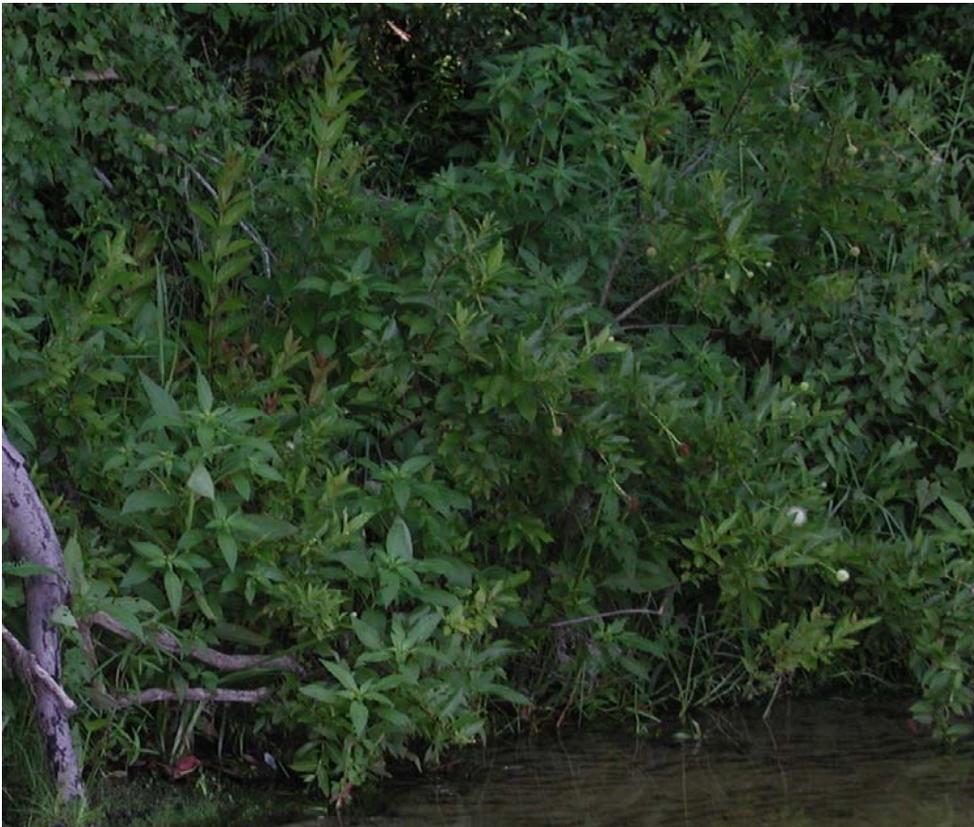
Figure 5. Common Buttonbush (*Cephalanthus occidentalis*) and Primrosewillow (*Ludwigia spp.*) growing on the shoreline of Lake Juanita.

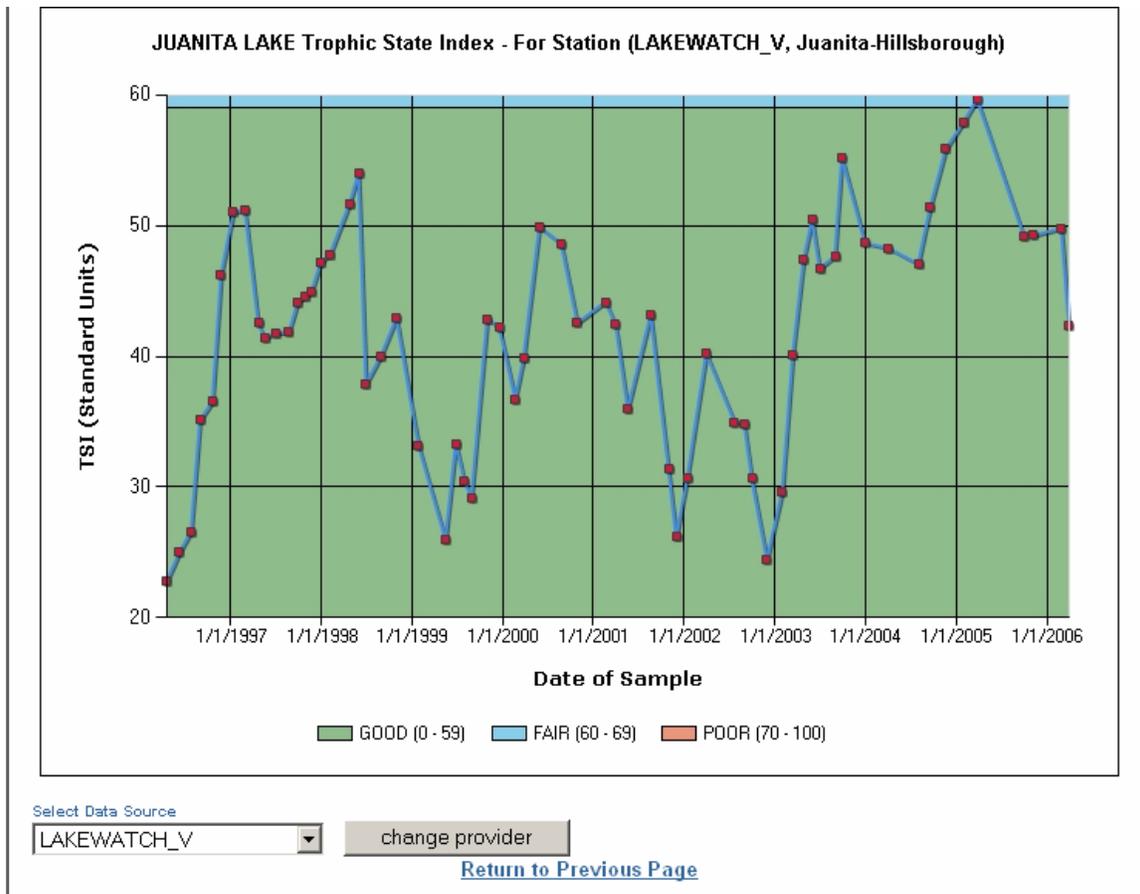
Figure 6a. Recent Trophic State Index graph from Hillsborough Watershed Atlas.

Note: The graph above includes benchmarks for using verbal descriptors of "good", "fair" and "poor". The verbal descriptors for these benchmarks are based on an early determination by stakeholders of the generally acceptable and understood terms for describing the state of lakes. The same benchmarks are used for nutrient graphs (Nitrogen and Phosphorus), chlorophyll graphs and trophic state index (TSI) graphs. The TSI is a calculated index of lake condition based on nutrient and chlorophyll (a) concentrations (please see "Learn more about Trophic State Index"). The benchmarks are established based on the TSI range that relates to a specific descriptor. The source for the TSI concentration relationships is the [Florida Water Quality Assessment, 1996, 305\(b\)](#) (Table 2-8). For many lakes there is more than a single source of water quality data. You have the option with the "Select Data Source" drop down to select any available data source and create the graph using that source or you may select "All" to graph all available data. The graph header will also change to reflect the source used.

A critical element in any lake assessment is the long-term water chemistry data set. The primary source of water quality trend data for Florida Lakes is the Florida LAKEWATCH volunteer and the Florida LAKEWATCH water chemistry data. Hillsborough County is fortunate to have a large cadre of volunteers who have collected lake water samples for significant time period. These data are displayed and analyzed on the Water Atlas as shown in Figure 6 for Lake Juanita. Additional data, when available, is also included on the Water Atlas; however, the LAKEWATCH data remains the primary source. By the trend data shown in Figures 6a and 6b, the lake may be considered good health in terms of the trophic state index. Lake Juanita is a clear water lake and as such it must maintain a TSI of below 40 to not be considered impaired by the State of Florida guidelines^{iv}. Lake Juanita's long term water quality data indicates enough violations of these criteria to be classified by Florida DEP as impaired. These violations are seen in both the LAKEWATCH (6a) and FDEP (6b) sample data. The more recent trends indicate a continuation of these violations.

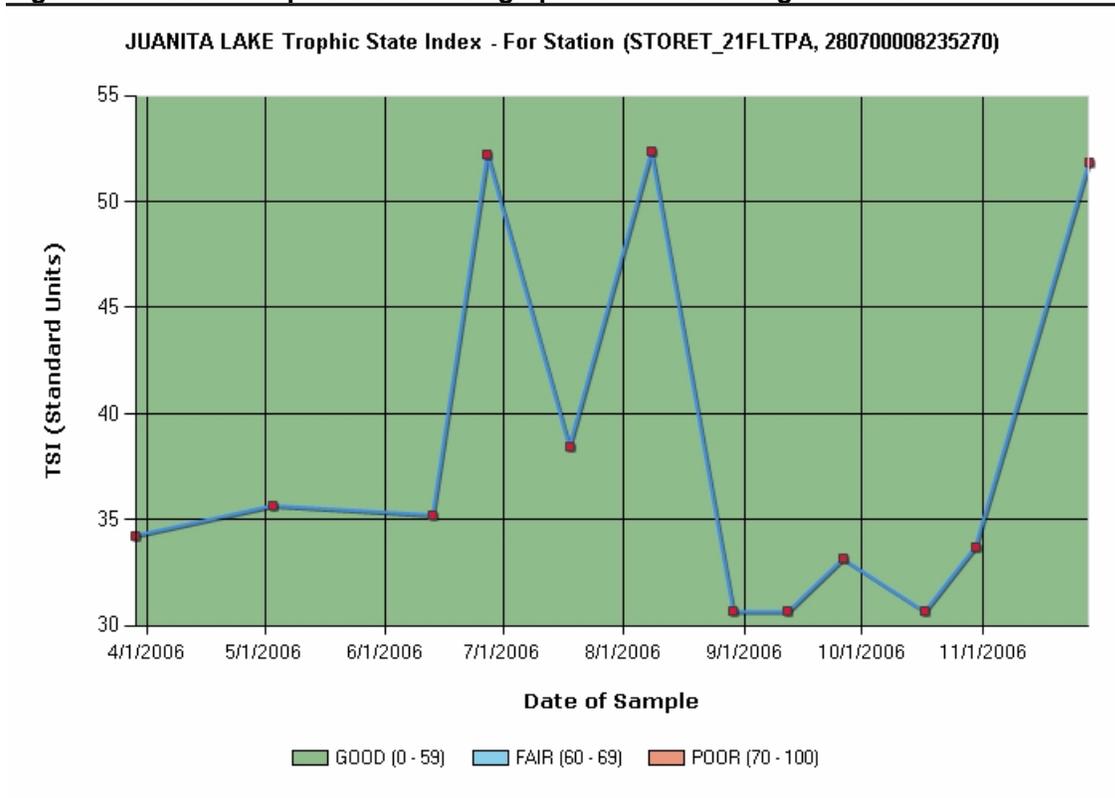
Figure 6b. Recent Trophic State Index graph from Hillsborough Watershed Atlas.

Note: The graph above includes benchmarks for using verbal descriptors of "good", "fair" and "poor". The verbal descriptors for these benchmarks are based on an early determination by stakeholders of the generally acceptable and understood terms for describing the state of lakes. The same benchmarks are used for nutrient graphs (Nitrogen and Phosphorus), chlorophyll graphs and trophic state index (TSI) graphs. The TSI is a calculated index of lake condition based on nutrient and chlorophyll (a) concentrations (please see "Learn more about Trophic State Index"). The benchmarks are established based on the TSI range that relates to a specific descriptor. The source for the TSI concentration relationships is the [Florida Water Quality Assessment, 1996, 305\(b\)](#) (Table 2-8). For many lakes there is more than a single source of water quality data. You have the option with the "Select Data Source" drop down to select any available data source and create the graph using that source or you may select "All" to graph all available data. The graph header will also change to reflect the source used.

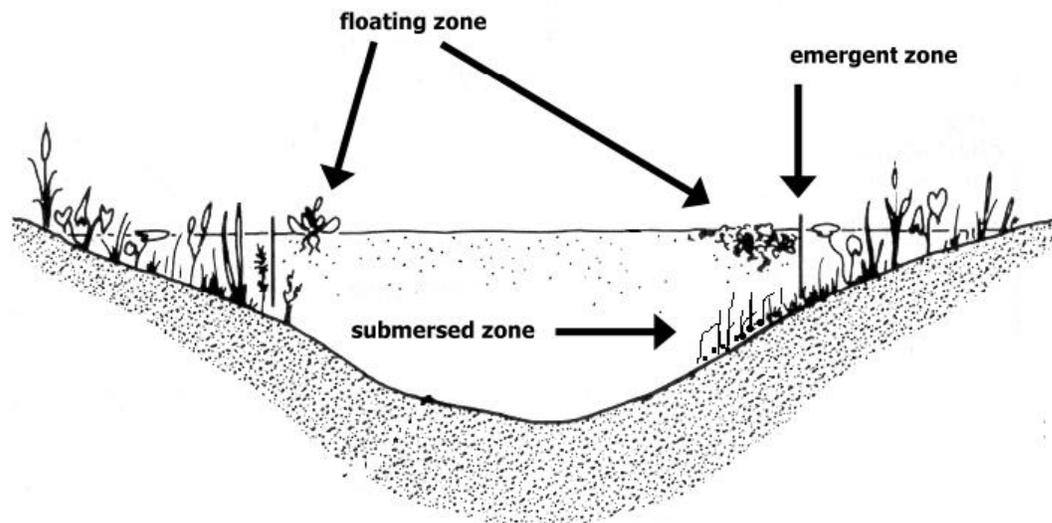
iv The three primary aquatic vegetation zones are shown below:
